# THERMAL SEGREGATION OF ASPHALT MATERIAL IN ROAD REPAIR

Juliana, BYZYKA  
Ph.D. Researcher  
Brunel University  
United Kingdom

## ABSTRACT

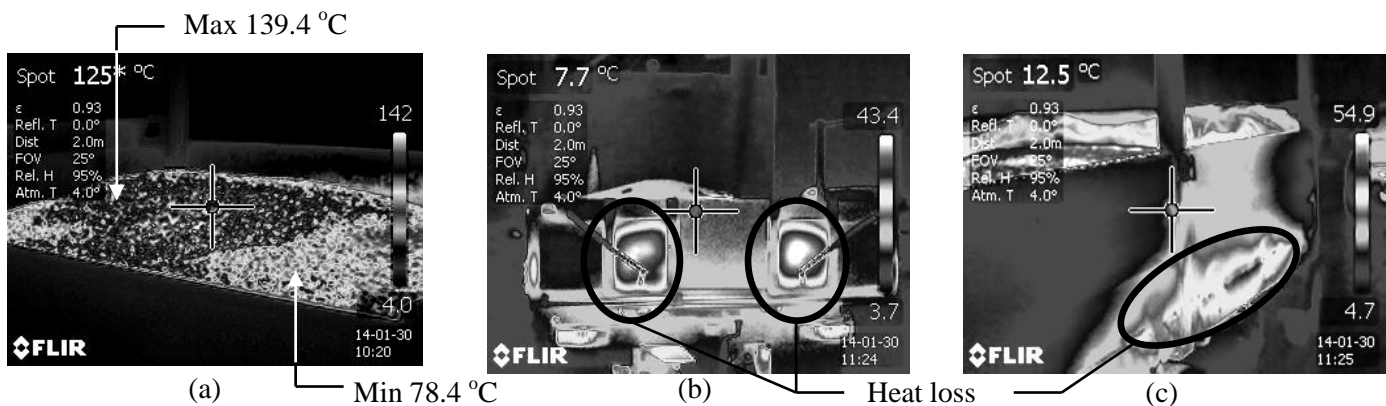
Company B was monitored during their patch repair activity on repair site 6, between the production facility and the single repair site. The process of transportation of Company B is very similar to that of Company A. A type of end dump truck was used to transport asphalt. When asphalt was loaded onto the track it was covered by a sheet. The prevailing weather temperature was around 0 °C (refer to Table 1). Thermal images of the asphalt were taken 5 minutes after it was loaded onto the truck, as shown in Figure 4(a).

Average, maximum and minimum temperatures were determined from the three thermal images with one of them shown in Figure 4(a), these being 138.8 °C and 79 °C respectively. Taking into consideration that the initial temperature of the asphalt was around 150 °C, the temperature had dropped dramatically and reached a difference of 11.2 °C between initial temperature and average maximum monitored, and a difference of 71 °C between initial temperature and average minimum. Therefore, it is apparent that the Company A transportation process results in notable heat loss and, thermal segregation. Further, Figures 4(b) and (c) demonstrate a heat loss from the joints at the back and alongside the vehicle respectively.

Figure 4: Thermal images indicating heat loss (a) Thermal image of asphalt on back of the truck five minutes after collection, (b) Thermal image on the back of the truck and (c) Thermal image alongside the vehicle

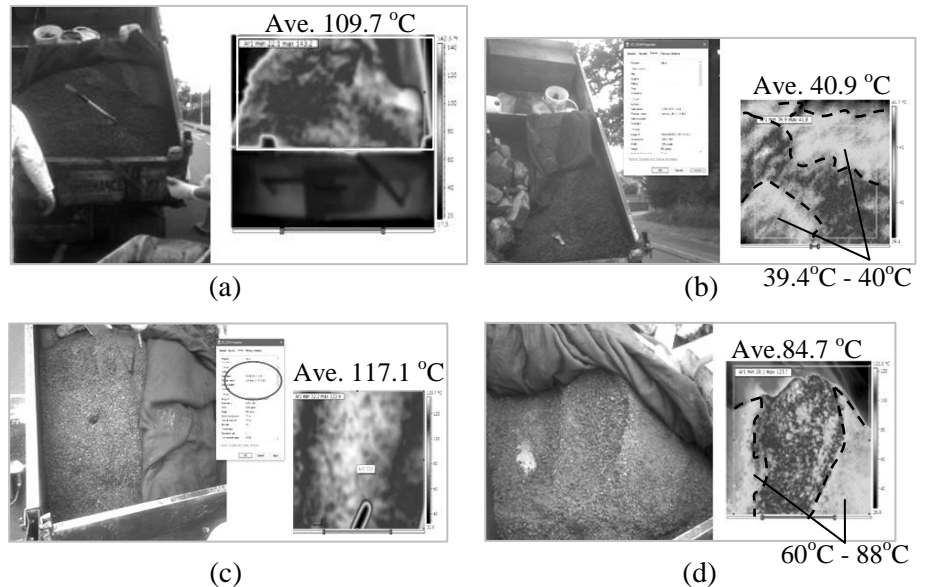
Figures 5 (a), (b), (c) and (d) present the asphalt and its thermal images when arrived at sites 7, 8, 9 and 10 respectively. Figures 6 (a) and (b) demonstrate the temperature variations when asphalt was loaded onto the truck, and when it was arrived on each repair site. As the results display, during asphalt transportation on day 1 there was an overall heat loss of 69% and on day 2 a temperature decrease of 35.9%.

Figure 5: Thermal images of asphalt at (a) Repair site 7, (b) Repair site 8, (c) Repair site 9 and (d) Repair site 10

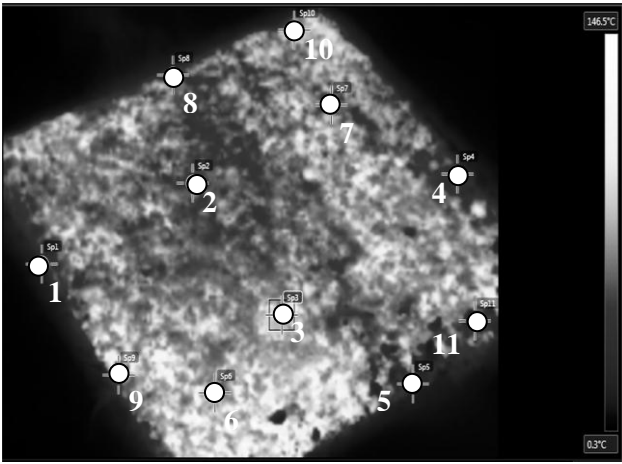
For Company A, Figures 7 and 8 were taken after compaction of the repairs at site 1. Figure 7 presents eleven points taken randomly on the mat. The maximum temperature in the image is 146.5 °C. The temperatures of the eleven points shown on Figure 7 are presented on Table 4. The results indicate uneven temperature distribution. In other words, this means that areas with low temperatures are most likely to fail if these temperatures reach cessation temperature and continue to decrease below that. As revealed from the measurements, most of the points had reached and decreased below cessation temperature. Therefore, the compaction during this stage was ineffective.

Figure 7: First thermal image of patch repair on paving site 1 immediately after compaction

No	Temperature °C
Point 1	38.3
Point 2	60.3
Point 3	90.5
Point 4	34.9
Point 5	39.5
Point 6	92.8
Point 7	73.7
Point 8	50.7
Point 9	80.2
Point 10	85.0
Point 11	46.5

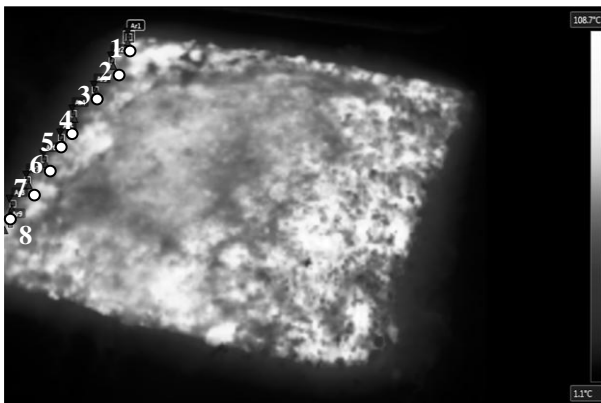
Figure 8 is the second thermal image taken after compaction at repair site 1. On this occasion eight points were chosen from the edge of the patch repair. The thermal image recorded a general maximum temperature of 108.7 °C in the mat which means that the compaction could be completed without major problems. However, the eight measurements on the edge of the patch repair revealed temperatures below the cessation temperature (refer to Table 5). Hence, although rollers can continue to improve smoothness and surface texture on the mat, compaction will generally not occur which would result on premature failure of the patch repair

Figure 8: Second thermal image of patch repair on paving site 1 immediately after compaction

No	Maximum °C	Minimum °C	Average °C
Point 1	43.2	27.8	35.5
Point 2	57.9	49.7	53.8
Point 3	51.1	48.7	49.9
Point 4	42.8	33.3	38.1
Point 5	53.5	44.9	49.2
Point 6	50.0	40.3	45.2
Point 7	48.4	39.9	44.2
Point 8	44.8	33.6	39.2

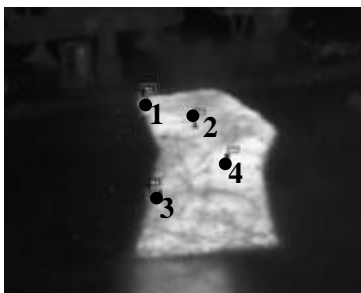
Figure 9 represents the third thermal image taken at repair site 2. After compaction four different points were selected to understand the variation in temperature. Further, for each point seven measurements were collected at different times. Points 1 and 3 were taken on the edges of the mat, and points 2 and 4 in the middle area of the mat. The measurements showed that different locations of the mat exhibit different repair quality. The points located on the edges (points 1 and 3) had lower temperatures than those located in the middle of the mat (points 2 and 4). The temperature reduced, reaching after 19 minutes from the first thermal image shot a temperature difference of 56.4 °C for point 1, 30.6 °C for point 2, 53.3 °C for point 3 and 32.9 °C for point 4 (refer to Table 6). This means that the average percentage of temperature reduction on the edges was 51% and in the middle 29%. Consequently, the edges of the repair appear to have a temperature difference with the middle of the mat of around 22%.

Figure 9: Thermal image of patch repair immediately after compaction on repair site 2

Thermal Image No	Time (min)	Temperature °C			
		Point 1	Point 2	Point 3	Point 4
1	15:34	109.1	109.1	109.1	109.1
2	15:36	101.2	107.0	100.5	101.5
3	15:37	95.5	104.0	95.0	98.0
4	15:39	84.0	94.0	85.0	90.0
5	15:40	72.0	86.3	75.3	89.0
6	15:43	61.0	84.0	66.8	81.7
7	15:45	52.7	78.5	55.8	76.2

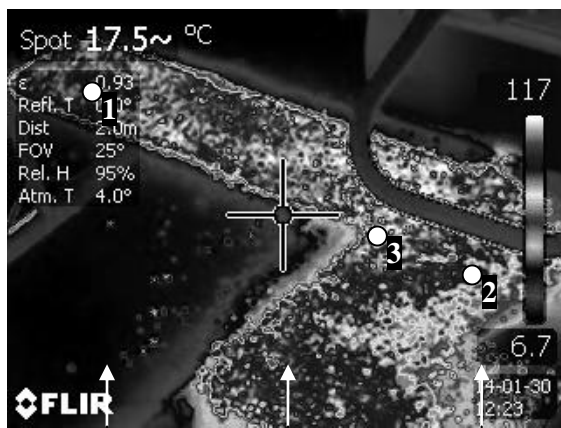
Figure 10 presents the patch repair area that Company B completed. In this figure there are shown three points where temperature was measured using the thermal imaging camera. Point 1 was situated away from the kerb line and drainage area. Point 2 was located near the kerb line and within the drainage area. Finally, Point 3 was at the edge between the new and old reinstatements. The temperature recordings for each point was as displayed in Table 7 where for each point eight temperature measurement were collected at different time. All points had an initial temperature of 100 °C. This is a 50 °C drop from 150 °C of asphalt temperature when it was collected from the production plant.

Further, the results presented on Table 7 indicate that in a period of 5 minutes temperature dropped for point 1 around 33%, for point 2 around 65% and for point 3 around 71%. As expected, having into consideration the results of temperature drop from Company A, points 2 and 3 displayed greater temperature reduction due to their position near the edge of the repair. As a result, the areas with less temperature of the cessation temperature tend to have lower density and cause failure of the patch repair around them.

Figure 10: Thermal image of patch repair immediately after compaction on repair site 6

Thermal Image No	Time (min)	Temperature °C		
		Point 1	Point 2	Point 3
1	12:22	100.0	100.0	100.0
2	12:23	98.0	92.7	81.4
3	12:23	92.0	79.0	75.1
4	12:24	84.6	73.6	73.6
5	12:24	77.1	69.2	57.6
6	12:25	76.6	44.3	39.2
7	12:26	73.8	36.5	33.5
8	12:27	66.7	35.2	29.4

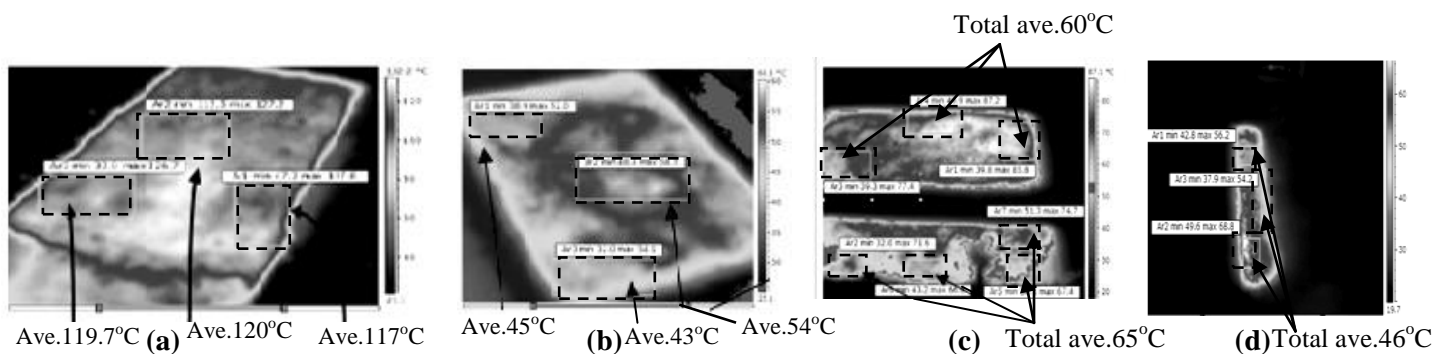
In contrast with the other two companies, temperatures during these repairs were measured on areas and not on specific points. Between sites 7 and 8, which were finalized at the same day with site 7 being completed first, thermal images showed quite acceptable levels of temperature for site 7 with an average temperature of 110.6 °C. However, on site 8 the average temperature was quite below cessation temperature (determined by pave-cool (Minnesota Department of Transportation, 2016)) and reached an average of 43 °C. Regarding sites 9 and 10 (completed the second day) the average temperatures were 60 °C and 65 °C for site 9, and 46 °C for site 10. On all repair sites the temperature on the edges was quite low (refer to Figure 11) as was seen on repairs of Company A and B.

Figure 11: Thermal image of patch repairs immediately after compaction on (a) Repair site 7, (b) Repair site 8, (c) Repair site 9, and (d) Repair site 10

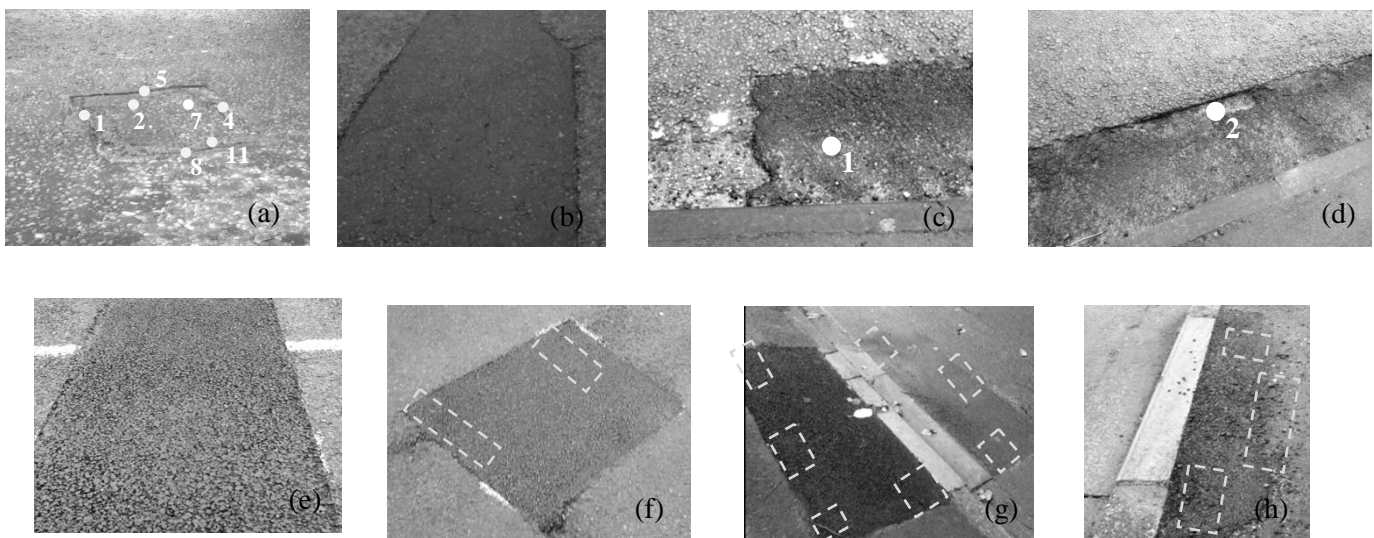
All the repaired sites were revisited three months after completion of the repair work. As is shown on the images of Figure 12, along the edges of the reinstatement, the new material had started to fall away. This is considered to be due to temperature differentials between the new and old surfaces, the temperatures in the material dropped below the cessation temperature when was laid and therefore inadequate compaction was occurred. On the other hand, on areas of the patch repair where the temperature was retained at levels over the cessation temperature there was no apparent deterioration.

Figure 12: Patch repair sites after three months of completion (a) Repair site 1, (b) Repair site 2, (c) and (d) Repair site 6, (e) Repair site 7, (f) Repair site 8, (g) Repair site 9 and (h) Repair site 10

Further, at all images of Figure 12 are included the points and areas respectively examined under the “Effect of compaction” section of this paper regarding their temperature levels after compaction. Those points and areas are the places with excessively low temperatures that correspond to failures shown on most of the images of Figure 12, excluding the images of 12(b) and (e) that continue to be in good condition. The points of Figure 12(a) and 12(b) are related to Figure 7 and 9 respectively, the points of Figure 12(c) and (d) are related to Figure 10, and the marked areas of Figure 12(e) – 12(h) are related to Figure 11.
