## MICE Running April 2014

### Summary of Shifts

4th April: Target Double Dip Rate Commissioning: Hall preparation

5th April: Target Double Dip Rate Commissioning: Full running

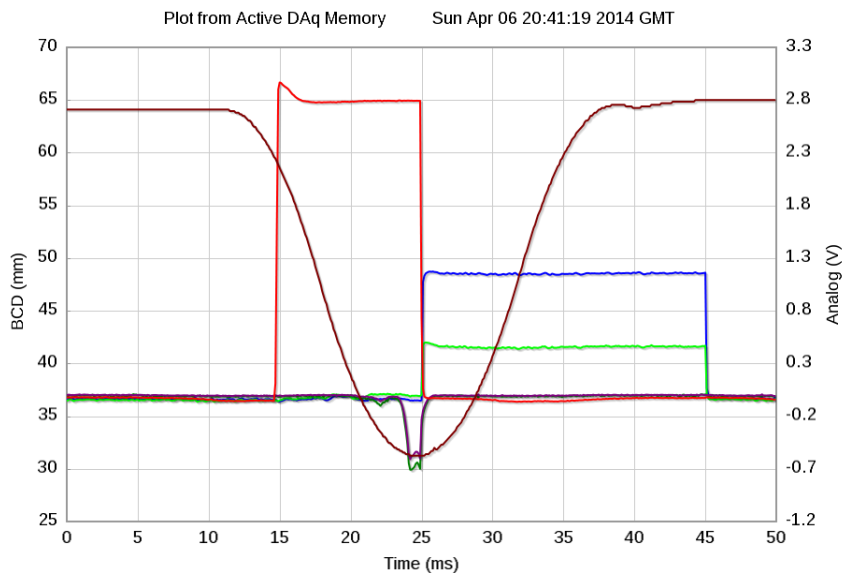
- Target coils running hotter 58-65 °C, but within tolerances
- Mid spill early beam loss peak more pronounced, but still negligible, see Fig. 1
- Stopped target and allowed it to cool (giving faster acceleration) and confirmed that its entry into beam on restart didn't cause unacceptable losses early in spill

Figure 1 Double rate dip at 4V beam loss

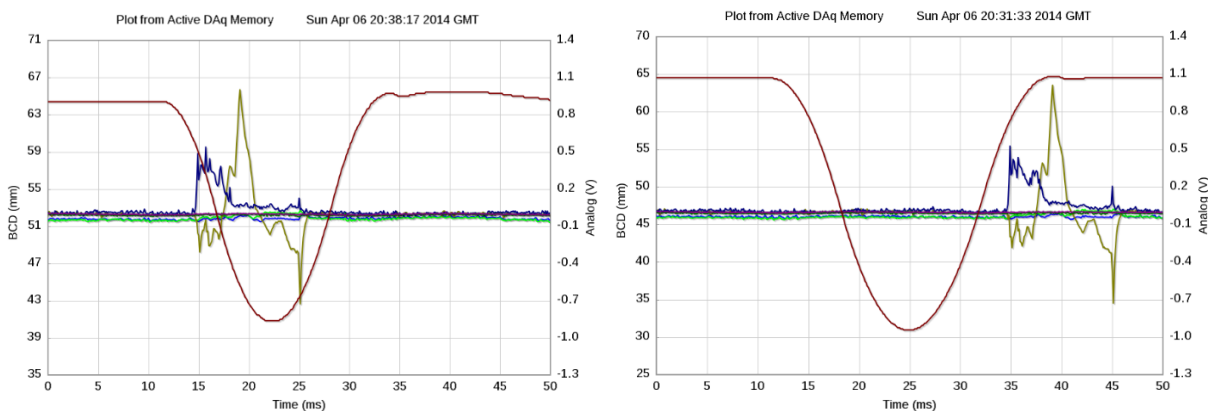
- Made target delay 20 ms earlier to test whether we would scrape next ISIS spill – no extra losses seen, ISIS happy that all is well (see Figs 2 and 3)

Figure 2 Left: Beam loss display with usual delay Right: Dip with 20 ms less delay, dipping into a “virtual” spill – no extra losses seen, indicating no scraping on next spill
