The Tumble Mode - Where Test Pilots Fear To Tread

Eur.Ing. Guy Gratton

Dr. Simon Newman

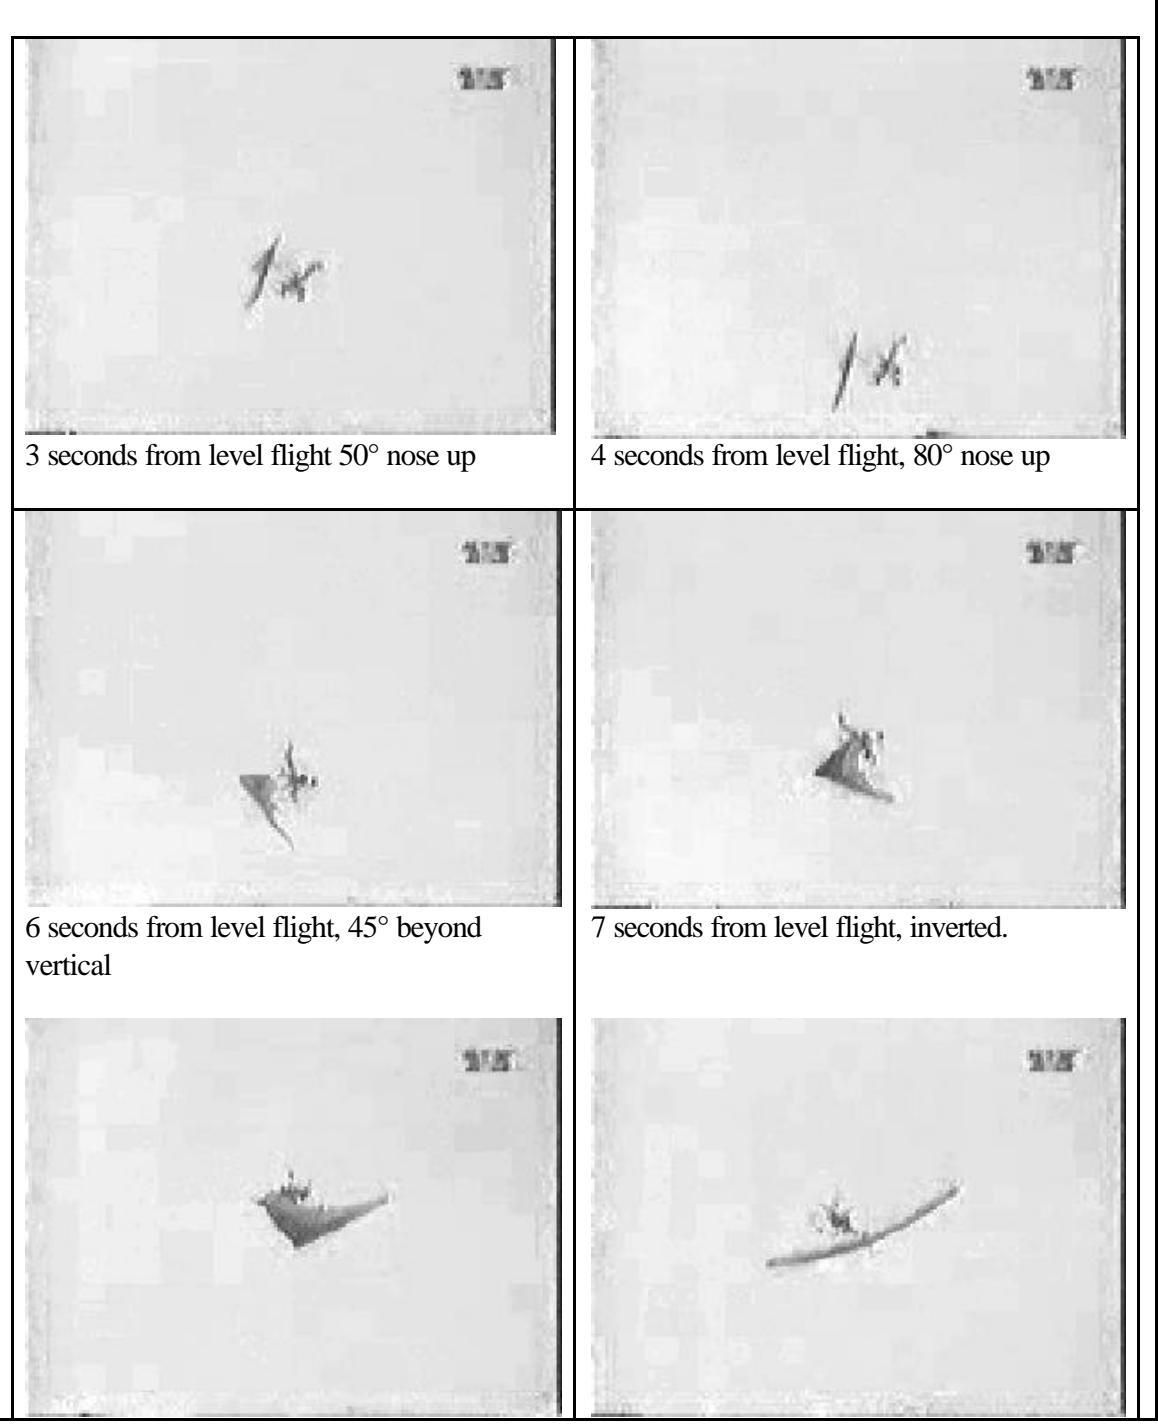
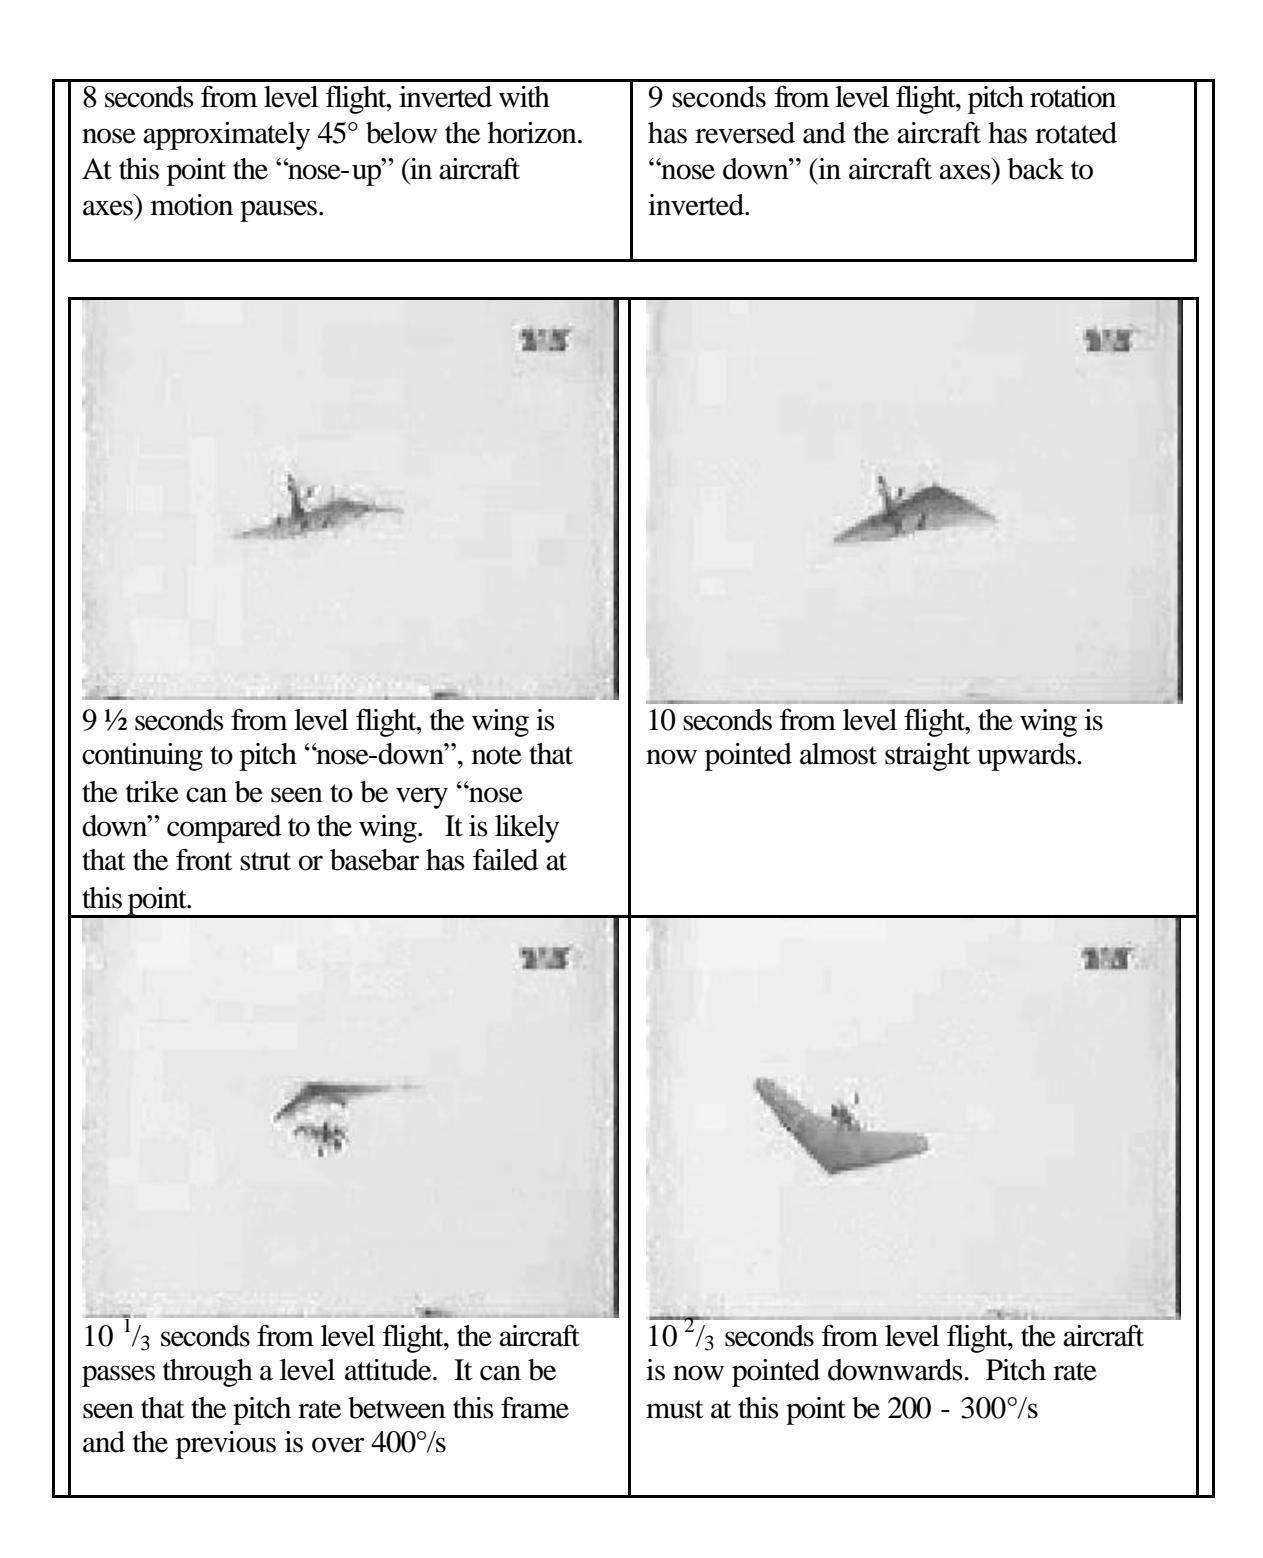
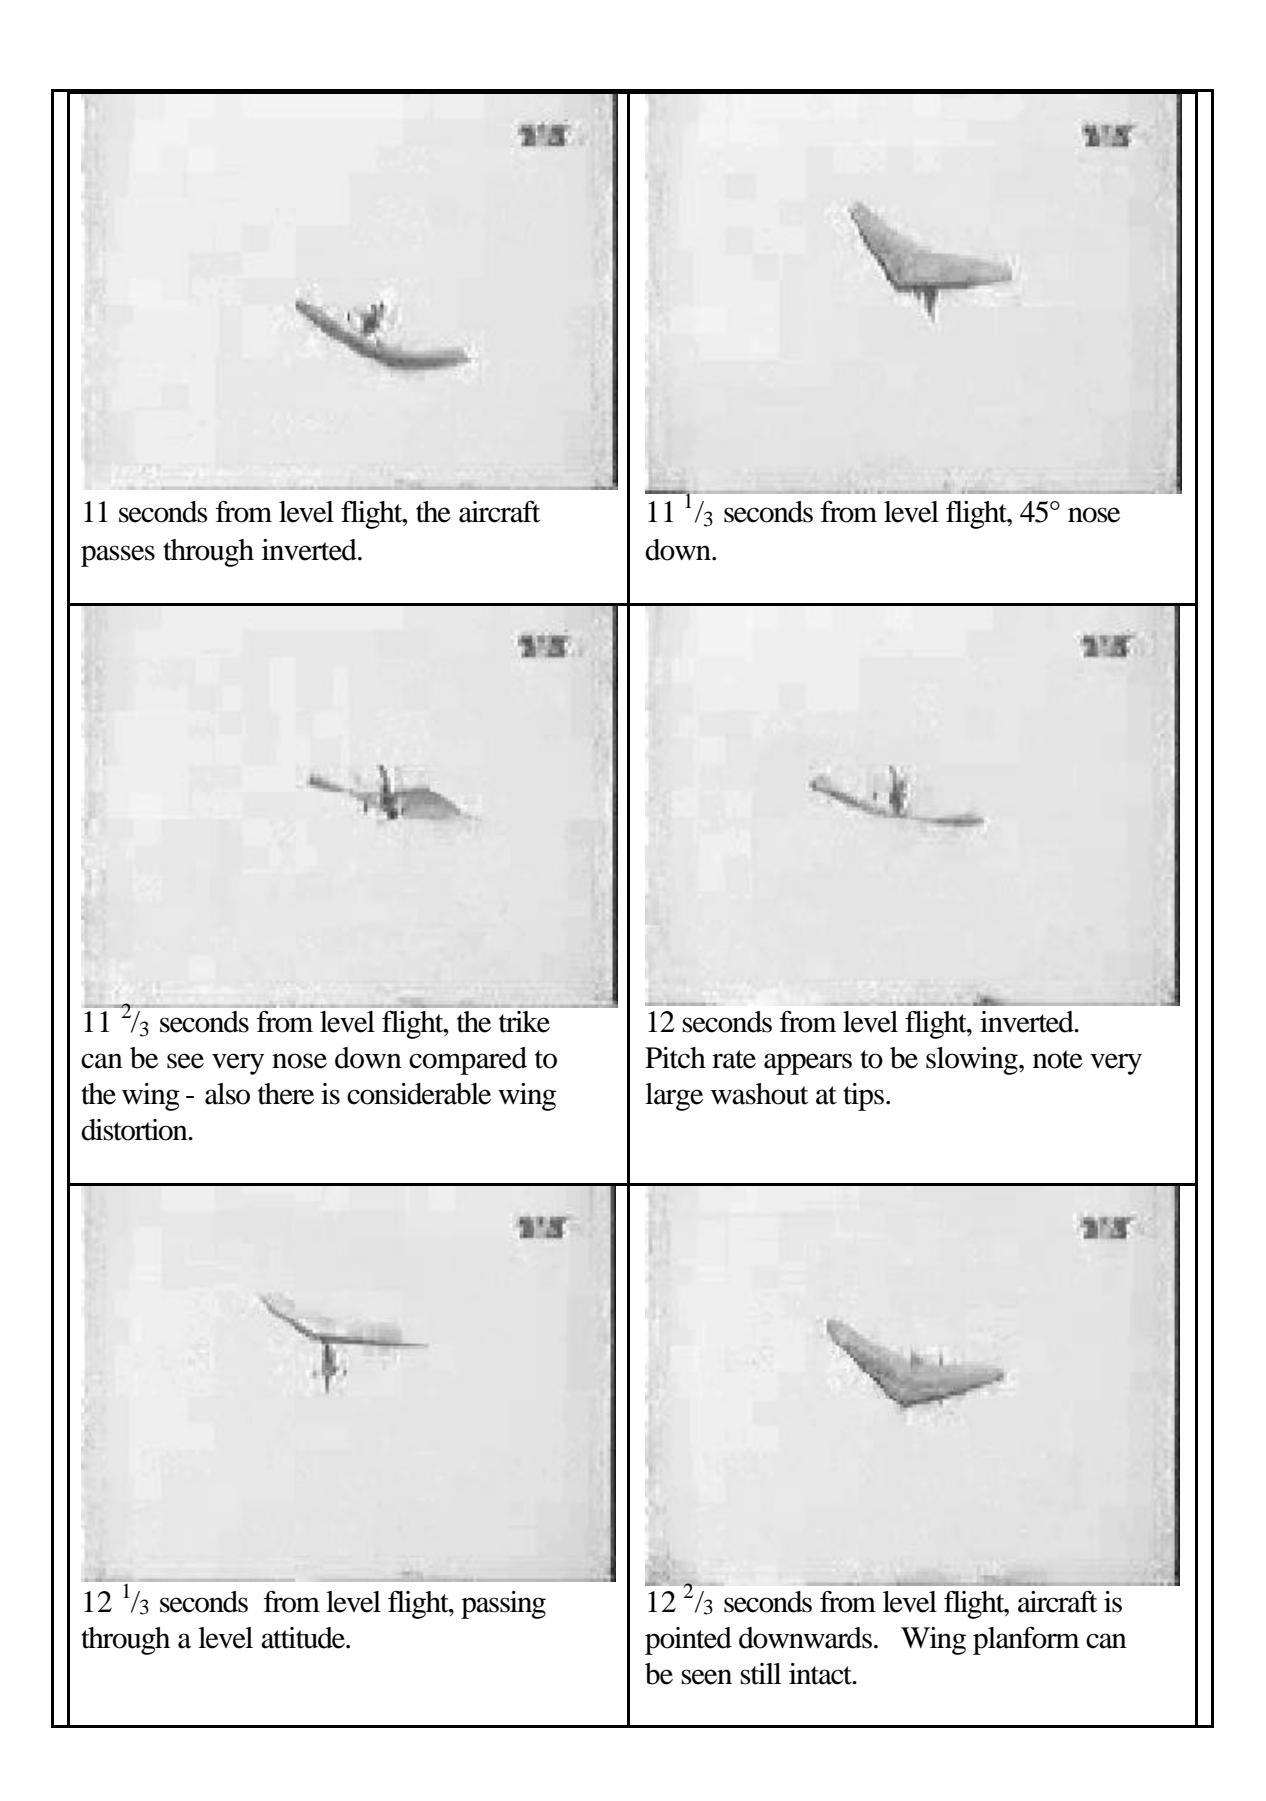
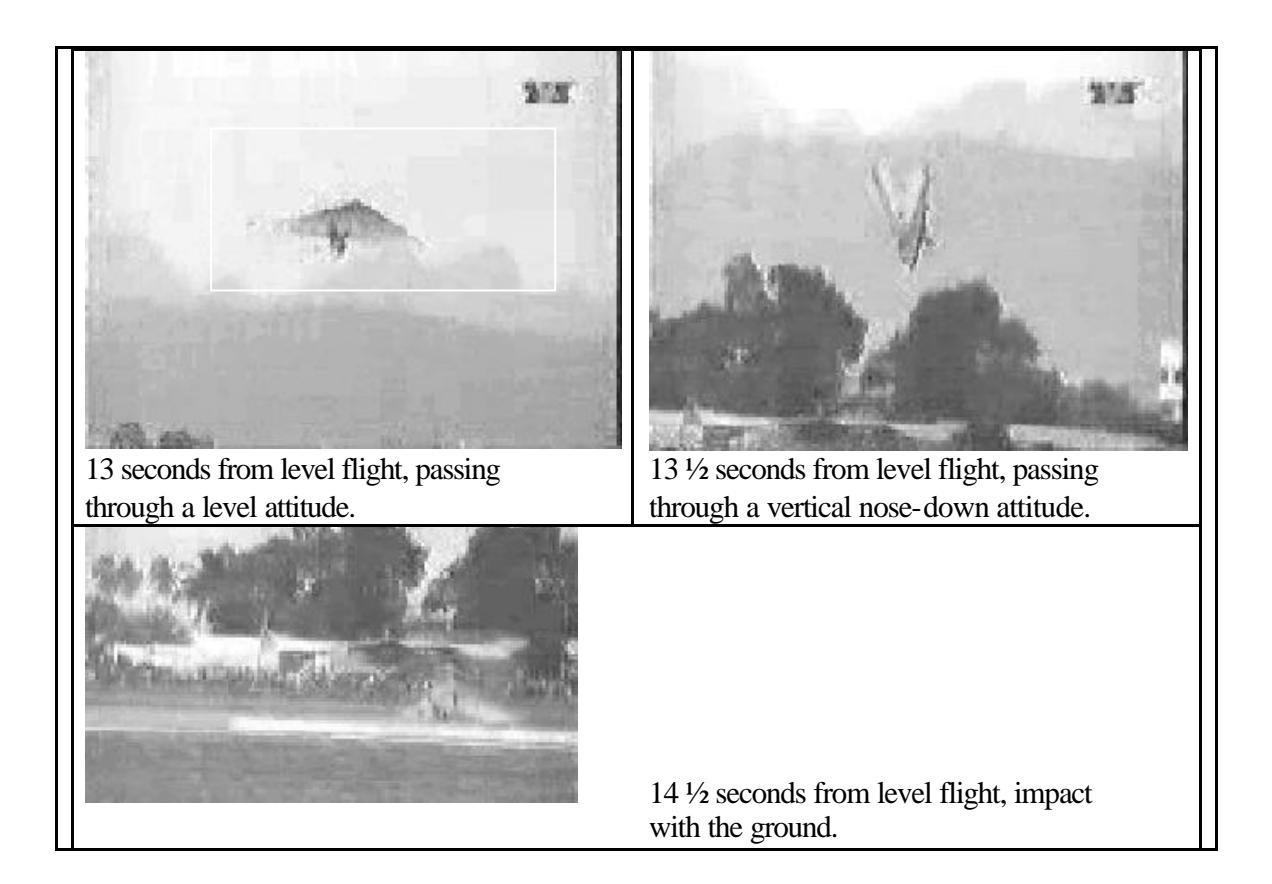
Figure 2, Illustration of a fatal tumble after a failed loop

The following sequence of photographs is the best known photographic evidence of a genuine tumble accident, the accident occurred at an airshow in Europe, and the type is identifiable as a French "Cosmos" aircraft. The accident is believed to have been fatal.

Figure 2) which shows the basebar and front strut apparently in continuous contact, together with the evidence from numerous wreckage inspections, which showed damage of both the basebar and front strut where they had struck each other.

Whilst weightshift microlight aircraft are neither approved, nor should be, for aerobatics, it is occasionally known for a misguided pilot to attempt aerobatic manoeuvres. There are several reported instances of pilots attempting to conduct a loop in such an aircraft. If positive normal acceleration is maintained throughout this manoeuvre then it can be executed as safely as in any other aircraft. However, as with any other aircraft, if the aircraft runs out of kinetic energy near to the top of the loop, then the pilot finds himself inverted without sufficient airspeed to complete the manoeuvre. In this case, the inevitable consequence will be a negative N_Z , leading potentially to a tumble. This is adequately demonstrated in

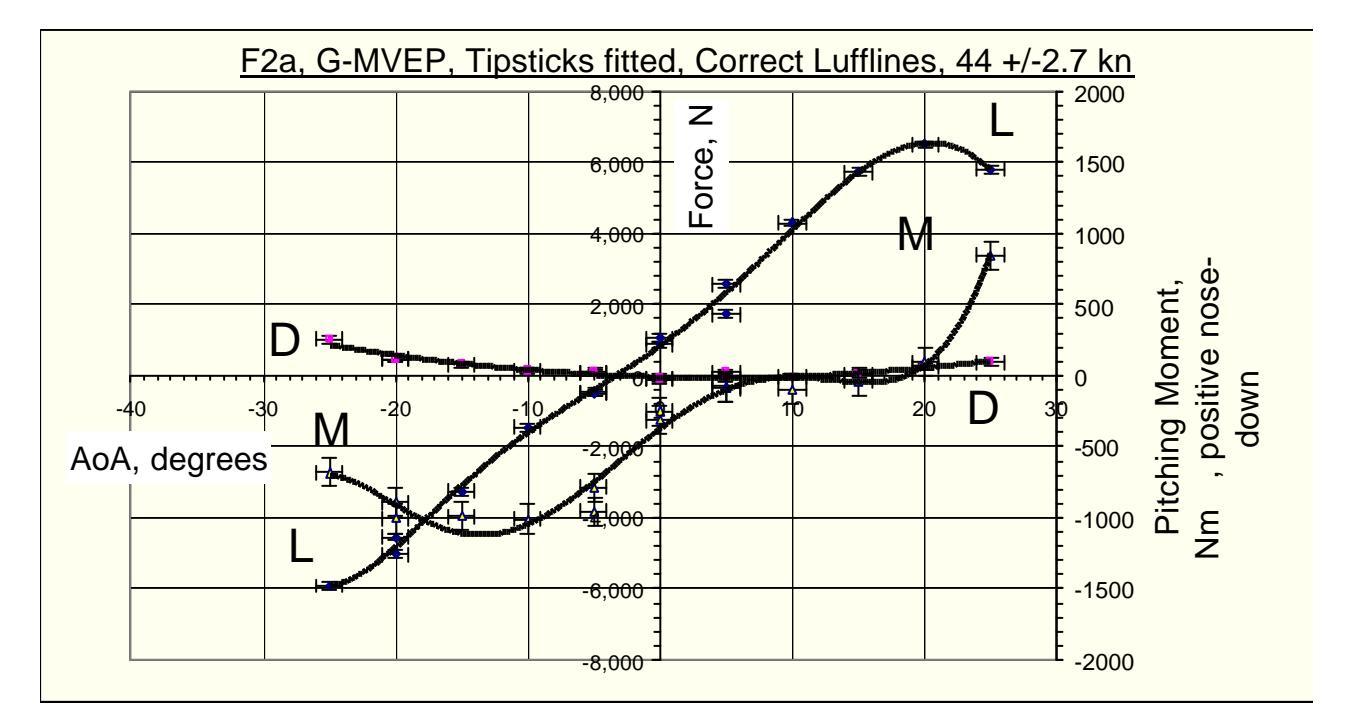
Figure 4, Characteristics of Mainair Flash 2 alpha wing

This produced a great deal of data, and demonstrated well the extremely non-linear $C_M.v.AoA$ characteristics of this class of wing, as well as their susceptibility to minor adjustments in configuration. Figure 4 is a typical data presentation. As may be seen, the lift and drag characteristics are unremarkable, but the pitching moment characteristics different to those of a conventional rigid wing.

Nonetheless however, this curve (nor any other curve generated) in itself showed no characteristic which in itself indicated a risk of pitch autorotation. Therefore a further model was developed (not included in this paper, but may be found at Reference **[13]**. This model showed that the main player was not the wing characteristics alone, but the combination of wing and trike. This is counter-intuitive, since the hangpoint design is such that "stick free" no significant pitching (or rolling) moment(s) should be transmitted between the wing and trike, and the forces applied by the pilot to the basebar produce a relatively small pitching moment. However, the main evidence which brought this together was the video of a nose-down autorotation (

- ?? At the point of stall, the wing aerodynamic pitching moment becomes strongly nose down (**Figure 4**).
- ?? Simultaneously however, the trike pitches nose-down, initially rotating about the hangpoint until the front strut locks against the basebar, creating a rigid system upon which a net nose-down pitching moment is acting.

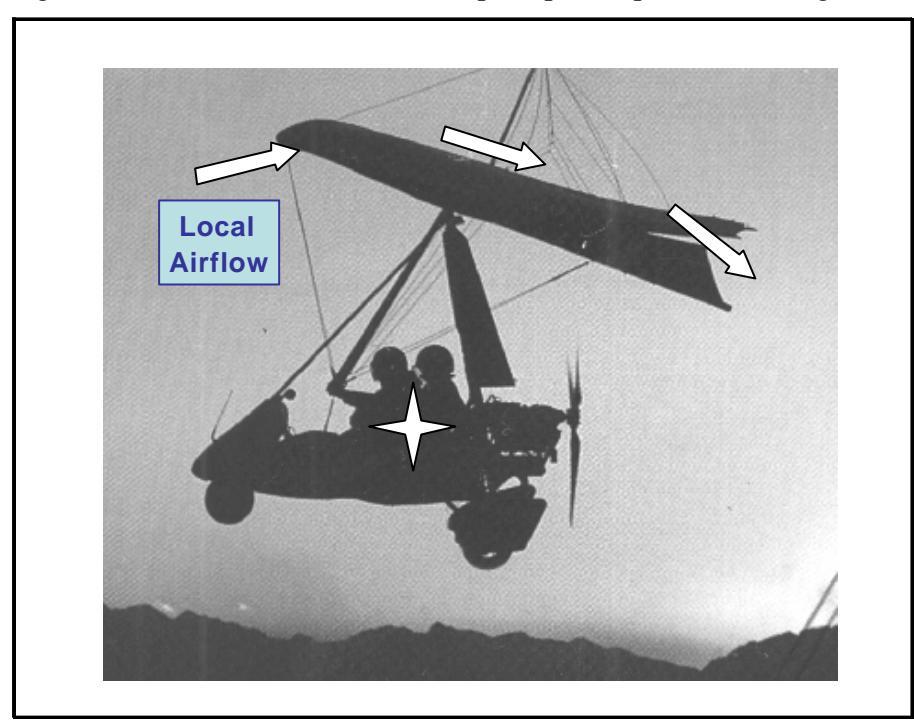
Figure 5, Illustration of induced flow, superimposed upon aircraft image

- ?? This creates what we have termed "induced flow", where the angle of attack becomes strongly positive at the leading edge and strongly negative at the trailing edge. This is illustrated in **Figure 5**, and creates effectively a wing with a large negative camber.

?? This "induced camber" locks the aircraft into the nose-down autorotation, which continues until the aircraft either hits the ground or breaks up.

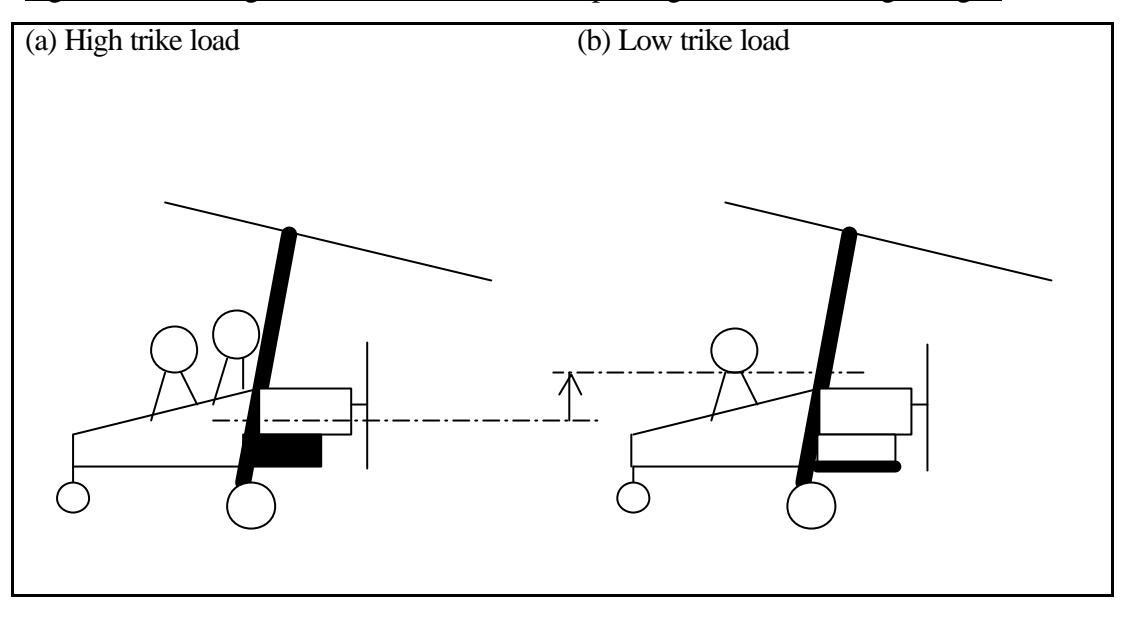
Figure 6, Illustrating the shift in vertical CG with passenger and fuel loading changes.

Related to this, it is known from the history of tumble accidents, that the more highly loaded the trike is, the less the aircraft will tend to tumble. Once the nose-down pitch departure occurs, a more lightly loaded trike will result in a whole-aircraft CG closer to the wing, and thus a greater angle of inflow into the wing – this is illustrated in **Figure 6** below. So, at a lower trike mass, the induced camber at the wing will be greater since the point of rotation will be closer to the wing. Also at lower trike mass, the rotational inertia in pitch will be less, causing a greater initial response to the induced flow.

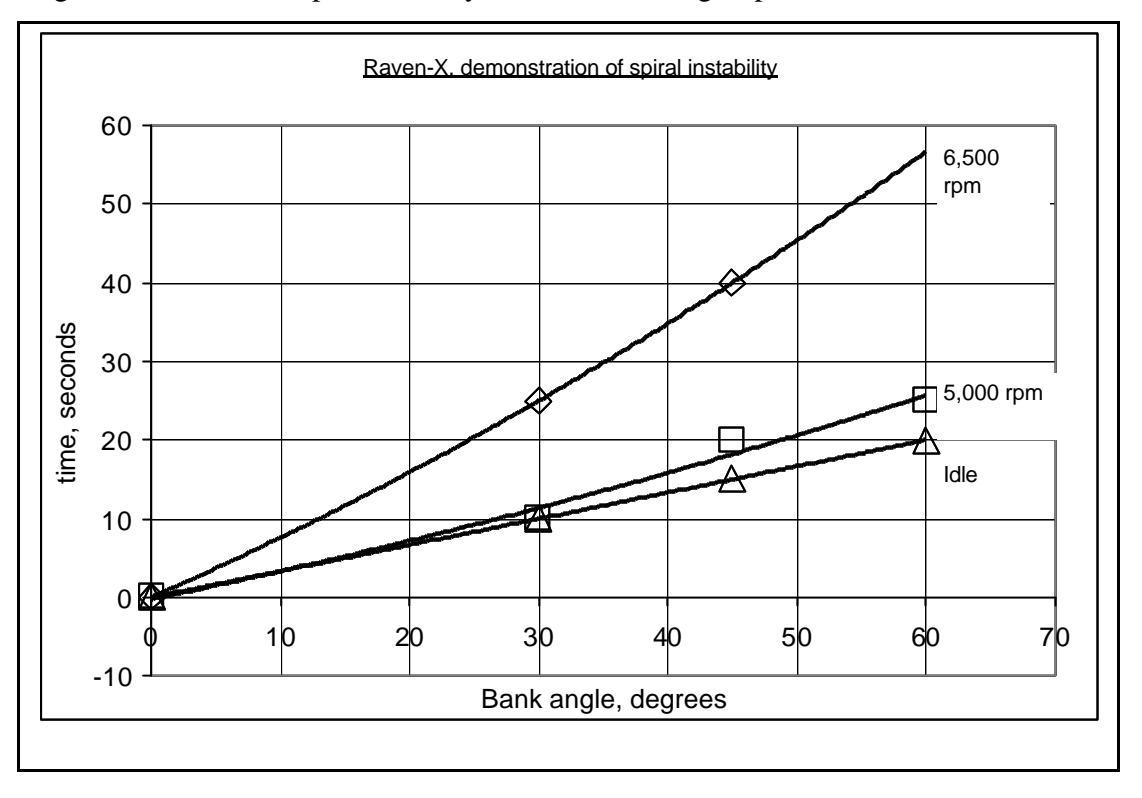
Figure 8, Illustration of spiral instability as a function of engine power: Raven-X

Table 1 shows the results of a brief test carried out to demonstrate the spiral instability of a weightshift aircraft. A Raven-X weightshift microlight (**Figure 9**) was trimmed in moderately turbulent conditions and the controls released. The resultant bank angle was estimated based upon a visual horizon and the time to reach given bank angles. This demonstrates that following flight into IMC such a departure could readily happen within 60 seconds (obviously, the presence of spiral instability will vary between aircraft types, and with power setting).

In the case of G-MVEP **[3]** (not an identical type, but one with similar handling qualities to the Raven), it would be a reasonable deduction that having lost the visual horizon the pilot (who was still under training) might have rolled beyond permissible limits in under 60 seconds.

A further comment may be made concerning the results above. This is that given that aircraft in this class appear to show the greatest spiral stability at low power settings, pilots should be taught, in the event of inadvertent flight into IMC, to descend out of it in idle power where possible, rather than attempting to climb out or maintain level flight.

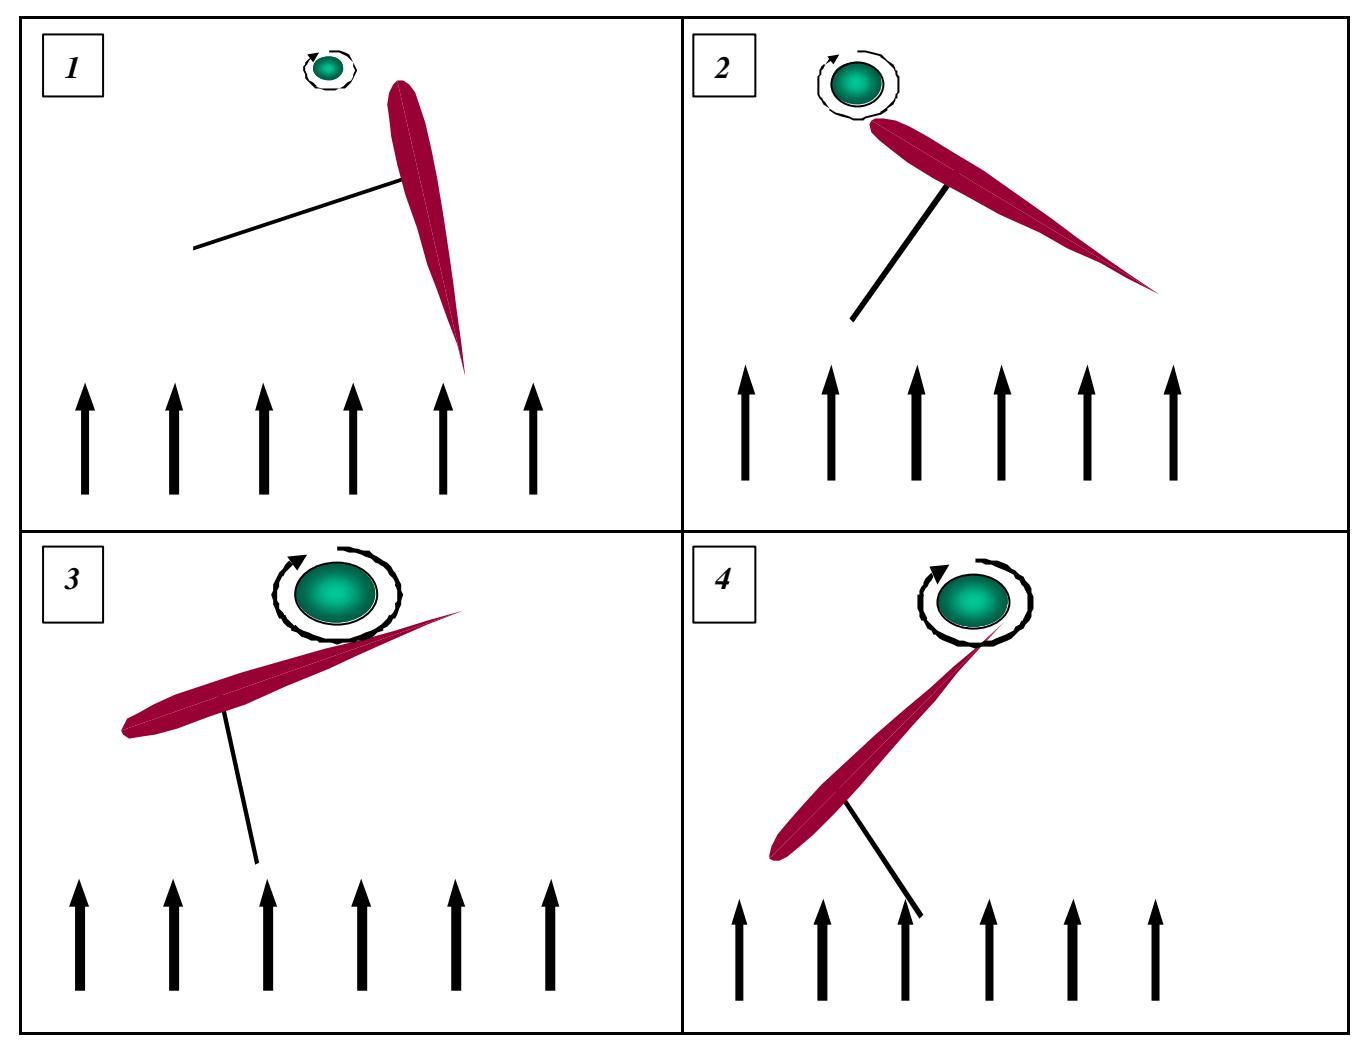
Figure 10, Vortex generation and passage during tumble motion (from wind tunnel results)

Some further recent work has been carried out at the University of Southampton and is reported in reference **[18]**. This work has involved testing in a wind tunnel a representative model of the whole aircraft, inducing a tumble motion within the wind tunnel. Flow measurement has shown that as the wing moves upward from the vertical a vortical flow develops – not unlike a starting vortex. As the wing passes through (what would be) the level flight attitude, this vortical flow intensifies and a concentrated vortex is produced over the leading edge. The strength increases as this vortex passes across the wing chord and produces a low pressure region towards the trailing edge of the wing. This will impart a nose-down pitching moment tending to promote the tumble motion. This effect disappears as the wing passes downwards and will reappear as the same part of the following cycle. This vortex development has large similarities with the flow caused by the dynamic stalling of an aerofoil which further supports the generation of the additional nose-down pitching moment. It also gives a partial explanation for the apparently non-constant pitch rate of the motion shown in Figure 2.

This is illustrated below in **Figure 10**; it should be emphasised that this is at this stage very early research. It is uncertain at present whether this work will make any meaningful contribution towards the development of tumble resistant aircraft.
