Comparison of 4-ball and 5-ball rolling contact fatigue tests on lubricated Si₃N₄/steel contact

J. Kang^{a,*}, M. Hadfield^b

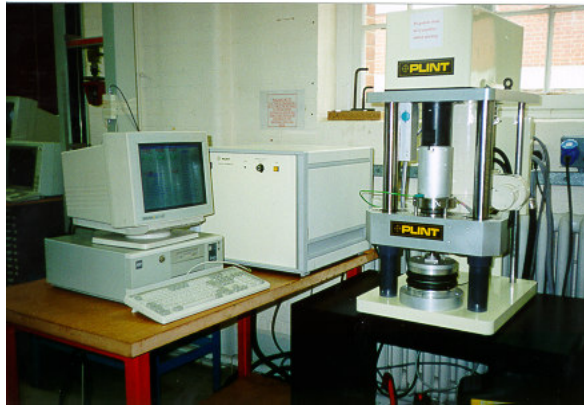
Fig. 1 Plint TE 92HS Microprocessor Controlled Rotary Tribometer

Rolling contact fatigue tests were conducted on a Plint TE 92 HS 10,000 rev/min Microprocessor Controlled Rotary Tribometer (Fig 1). A full description about this tribometer can be found in a previous publication [9]. In this research, it was configured to run 4-ball and 5-ball rolling contact fatigue tests. Through a computer interface, the test speed, load, temperature, etc. were controlled by editing values, ramps and steps in the menu. During the test, the test speed, load, temperature, etc. were recorded to a computer file. The test will be stopped after a pre-set number of revolutions of the driving-shaft as measured by a counter. If the upper ball or the lower balls failed during testing the machine would vibrate, and a vibration sensor automatically stops the test at a pre-determined sensitivity. The contact region between the upper ball and lower balls is immersed in lubricating oil during each test. The lubricant oil is a base mineral oil with kinematic viscosity (cSt) 94.6 at 40 °C and 8.8 at 100 °C.

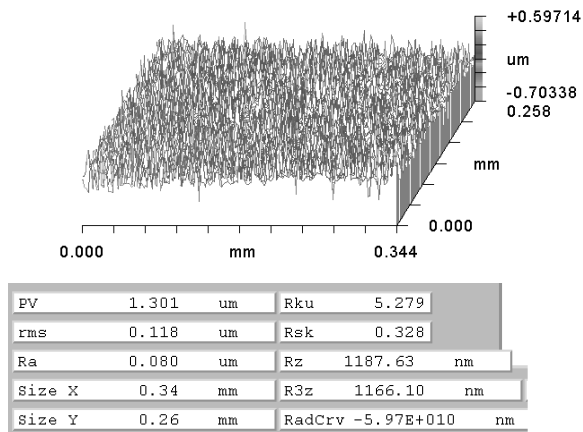
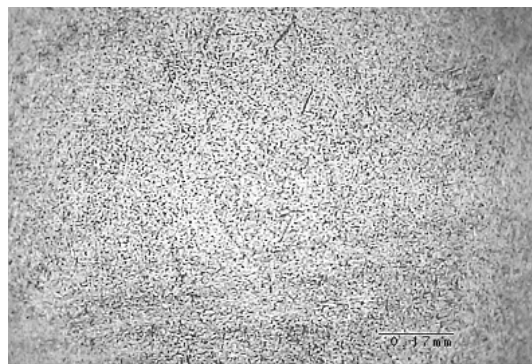
Fig. 2 3D topographic measurement (a) and microscopy observation (b) of the Si_3N_4 sample ball surface.

The lower balls are standard steel testing balls (specification: 0.5" ball Reference RB12.7/310995A, material: AISI 52100 bearing steel). The measured geometric and physical properties of the steel test balls are listed in Table 1. The upper ball is the HIPed Si_3N_4 specimen ball. The test Si_3N_4 samples for this investigation were rough lapped by the authors using an eccentric lapping machine [10]. It was anticipated that the traction between 4-ball test and 5-ball test would be different, and this will be best revealed by a rougher surface. The measured geometric and physical properties are listed in Table 2. Fig.2 shows 3D topographic measurement (a) and microscopy observation (b) of the Si_3N_4 test sample surface.

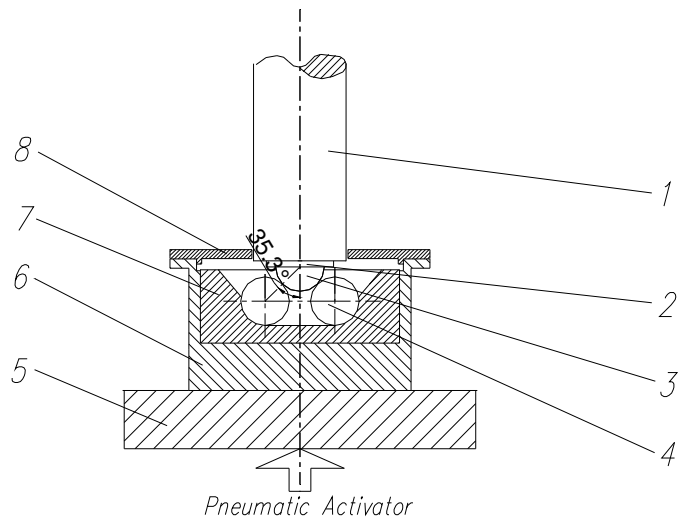
Fig 3 Modified 4-ball rolling configuration

| 1 spindle | 2 collet | 3 upper-ball | 4 lower-balls | 5 heater pad |
| 6 cup holder | 7 retainer cup | 8 cup cover | | |

The TE 92HS Rotary Tribometer was configured as a modified 4-ball machine according to the Institute of Petroleum (UK) IP 300 rolling test procedure. Fig 3 shows the modified 4-ball rolling configuration. The upper ball (3) was held in the collet (2) and rotated at the spindle (1) speed. The retainer cup (7) had a race with slightly bigger radius than a 12.7mm ($\frac{1}{2}$ ") ball to accommodate three lower balls (4). The cup was filled with oil before the test, and during the test period oil could be added through a hole in the cup cover (8) to ensure the test was conducted under fully lubricated condition. A heater pad (5) was connected to a thermocouple to ensure the temperature remained above the specified level. Whenever the temperature falls below this specified level the heater pad will be on.

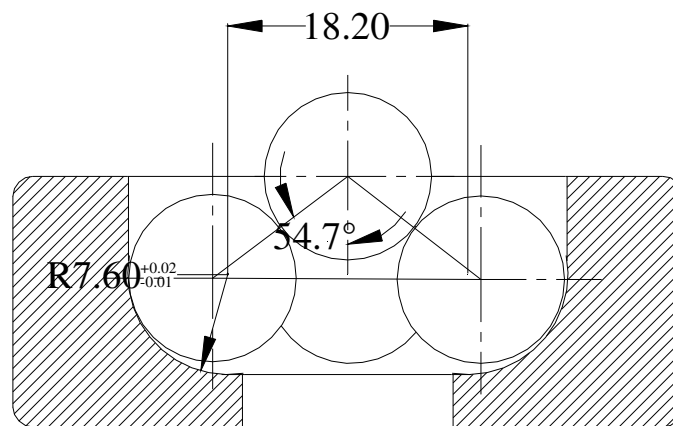
Fig. 4 5-ball rolling cup

The 5-ball rolling contact fatigue tester was first reported by Paker and Zaretsky [8] from NASA, USA. In the current study, the 5-ball rolling contact fatigue test was conducted on the TE92 HS Rotary Tribometer, by incorporating a new 5-ball rolling retainer cup designed by the authors. The design of the 5-ball rolling retainer cup made modifications to TE92 HS Rotary Tribometer's 4-ball retainer cup to accommodate four lower balls in the cup instead of three. The race maintained the same radius as the 4-ball cup with a maximum size of 7.62 mm and minimum size of 7.59 mm. The only change was the distance between the two centres of the radius of the race in a section. This measured 13.21 ± 0.02 mm for the 4-ball cup and was increased to 18.20 ± 0.02 mm for the 5-ball cup (Fig. 4). All the other technical specifications and dimensions for the 5-ball cup are the same as for the 4-ball cup in the TE92 HS Rotary Tribometer.

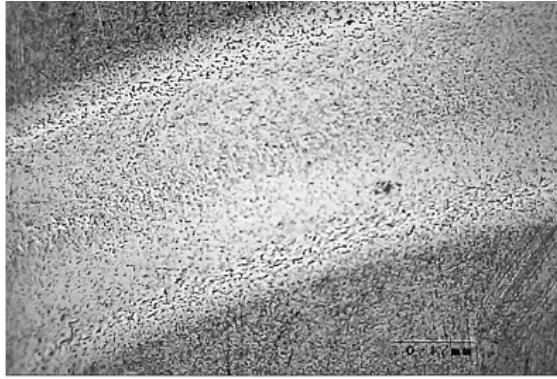
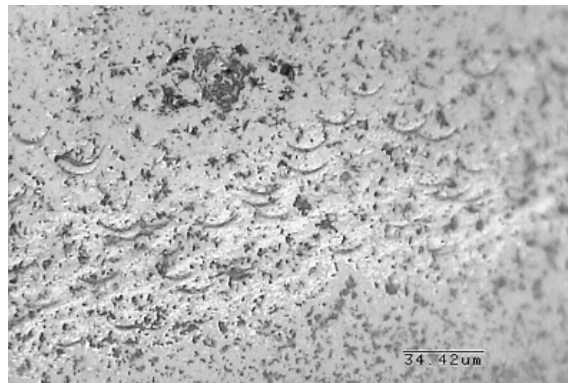
Fig 5 Rolling track appearance after 136 hours 22 minutes 4-ball rolling test

After running for 136 hours 22 minutes (184 million stress cycles), no failure occurred on upper silicon nitride ball and the surface of the rolling track appeared smoother under optical microscopy (Fig. 5). Occasional surface pitting was also found on the rolling track (Fig. 5 (b)). The characteristic of this sample was many small arc cracks with chord parallel to the rolling direction at the two edges of the rolling track as illustrated in Fig. 5 (b). The chords of these small arc cracks are around 20 μ m, and the shapes and the orientations along the rolling track are the same. The failure of lower steel balls occurred ranging from after 22 hours 37 minutes to after 67 hours with an average failure time 45.5 hours.

Compared with 5-ball rolling tracks, much less sliding occurred on the 4-ball rolling track (Fig. 5) although it has been tested for 136 hours (184 million stress cycles). Regarding to the small arc cracks in Fig. 5 (b), it is possible that these cracks were small Hertzian cracks formed by asperity contacts. These asperities may be formed during the rough lapping process. Further lapping removed some of these asperities, although some remained with their peaks removed. There are many asperities lying within the contact zone, true contact only thus occurring at the tips of these asperities, which are compressed as elastic solids under normal contact conditions and their deformations are explored by the classic Hertz theory [14]. Because the maximum tensile stress on the whole contact zone is located near the track edge, the small arc cracks are generated there with the chords of the arcs perpendicular to the maximum tensile stress direction. This can be considered as a superposition of small asperities Hertz contact on top of Hertz contact on large scale (on the entire contact zone).

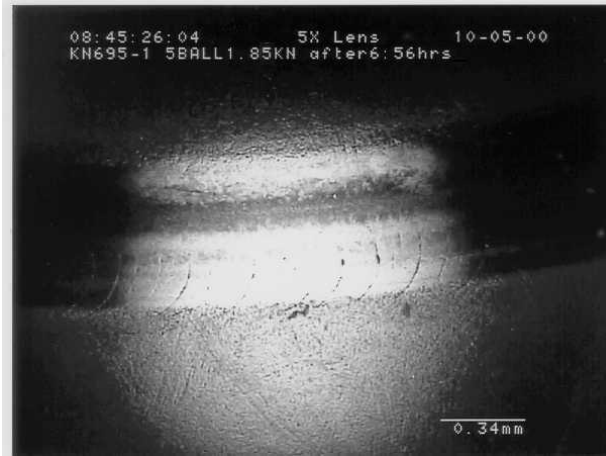
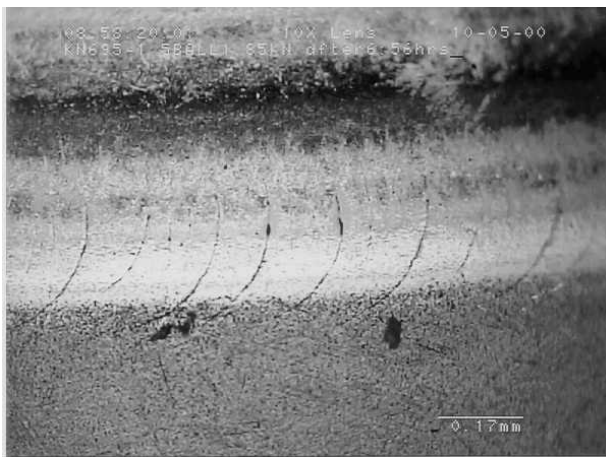
Fig. 6 Arc cracks on No.1 ball after 6 hours and 56 minutes 5-ball rolling test

Tests were conducted on four silicon nitride ball samples from the same batch (Table 2). The first ball—No. 1, after running 6 hours and 56 minutes (9.4 million stress cycles), arc cracks (C-cracks, ring cracks) appeared all over the rolling track, more obvious on the outer side half of the track. Fig. 6 (a) and (b) show these arc cracks at different magnifications. The chords of these arc cracks are around $250 \mu\text{m}$, which is nearly half of the rolling track width. After another 5 hours and 1 minute (total 11 hour 57 minutes, 16.1 million stress cycles), this ball failed with a big spall (Fig. 7 (a)). The diameter of this spall is about $500 \mu\text{m}$ and the depth is about $100 \mu\text{m}$ measured by microscopy focus method. It is likely this spall was initiated by two arc cracks in the outer side half of the track, and two arc cracks in the inner side half of the track (upper left), because these arc orientations can be seen inside the spall (Fig. 7 (a)). The arc cracks are now clearly on both sides of the track, prevailing along the entire rolling track (Fig. 7 (b) and (c)). Delamination also occurred on the track (Fig. 7 (c)). It is very interesting that the crack orientations are absolutely opposite at two sides of the track (Fig. 7 (b) and (c)), and this is more clearly illustrated in Fig 8.

track from right to the left (Fig. 12). This kind of continuous sliding eventually leads to the opposite traction cracks at two sides of the track. The rolling direction of upper silicon nitride ball is from the left to the right (Fig. 8), which is opposite in direction to the sliding of steel balls on the outer side half of the track (the lower half of the track). This is why the arc cracks occurred more obvious on the outer side of the track in the first instance (Fig. 6).

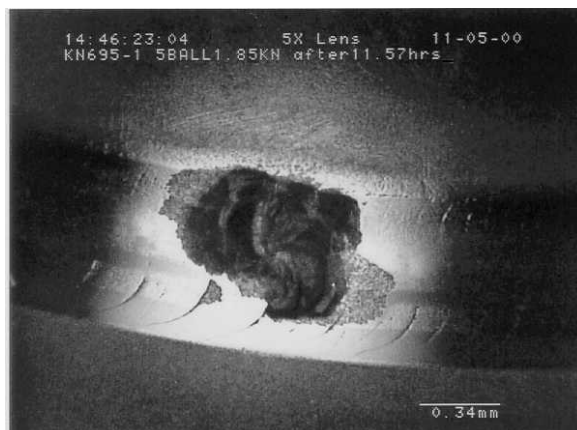
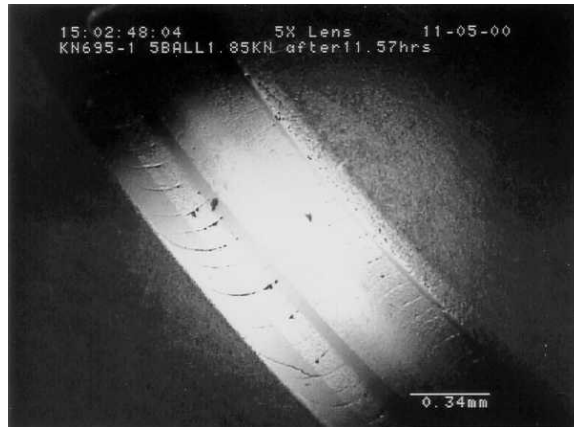
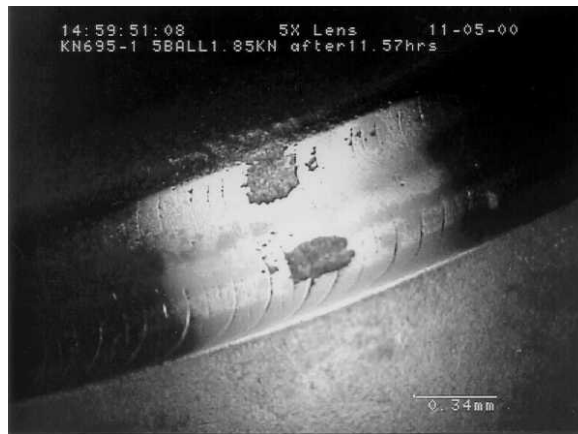
Fig 7 No.1 ball after 11 hours and 57 minutes 5-ball rolling test

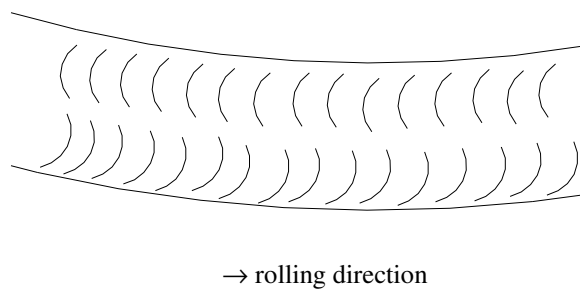
Fig 8 Opposite crack orientations on two sides of the rolling track

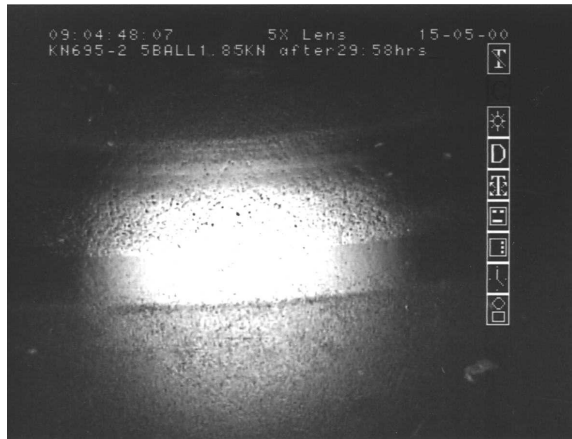
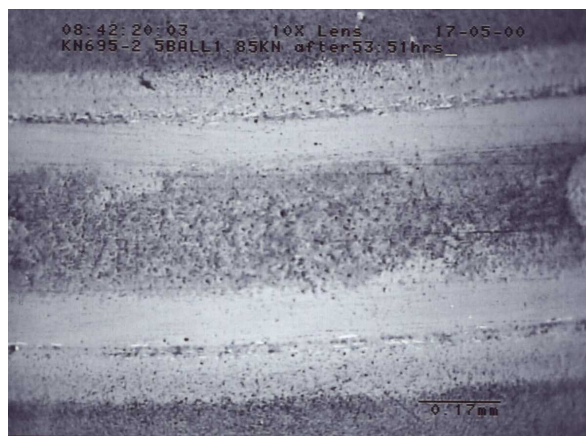
Fig. 9 No 2 ball after 29 hours 58 minutes (a), and after 53 hours 51 minutes (b) 5-ball rolling test

To see if this kind of arc cracks is inevitable, No.2 ball was tested for over 135 million stress cycles (102 hours 19 minutes). No arc cracks occurred on the rolling track. After 29 hours and 58 minutes, a symmetric smooth zone appeared on each side of the rolling track (Fig. 9 (a)). The width of this smooth zone is about $170 \mu\text{m}$, which is $1/3$ of the rolling track width. After 53 hours and 51 minutes, it appeared each of the smooth zones was further divided into two portions with an obvious line in the middle. The portions closer to the rolling track centre became even smoother. After 102 hours and 19 minutes, near the inner edge of the rolling track some continuous small pittings occurred (Fig. 10 (a)), and some evenly distributed round pittings also appeared (Fig. 10 (b) and (c)). The diameters of these round pittings are around $50 \mu\text{m}$. It is very interesting that these round pittings are almost exactly evenly spaced.

In comparison the rolling tracks of upper Si_3N_4 balls after 4-ball rolling test with those after 5-ball rolling tests, it seems that much severe sliding occurred during the 5-ball rolling. The sliding on the rolling tracks in 5-ball tests featured severe polishing wear on the two sides of the tracks (Fig. 9 and Fig. 11), from after 22 hours 41 minutes (30.6 million stress cycles) to after 53 hours 51 minutes (72.7 million stress cycles). The lubrication regime for the 4-ball and 5-ball rolling tests were calculated [13] and listed in Table 3. The λ ratio for the 4-ball rolling tests is 1, which means the lubrication regime will be in the border of partial EHL and boundary lubrication. The λ ratio for the 5-ball rolling tests is 0.827, which means the lubrication regime will be in the boundary lubrication. The lubrication condition for the 4-ball tests was slightly better than the 5-ball tests. But lubrication regime alone could not explain severe polishing wear only occurred on

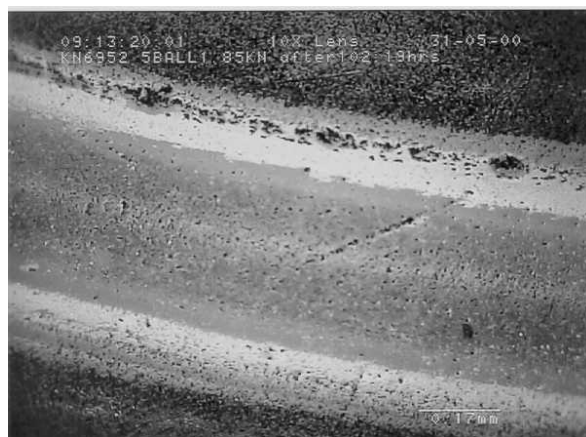
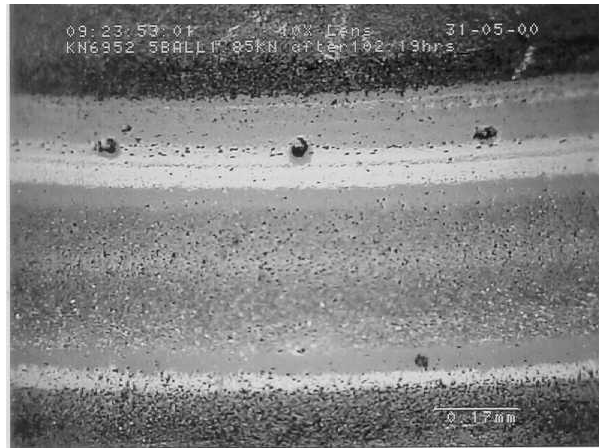
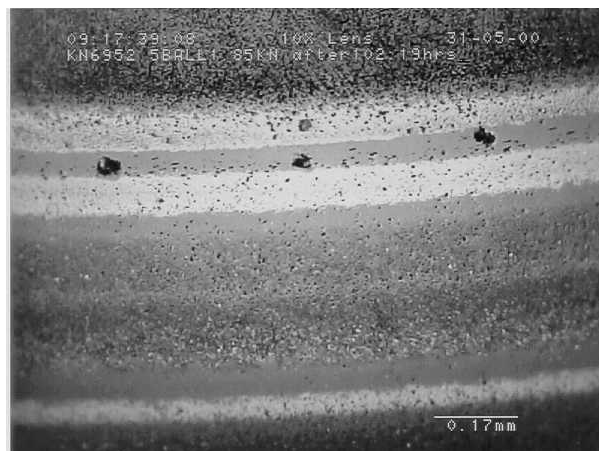
Fig. 10 No 2 ball after 102 hours 19 minutes 5-ball rolling test

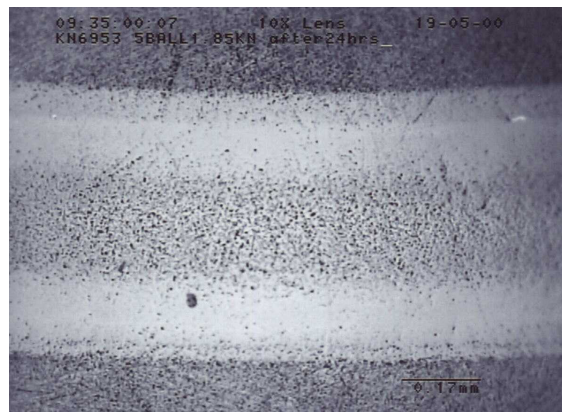
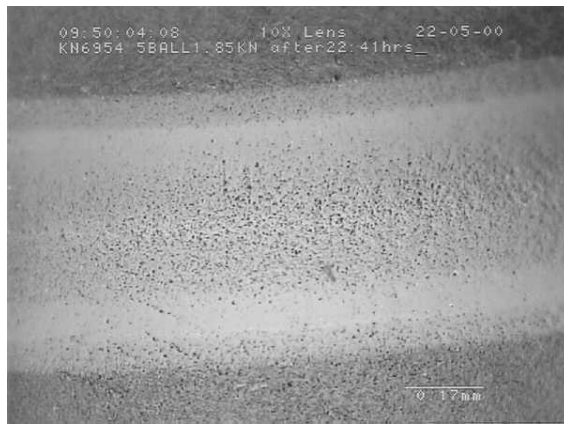
Fig 11 No. 3 ball after 24 hours (a), and No. 4 ball after 22 hours 41 minutes (b) 5 ball rolling test

No. 3 ball was tested for 24 hours, and No. 4 ball for 22 hours 41 minutes respectively. No arc cracks occurred on these two balls (Fig. 11 (a) and (b)). The appearance of these two tracks, however, is very similar to the appearance of No. 2 ball after 29 hours 58 minutes (Fig. 9 (a)). It was anticipated that it is unlikely for the arc cracks to appear on these two balls within a near extended testing period, (because the

the two sides of the tracks in 5-ball tests (Fig. 9 and Fig. 11). This severe polishing wear on the two sides of the rolling track has not appeared on another 4-ball rolling tested Si_3N_4 rough surface with R_a 0.094 μm and R_q 0.132 μm (the λ ratio is 0.91, also in boundary lubrication) under the same contact stress for over 197 million stress cycles [11] (Fig.14). It must be the complex motion of lower balls in 5-ball tests led to the sliding at two sides of the contact zone.

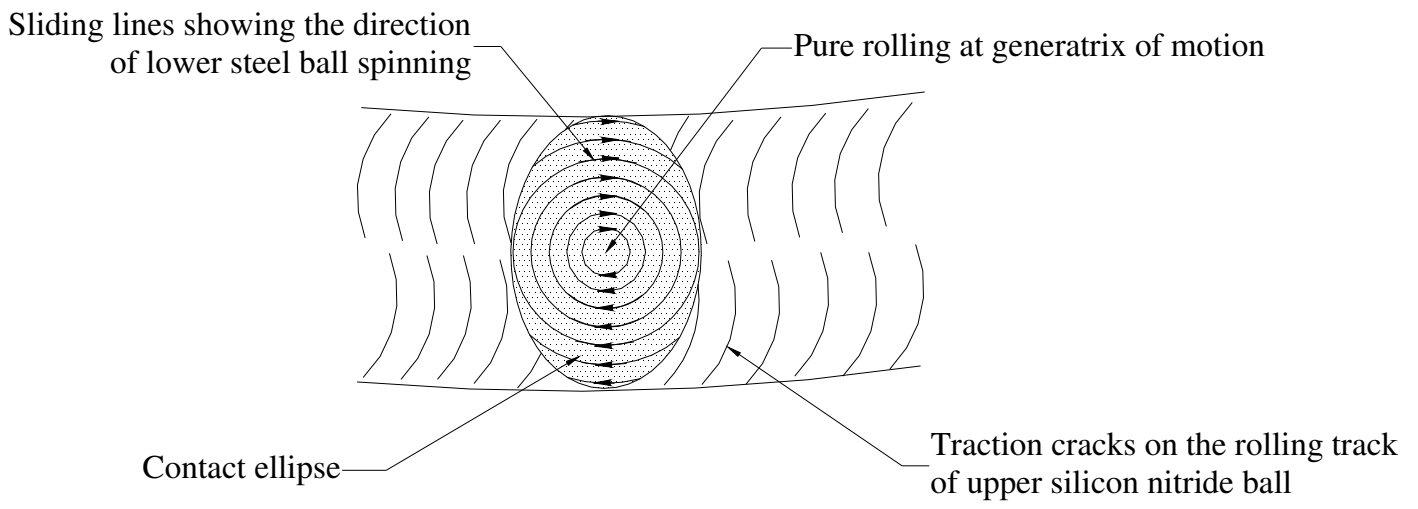
Fig. 12 Spinning of lower steel ball generated the traction cracks

It was generally recognised that in a counterformal contact on a much larger scale (not by a sharp hard indenter), brittle fracture will occur just outside the Hertz contact zone due to tensile stress when the normal load reaches the critical value. If a tangential force is applied to the contact, as in sliding, the critical normal load necessary to initiate fracture is greatly reduced. In experiments with a TiC sphere on a flat of the same material, the critical normal load was reduced by a factor of 10 under sliding condition in air with coefficient of friction $\mu \approx 0.2$ [12]. Under sliding condition, the cracks which form no longer intersect the surface on complete circles, but in a series of arcs initiated from the trailing edge of the contact zone [12]. Corresponding to the opposite traction crack orientations on the two sides of the rolling track in No.1 ball (Fig. 8), it is possible that this is caused by the spinning of lower steel balls around the centre of contact zones. In the Hertz contact zone, pure rolling only occurs at the generatrix of motion, and the sliding to opposite direction at two sides of the contact zone due to spinning of lower steel ball generated the traction cracks (Fig. 12). Although the spinning of lower steel ball also generated opposite sliding direction at the leading side and trailing side of contact zone. As the lower steel ball rolled along the track, on a specific area on the track at one instance it endures the sliding from up to down, and next instance it will endure the sliding from down to up. So the overall effect of the sliding perpendicular to the rolling direction is counterbalanced. Whereas the sliding parallel to the rolling track is a continuous sliding towards the same direction, on the upper side of the track from left to right and on the lower side of the

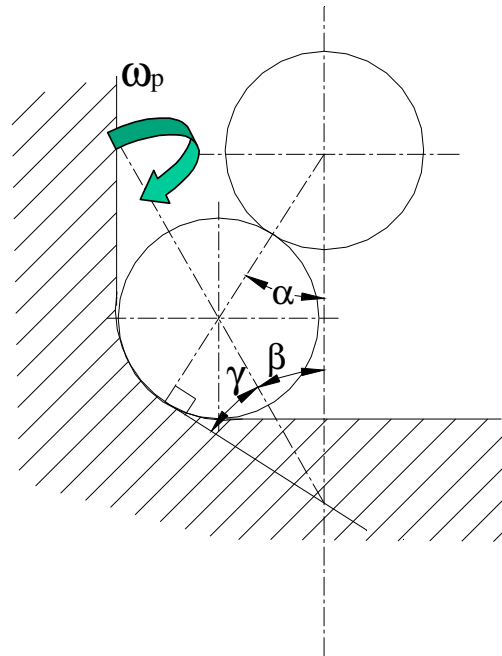
Fig. 13 Simplified kinematics model

In the simplified ball kinematics analysis model by Kruger and Bartz [7] (considering balls and cup are rigid bodies, point contact) as shown in Fig. 13, the spinning of lower ball ω_p projected to the axis through lower ball/upper ball contact point will be $\omega_p \cos(90^\circ - \gamma)$. The calculated γ for 4-ball rolling test is 25.2° , and the calculated γ for 5-ball rolling test is 13.3° . The spinning of lower ball projected to the axis through lower ball/upper ball contact point will be $0.425\omega_p$ for the 4-ball rolling test and $0.23\omega_p$ for the 5-ball rolling test. The simplified ball kinematics model could not explain the opposite traction cracks occurred in No. 1 ball. Obviously, the motion of lower balls is much more complicated than the simplified kinematics model.

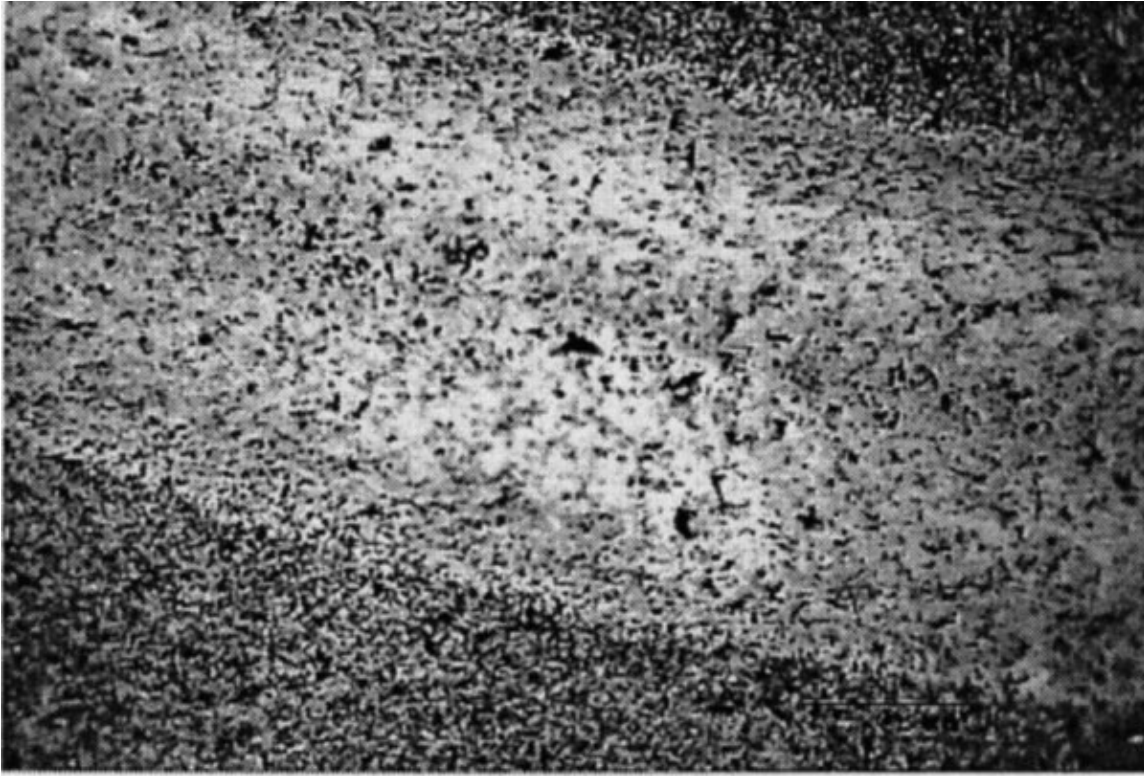
Fig. 14 Another rough surface of HIPed Si_3N_4 after 197 million stress cycles RCF test
