# The Effects of Material Combination and Surface Roughness in Lubricated Silicon Nitride/Steel Rolling Contact Fatigue

**Abstract:** Four kinds of commercially finished 12.7 mm HIPed silicon nitride bearing balls with surface roughness values  $R_a$  ranging from 0.002 to 0.016  $\mu\text{m}$  were tested using a four-ball rolling configuration. They were rolling against two types of steel testing balls with different surface roughness and hardness, in fully lubricated condition at a maximum compressive stress of 6.58GPa and at a speed of 10,000 rpm for over 135 million stress cycles. Rolling track surfaces were examined by microscope, SEM, 3-D surface analysis and interference profilometry. Experiment results show that the composite surface roughness are most influential. The shape of the surface topography of silicon nitride are not very sensitive. The slight difference in steel hardness may lead to significant differences in steel fatigue life.

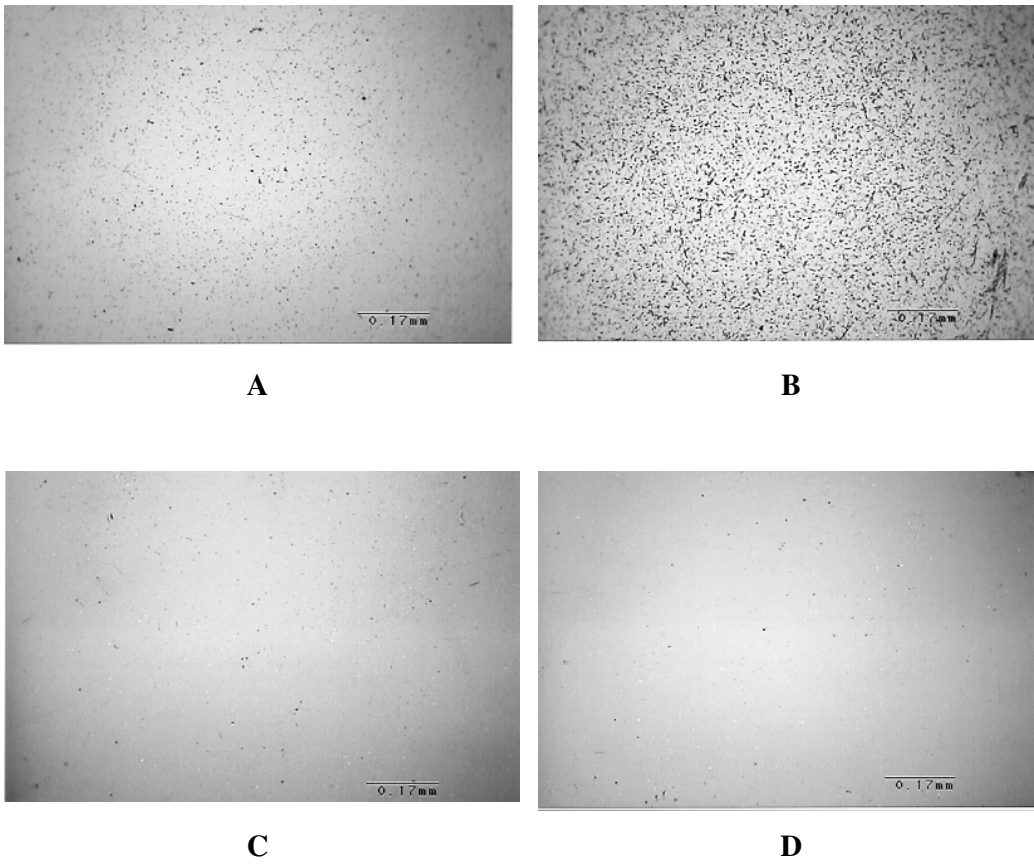
Fig. 1 2D statistical analysis of HIPed Si<sub>3</sub>N<sub>4</sub> sample surfaces A to D before testing.

Four kinds of HIPed silicon nitride balls with diameters 12.7 mm ( $\frac{1}{2}$ "), commercially finished to grade 5, were procured from different manufacturers, and were designated as A, B, C and D. Table 1 summarises the measured geometric and material properties of testing samples A to D. Surface hardness were measured using a Buehler Hardness Indenter, at a load 10kg, loading time 10 sec and loading speed 100 $\mu\text{m}/\text{sec}$ . Fig. 1 gives the detailed statistical analysis values for different roughness parameters of testing samples A through D measured by a Talysurf 2D surface profiler, with each sample 3 balls, each ball 3 points. Fig. 2 is the microscopy observation on the surfaces of samples A ~ D before RCF test.

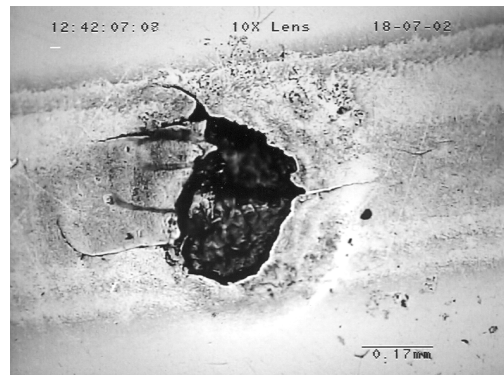
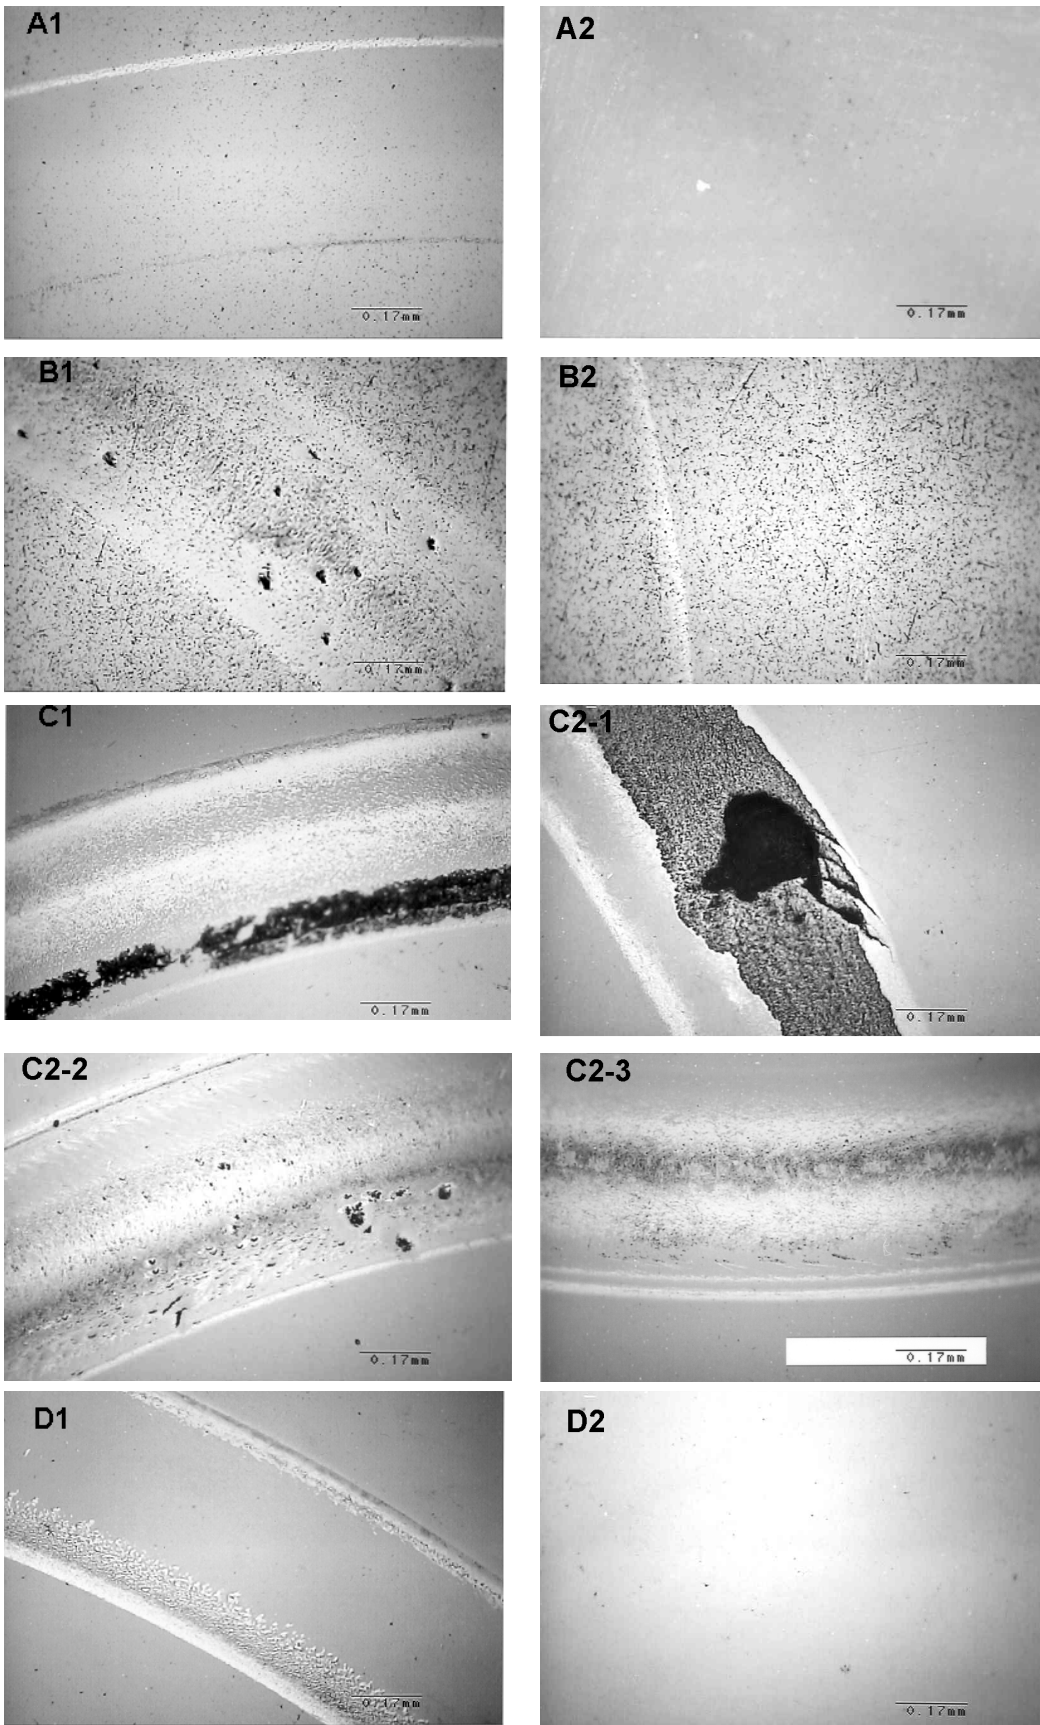
Fig. 5 Typical big and small fatigue spalls on steel balls

C2-2 and C2-3. In all of the tests, only one silicon nitride ball was failed by a fatigue spall, which is C2-1. Steel balls (Type 1 and Type 2) were constantly failed by fatigue spalls of various sizes, as shown in Fig. 5. These fatigue spalls were comparable in size with the rolling track width (diameter of the Hertzian contact circle). The fatigue spall in Fig. 5 (a) is about 700  $\mu\text{m}$  by 500  $\mu\text{m}$ , whilst in Fig. 5 (b) it is about 380  $\mu\text{m}$  by 250  $\mu\text{m}$ . When one of the steel balls failed with a fatigue spall, three new steel balls of the same type were fitted, and the time for this kind of change is listed in Table 3 under the column of "Lower steel balls changed after (hours)". Fig. 6 shows the microscopy observations of the rolling tracks of silicon nitride A to D after testing.

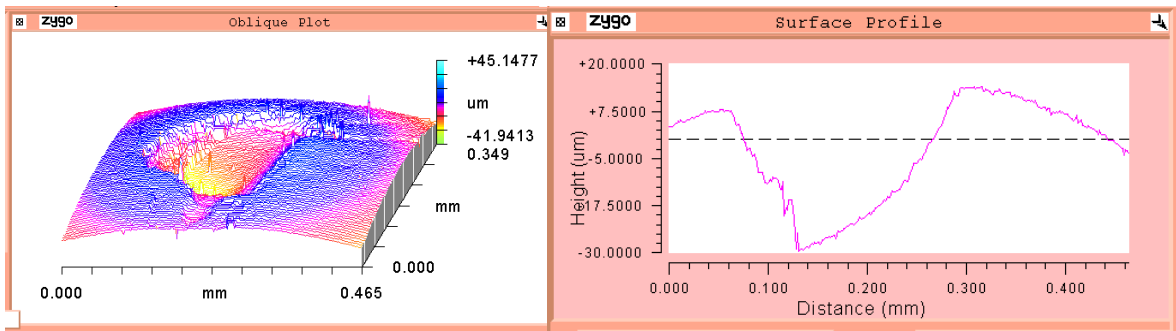
Fig. 11 the black area of sample C1 examined by the 3D surface analyzer.

Silicon nitride C are with an average  $R_a$  value  $0.002 \mu\text{m}$ . After 110.48 hours RCF test (149 million stress cycles) with Type 1 steel balls, the rolling track surface of C1 became rougher under optical microscopy observation (Fig. 6 C1). Oil residuals have deposited on both rolling track edges, with some black oil residuals on the inner edge in the width of 0.1mm. Fig. 10 shows the rolling track of sample C1 examined by the 3D surface analyzer. The amount of wear and the height of the oil deposits are similar to sample A1. A further 3D surface analysis on the black area of the rolling track confirms the black thing is oil stain with a height of  $0.2\sim 0.3 \mu\text{m}$  (Fig 11).

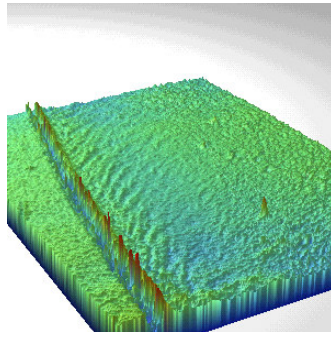
Fig. 13 Delamination on the Rolling track of sample C2-1 measured by 3D analysis

For silicon nitride C with Type 2 steel balls, three tests were conducted. Sample C2-1 failed with a fatigue spall after 21.94 hours (29.6 million stress cycles) as shown in Fig. 6 C2-1. This spall was examined by the 3D surface analyzer, and the result is shown in Fig. 12. The diameter of the spall is about  $200 \mu\text{m}$ , and the deepest inside the spall is about  $40 \mu\text{m}$ . Delamination occurred adjacent to the spall along the rolling track, a 3D surface analysis shows the depth of the delamination is about  $0.8\sim 1 \mu\text{m}$  (Fig. 13).

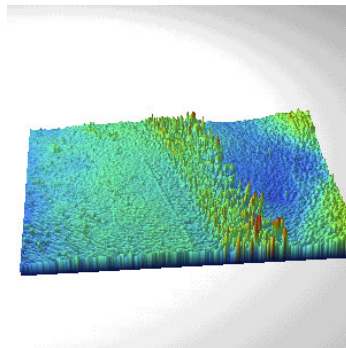
Fig. 15 Rolling track of sample C2-3 observed by 3D surface structure analysis.

Sample C2-3 tested for 44.66 hours (60 million stress cycles). After test, wear can be observed on the rolling track under microscope. The wear is located near the centre of the rolling track, in the range of  $0.15\sim 0.2 \mu\text{m}$  as measured by 3D surface analysis (Fig. 15), which is severe than samples A1 and C1.

For silicon nitride C in rolling contact with Type 1 steel, the amount of wear on the rolling track is comparable to Sample A1 as measured by 3D surface analyzer (Fig. 10). The rolling track is not as clean as other samples (Fig. 6 C1), and black oil stain deposited on the rolling track (Fig. 11). For silicon nitride C in rolling contact with Type 2 steel, C2-1 failed with a fatigue spall after 29.6 million stress cycles. This failure may be probabilistic, or due to an undetected pre-existed surface defect (flaw) on the rolling track. Two more RCF tests on silicon nitride C in rolling contact with Type 2 steel were conducted, and no further fatigue spall was found. To conduct a reasonable probabilistic failure analysis, at least 20 tests were needed for each kind of samples, and this is beyond the scope and capability of current study. But the further two RCF tests on C2 did show some differences on the rolling tracks, compared with similar surface roughness samples A2 and D2, and compared with the same surface but in rolling contact with Type 1 steel (C1). For Sample C2-2 after 173 million stress cycles, wear and surface pittings can be seen on the rolling track (Fig. 6 C2-2), and interference profilometry image revealed a groove at the edge of the rolling track (Fig. 14). For Sample C2-3 after 60 million stress cycles, wear on the rolling track is severe than samples A1 and C1, as measured by 3D surface analyzer (Fig. 15).

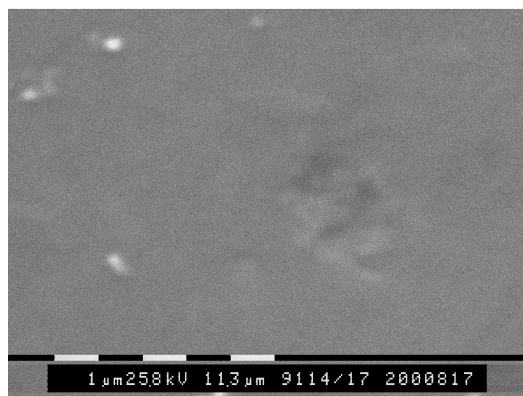
Fig. 16 The interference profilometry image of the rolling track of sample D1.

Silicon nitride D are with an average  $R_a$  value  $0.002 \mu\text{m}$  and an average  $R_q$  value  $0.003 \mu\text{m}$ , which are the same as samples C. But silicon nitride D are with a high positive skewness value  $R_{sk}$  of 3.1 and a very high kurtosis value  $R_{ku}$  of 34.7, which means that the surfaces of D have more peaks than valleys and are “spiky”. After 131.85 hours (177 million stress cycles), no difference can be observed on the rolling track of sample D1 except for oil stains at the track edges under optical microscopy (Fig. 6 D1). The high skewness and kurtosis values did not make any difference. The interference profilometry image in Fig. 15 shows the oil stain at the outer edge of the track. Small and shallow pitting around  $2\mu\text{m}$  in size was observed on the rolling track of sample D1 with the SEM as shown in Fig. 17.
