The seismic performance of end-perforated RC frame beams strengthened with CFRP sheets

Abstract: This paper presents eight tests on the end-perforated RC frame beams with the different sizes of perforations and arrangement styles of strengthening carbon fibre (CFRP) sheets subjected to hybrid load-displacement control loading condition. The research focuses on the assessment of beams' seismic performance. The ultimate load resistance, hysteretic performance, energy dissipation capability, ductility and stiffness degradation of the end-perforated RC frame beams with and without strengthening CFRP sheets have been investigated. The test results show that the beams strengthened with CFRP sheets can effectively improve their seismic performances. The perforation size of a beam has significant influence on its seismic behaviour. With the increase of hole diameter, the hysteresis performance, energy dissipation capacity and ductility of beams are decreased considerably.

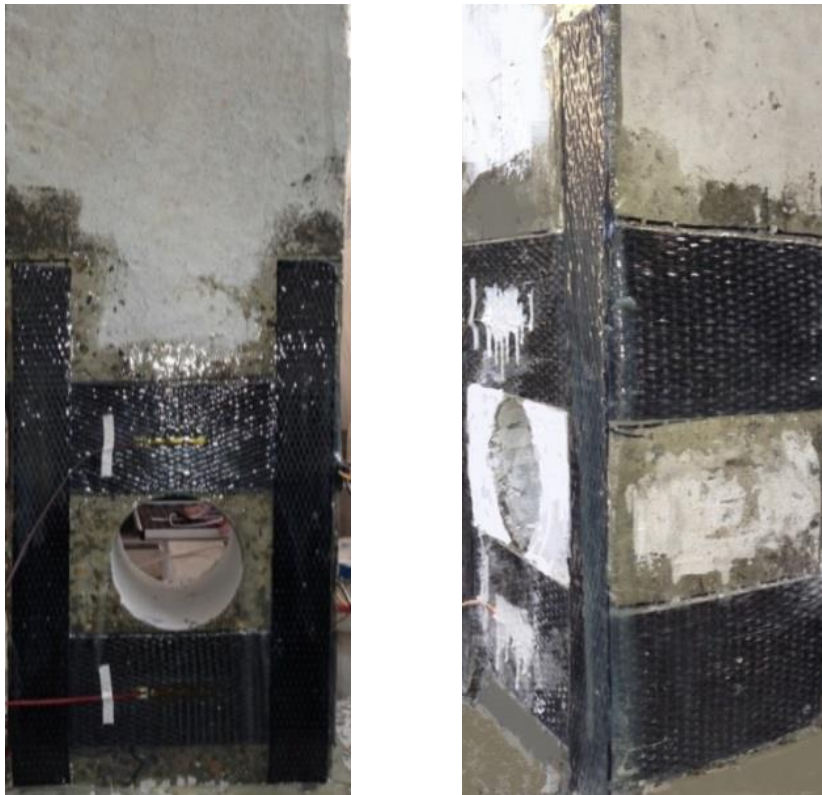
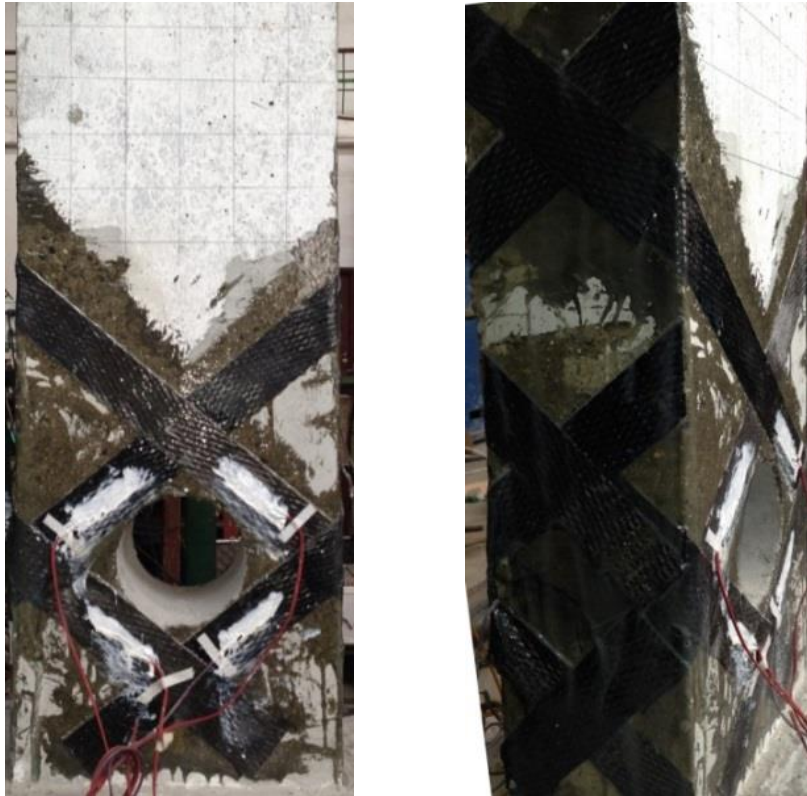
Fig. 4 Two strengthening methods for the perforated beams.

(a) Strengthening with horizontal arrangement

(b) Strengthening with 45° diagonal arrangement

Two strengthening methods were employed for the perforated beams: (1) horizontal arrangement (Fig. 2 and Fig. 4(a)); (2) 45° diagonal arrangement (Fig. 3 and Fig. 4(b)). The amount of CFRP usage and applied strengthening procedure were based on the guideline described in the “*Constructional detailing for structures*” (The Editorial Board of the Building Structural Data Set 1995). In this process, the structural adhesive glue was smeared evenly on the concrete surface then the CFRP sheets were attached to the concrete surface with fully flattening, along the fibre direction rolling compaction for several times. After completing the strengthening procedure, the specimens were stored and cured for more than 3 days under the room temperature before the tests. The completed specimens are shown in Fig. 4.

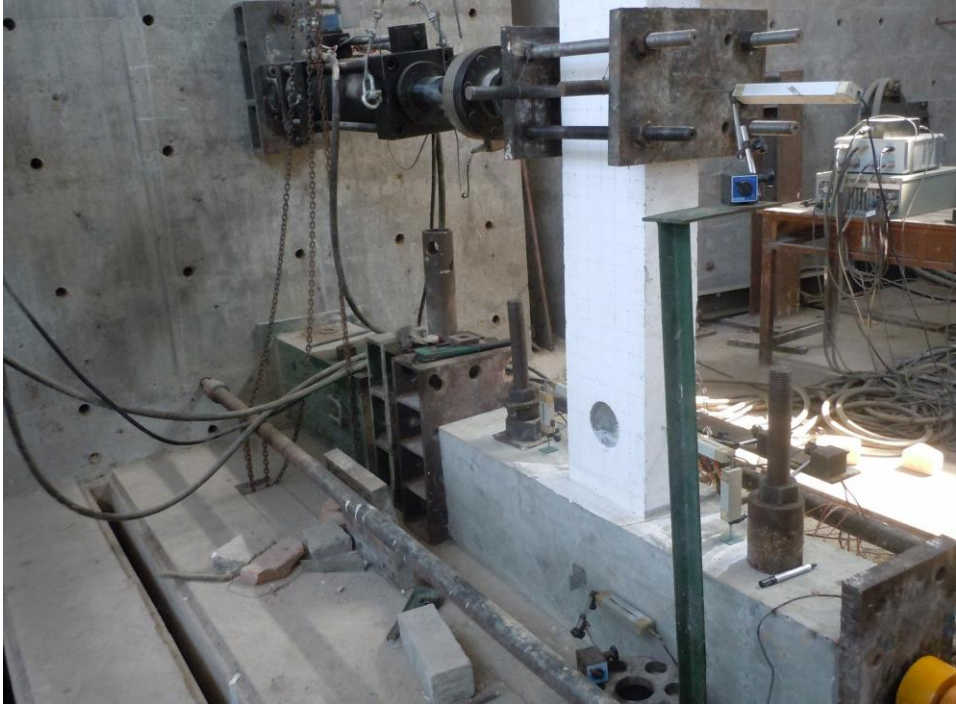
Fig. 6 Panorama view of the test.

As shown in Figs. 5 and 6, horizontal cyclic loading scheme was adopted to carry out the tests. The servo actuator mounted on the reaction wall was connected to the end of the beam through four screws and two steel plates to apply cyclic load. The beam specimen was connected with the column (Fig. 1 and Fig. 6) in which the column was strongly bolted into the ground and horizontally jacked in position. Fig. 7 shows the locations of strain gauges on the stirrups and CFRP sheets surrounding the perforation. As shown in Fig. 8, six LVDT displacement meters were used to measure the horizontal displacement and rotation of the beam under cyclic loading.

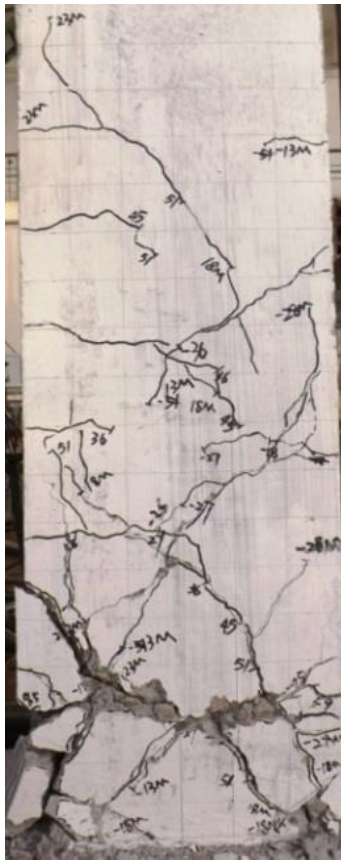
(a) LA0

Fig. 10 Failure patterns of the specimens.

LA0 was a non-perforated beam. Its failure pattern is shown in Fig. 10(a). In the test, when the beam was loaded to -9.0 kN, a crack was formed on the bottom of the beam, 150 mm away from the column. When the load was increased to -36.0 kN, an X-crack was seen, 350 mm away from the column. More cracks were appeared after further loading. When the load was increased to 50.0 kN, the specimen was yielded, after that the actuator was reset to zero and the loading scheme was switched to displacement control. At the loaded displacement $\Delta = -33$ mm in the first cycle, the maximum resistance of the specimen was reached, that was -66.2 kN. The specimen was failed at $\Delta=38$ mm. Then the test was terminated.

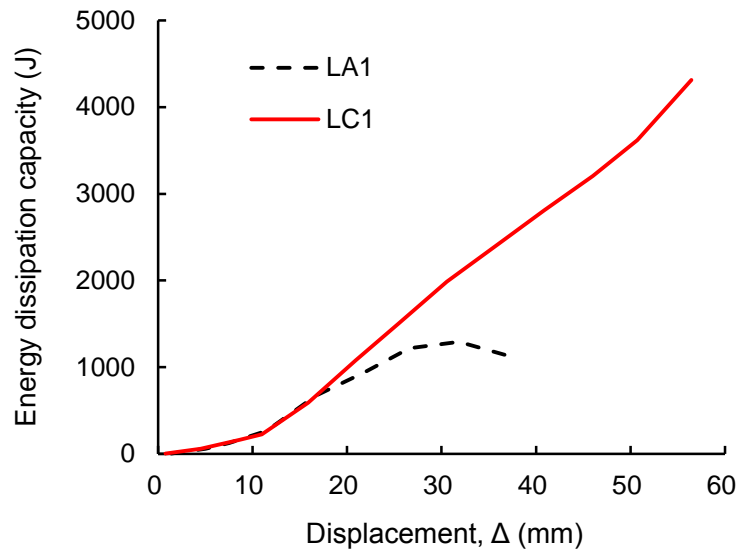
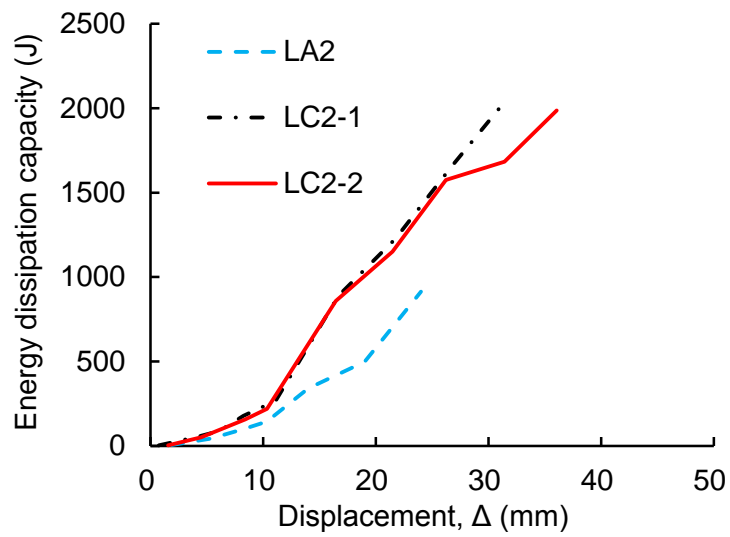
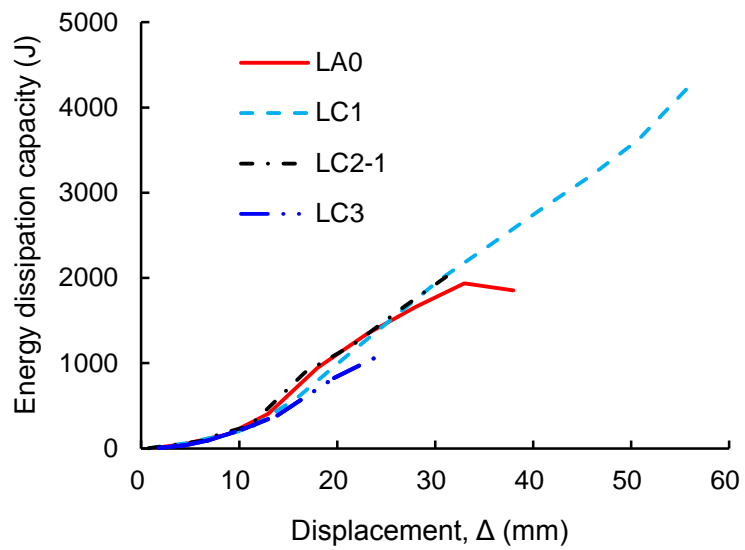
Fig. 13 Energy dissipation capacity of the beams.

Under low frequency cyclic load, the amount of energy dissipated in one load cycle can be represented as the encompassed area of the load-displacement hysteresis curve in that cycle (Structural Engineers Association of California 1995). The energy dissipation capacity in each load cycle can be represented by the relationship between the area of the first hysteresis loop and the peak displacement Δ in that loop. Fig. 13 shows the energy dissipation capacity of the beams.

It can be seen from Figs. 13(a), (b) and (c) that, at the same displacement, energy dissipation capacities of Beams LC1, LC2-1 and LC3 (with strengthening) are higher than Beams LA1, LA2 and LA3 (without strengthening). As shown in Fig. 13(b), Beams LC2-1 and LC2-2 have nearly the same energy dissipation capacities. This indicates that the two strengthening methods have the similar energy dissipation capacity. Fig. 13(d) shows the influence of the perforation size on the energy dissipation capacity of the beams. It can be seen that energy dissipation capacity decreases considerably with increase of the perforation size of beams. For the beams with the perforation size less than $0.4h$, the energy dissipation capacity of strengthened perforated beams is comparable to non-perforated beam LA0. Hence, it is better to limit the size of perforation less than $0.4h$.
