## Storm wave runups and sea level variations for the September 2017 Hurricane Maria along the coast of Dominica, eastern Caribbean sea: evidence from field surveys and sea-level data analysis

Dominica, along with several other Caribbean islands, was severely damaged by category-5 Hurricane Maria in September 2017. The hurricane left 68 people dead or missing, marking Maria as the worst natural catastrophe to hit this small island nation. Here, we report the results of our coastal runup field survey in February 2018 and of tide gauge sea-level data analysis. Analysis of tide gauge records shows that the duration of Maria's surge varied between 2.1 and 2.6 days in the Caribbean region and was 2.1 days at Marigot, Dominica. The surge amplitude was 75 cm in Marigot, which indicates that the size of the surge was small for a category-5 hurricane. The measured field survey runups were from 1.0 to 3.7 m, with the maximum runup at Scotts Head on the southern tip of Dominica. The largest measured runups were concentrated along the west coast of the southern half of the island and consistently decreased northwards. We attribute the observed damage to coastal structures to four mechanisms:

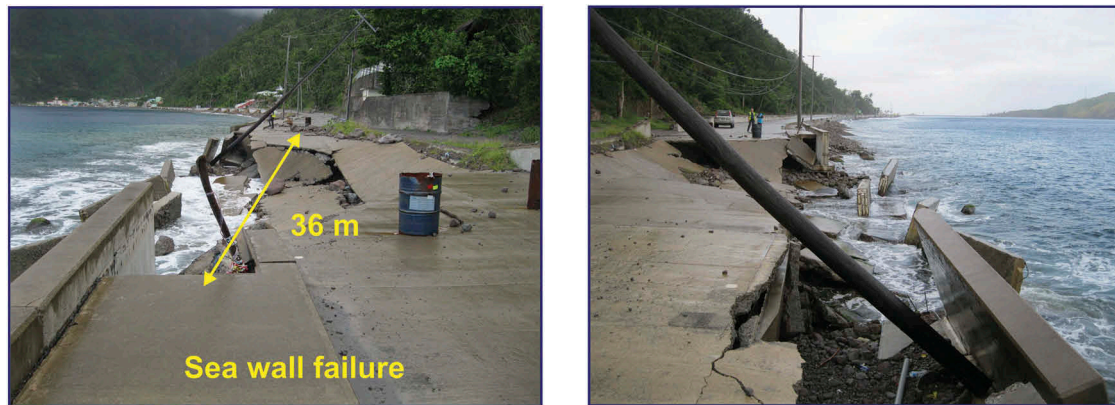
### a) Damage due wave/surge erosion (Scotts Head)

Damage to the coastal sea wall along the main road near the village of Scotts Head ([Figure 7\(a\)](#)) was a direct result of Hurricane Maria storm surge impact and wave erosion of the beach and sea wall foundation. A total of 36 m of the length of the sea wall, formed by six blocks each 6 m long, were displaced and separated; some fell over onto their faces. We infer that these failures were

due to scouring of the beach sediments and erosion beneath the foot of the wall. Minor displacements of adjacent blocks were also observed. As the road was only protected by a sea wall at this location, it was left defenceless against wave-related erosion after the collapse of the sea wall blocks. The road section behind the displaced and separated blocks was washed away due to wave action, with the concrete slabs of the road broken into many pieces (Figure 7(a)). We infer that this sequence of events was due to a combination of the large storm surge/wave heights in the Scotts Head area (3.1–3.7 m; Table 1, Figure 3) and the lack of any rock/concrete armor protection at the toe of the sea wall (Figure 7(a)). It is normal practice to protect the foundations of sea walls, and in particular the seaward toe of the sea walls, against wave actions by installation of particulate rock/concrete armor units, such as riprap, tetrapods, and concrete blocks (Sorensen 2005). However, no such armor was placed in front of the long sea wall along the road leading to Scotts Head.

- A third example was seen in Scotts Head (Figure 7(a)) where the coastal road was damaged as a result of erosion of the road foundation which itself was a result of the failure of the protecting seawall.

In terms of coastal resilience against hurricanes, it is important to understand the sequence of events that lead to a particular damage to an infrastructure and to increase resilience by breaking the chain of events where possible before the damage is made. In such a context, Figure 10 guides where the investment should be focused to increase the resilience. For instance, wave-related coastal erosion can be prevented by protecting coastal infrastructure by an appropriate seawall to stop the waves or by a breakwater to dampen wave actions.

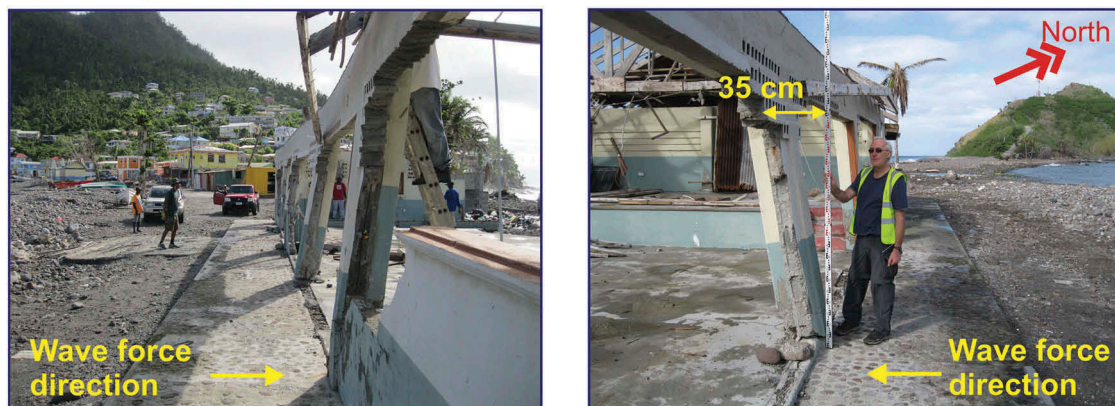
### b) Damage due to wave/surge forces and impacts (Caribantic, Scotts Head)

Direct surge/wave hydrodynamic forces and wave impacts were responsible for damage on various parts of the Dominica coastline. An example of this type of damage is shown in Figure 7(b) where a large community center was damaged in Scotts Head. A deflection of 35 cm can be seen from base to top of a side wall of this center, while most of the building was washed away by the surges/waves. Numerous examples of these types of failure were observed during the field survey. Although in other cases it is likely that the direct wave/surge forces and impacts were enhanced by large debris carried by the waves, in the case of Scotts Head there are no nearby sources of large debris objects, thus we infer that the damage there was due primarily to hydrodynamic forces and water impacts.

**Figure 7.** Different types of damage to coastal structures from Hurricane Maria in Dominica, observed during the field survey (part 1).

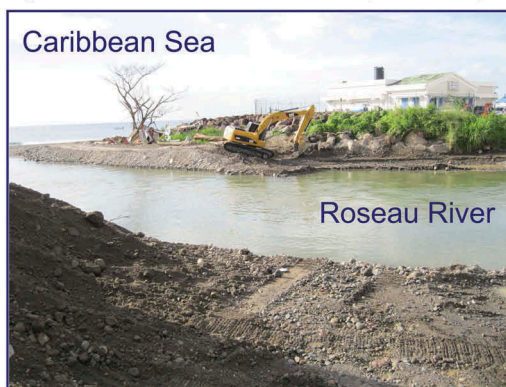
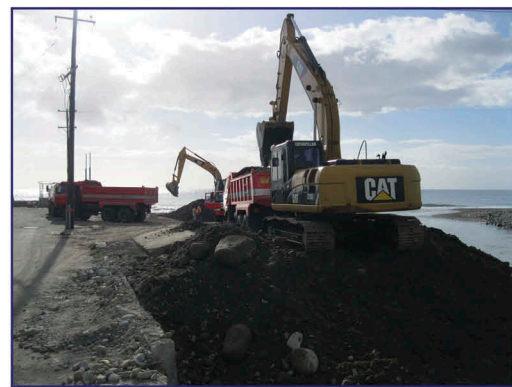
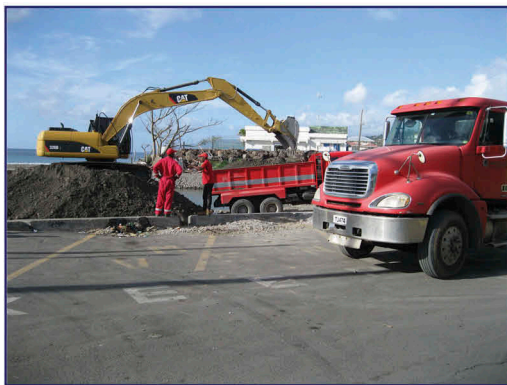
**b) Coastal sedimentation (Roseau)**

At several coastal locations close to river mouths, evidence of intense sediment transport and deposition were observed (Figure 8(b)). The example in Figure 8(b) shows the Roseau river mouth: this location accumulated a large amount of river flow sediments, resulting from the erosion and landslides caused by Hurricane Maria's heavy rainfall inland and which were subsequently deposited as flood waters decelerated on entering the ocean. Such focused sedimentation has the potential to block the river mouths, increasing the potential for river

overbank flooding upstream. Dredging operations to remove such sediment were ongoing in Roseau's main river channel at the time of the survey, around four months after Hurricane Maria (Figure 8(b)). These dredging operations to remove such intense sediment loads are costly and take a long time to complete but are vital to prevent further reworking of the sediments and flooding. In addition, such large volumes of sediments have the potential to change the coastal dynamics and to impact the coastal ecosystems, which have not yet been evaluated.

**Figure 8.** Different types of damage to coastal structures from Hurricane Maria in Dominica, observed during the field survey (part 2).

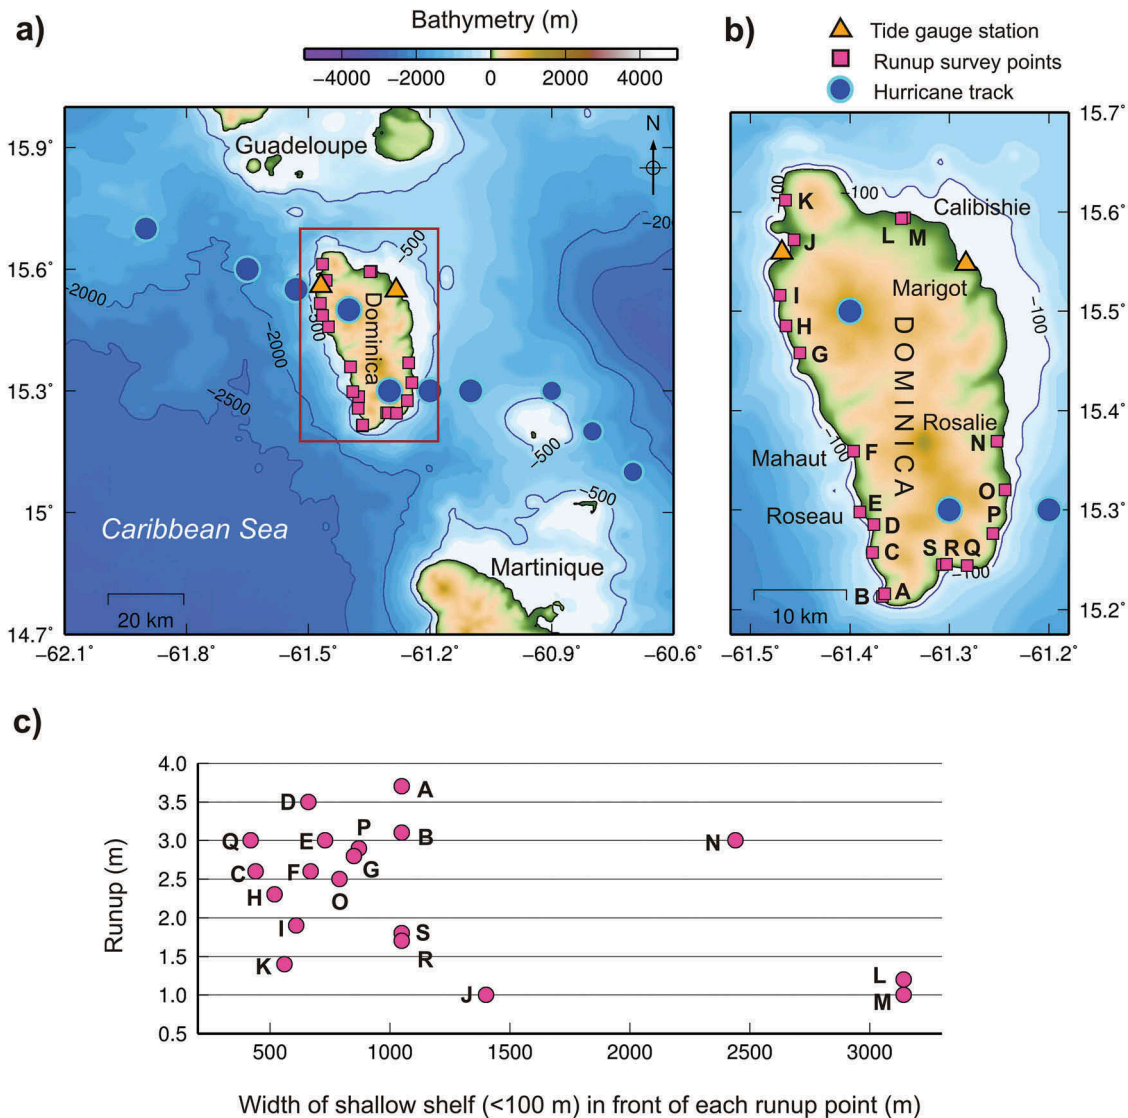
**Figure 9.** (a,b): Bathymetry contours in the Caribbean Sea around Dominica. (c): relationship between runup heights and the width of shallow shelf (depth <100 m) in front of each runup measurement point. The letters A-S are used to pair runup locations and heights in panels "b" and "c".

To further explain the effect of local/regional bathymetry on the storm surge, the bathymetry contours around Dominica are shown in Figure 9(a,b). The

offshore regions to the south and to the east and north of Dominica are sheltered by the two neighboring islands of Martinique and Guadeloupe, respectively, while the southwest and west coasts of Dominica are exposed to deep waters. In terms of fetch length, longer fetches affect more the west and southwest coasts than at the east and north. As a reference, we measured the shelf width (water depth <100 m) ( $W$ ) in front of each runup measurement point and compared it with the runup values ( $R$ ) (Table 2, Figure 9(c)). In contrast to the study by Shimozono et al. (2015), no correlations can be established between  $W$  and  $R$ . This is similar to the result previously reported by Tajima et al. (2017) for Super Typhoon Meranti (October 2016). The lack of correlation between  $W$  and  $R$  can be attributed to other factors, such as the sheltering effects of neighboring islands which could protect Dominica against the storm waves (Tajima et al. 2017). In addition, as there are many small islands in the east Caribbean

Sea (Figure 1(c)) which form a discontinuous border with several straits between them, any wind-dragged water mass piled up along the coasts will likely leak through the straits between the islands; consequently storms may not gain significant heights along the coasts of the east Caribbean Sea.

**Table 2.** Corrected runup heights (R) of Hurricane Maria in Dominica versus the width of the shallow shelf in front of each runup measurement point (W) and the respective ratio.
