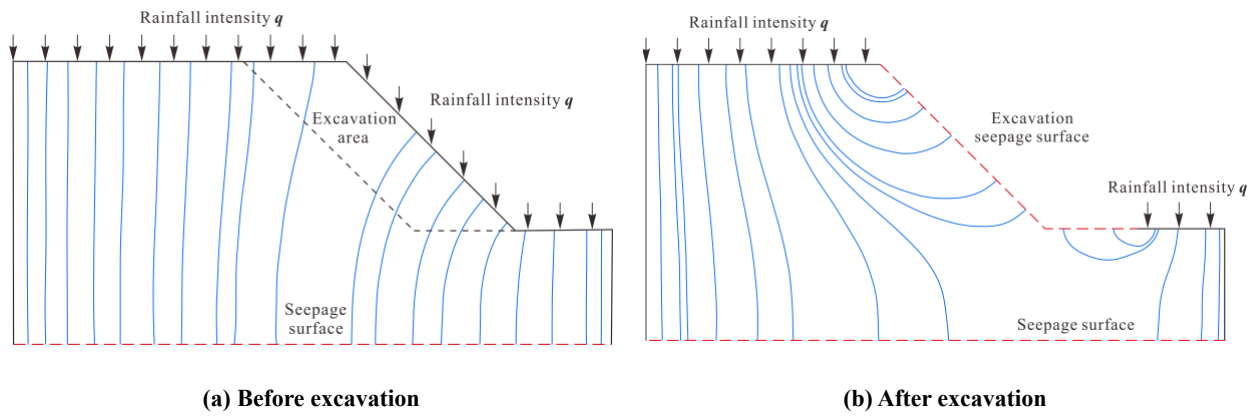
Fig. 1 Schematic diagram of seepage path changes in unsaturated soil slope excavation simulation

(Blue lines in the figure are the seepage lines)

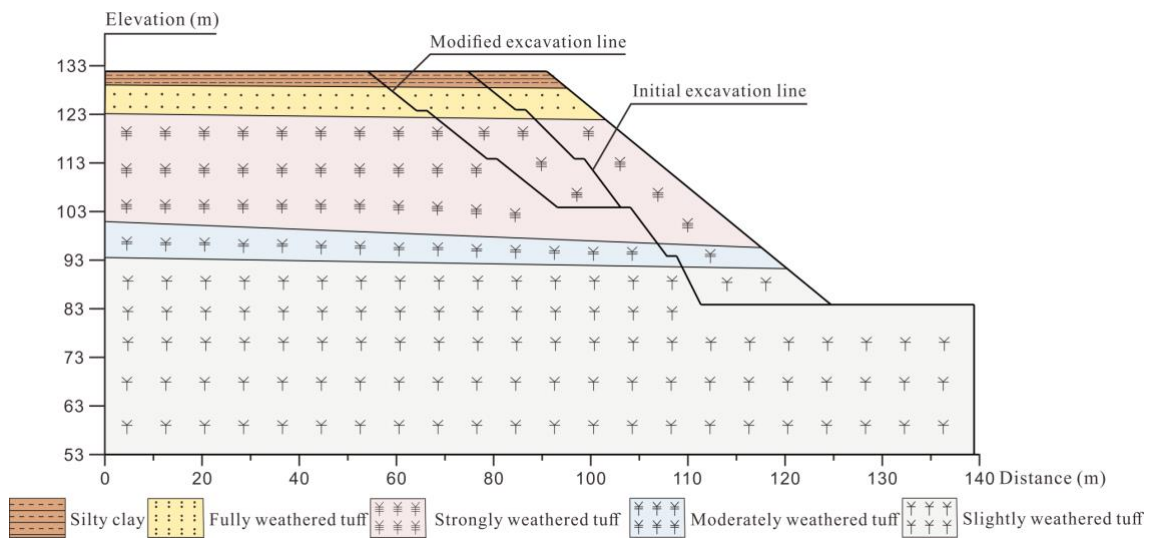
Fig. 3 Slope morphology and engineering geological conditions

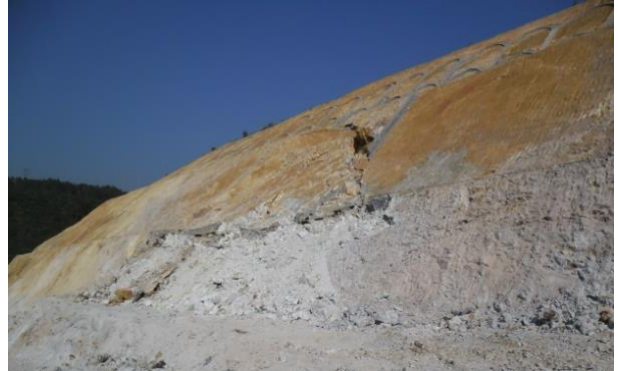
Fig. 4 Status of the slope sliding area in January 2015

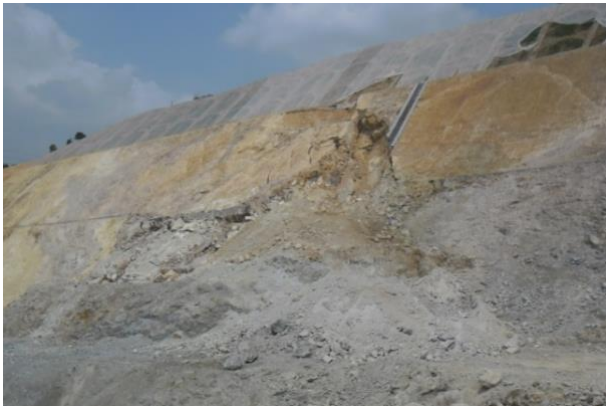
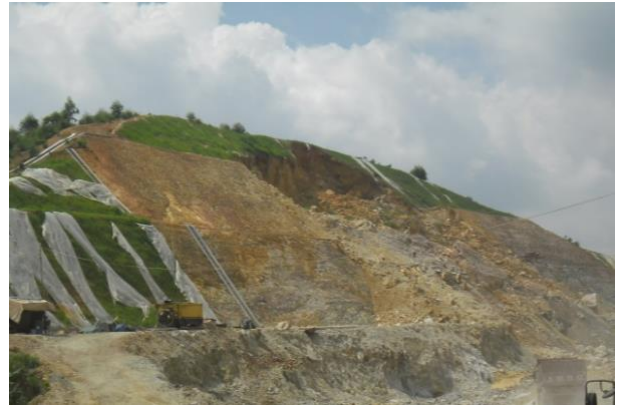
Fig. 5 Development of the slope sliding area from May to June 2015

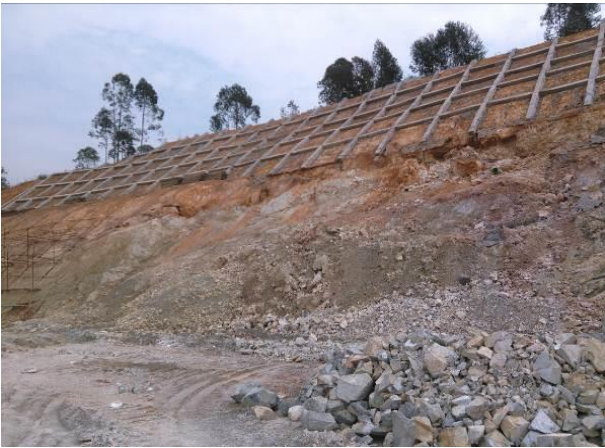
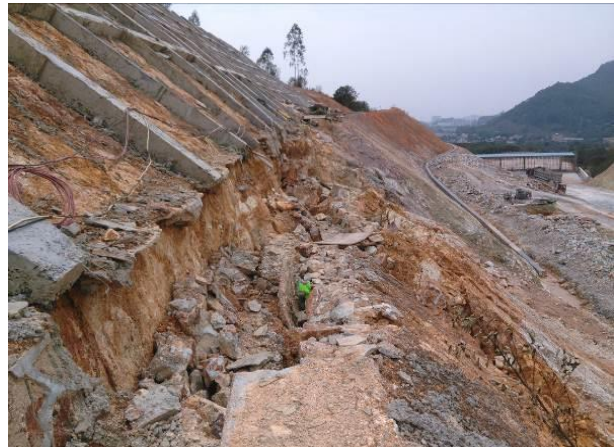
Fig. 6 Status of the slide after the modified excavation in January 2016

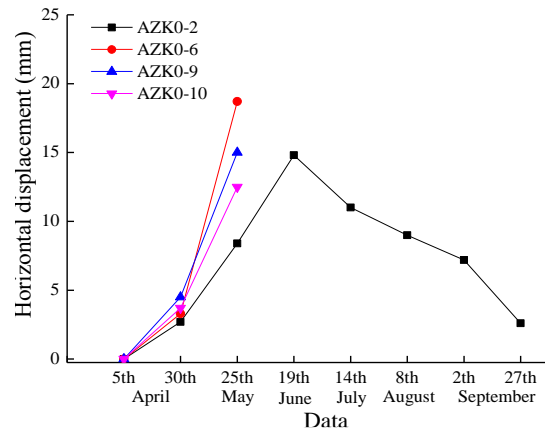
(a) The first monitoring stage

(December 2014 to March 2015)

(b) The second monitoring stage

(April to September 2015)

(c) The third monitoring stage

(October 2015 to January 2016)

Fig. 8 Horizontal displacements of typical measuring points during each stage

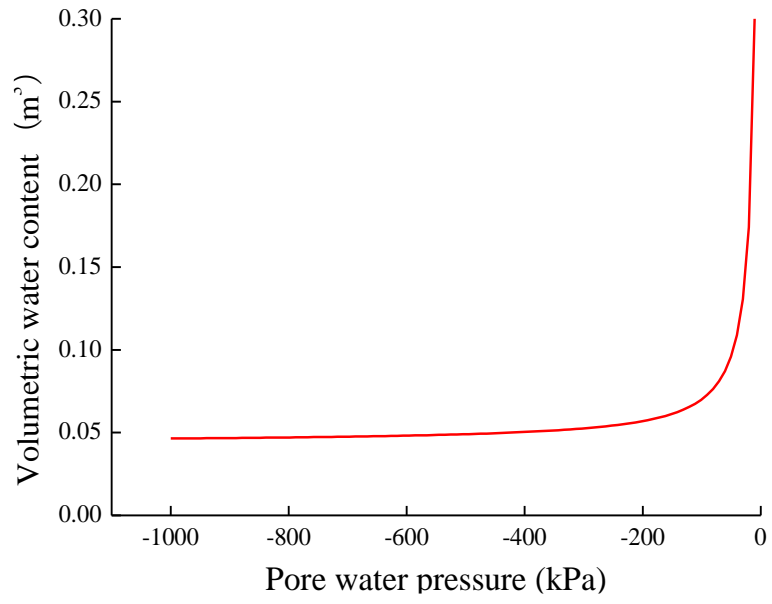
Fig. 12 Water content function curve of the silty clay

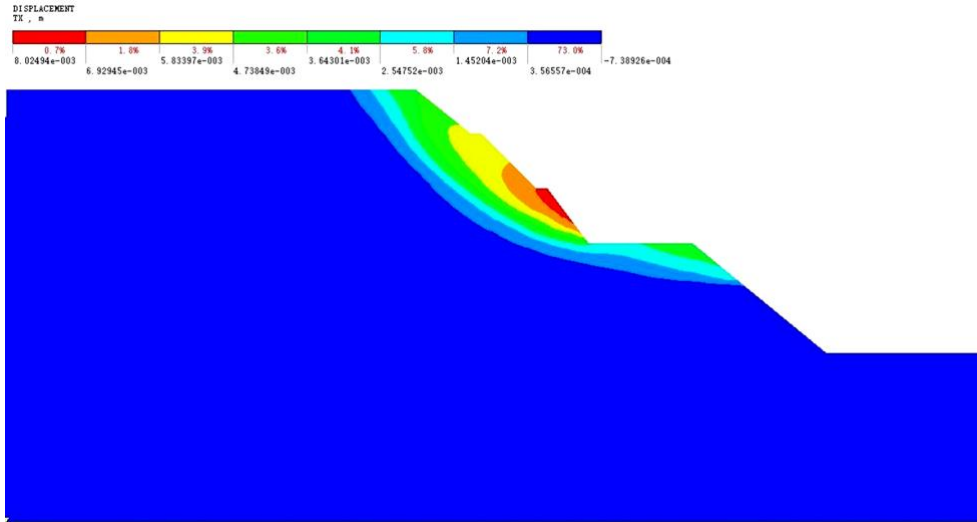
Fig. 20 Horizontal displacement distribution after initial excavation of the third-level slope

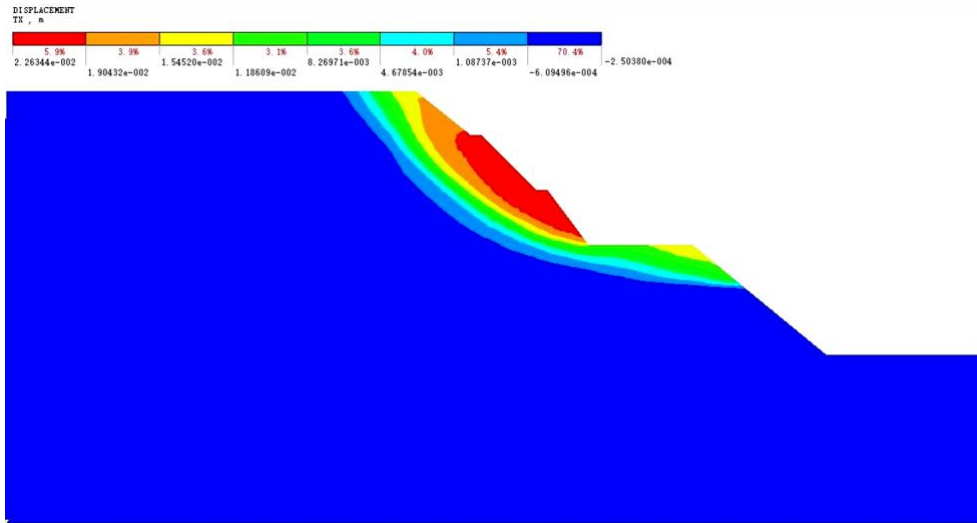
Fig. 22 Horizontal displacement distribution after the second rainfall
