Failure mechanism of boulder-embedded slope under excavation disturbance and rainfall

Abstract

Keywords Boulder-embedded slope · Failure mechanism · Excavation disturbance · Rainfall infiltration · Seepage modeling

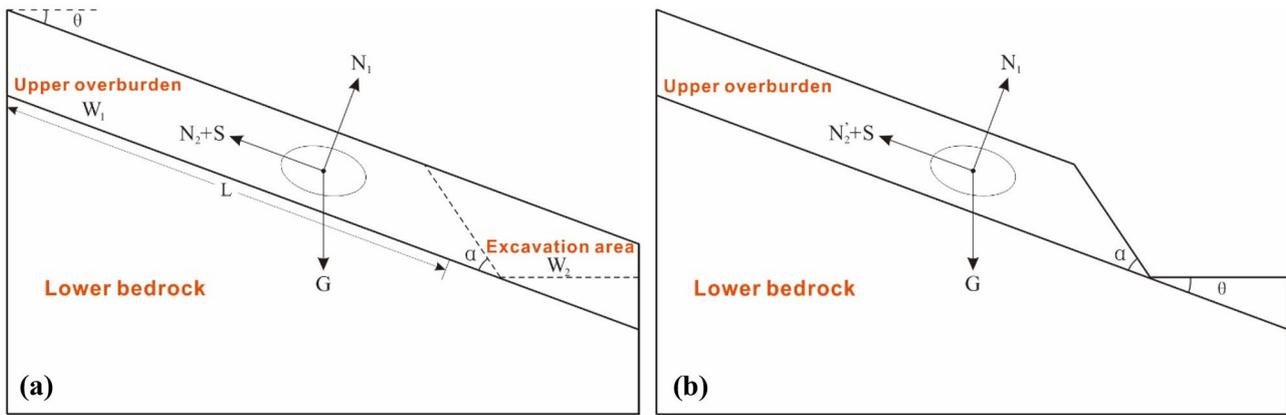
Fig. 1 Force analysis diagram of boulder in a slope: **a** before excavation and **b** after excavation

Since the boulder is firmly embedded in soil, it is assumed that the boulder is a rigid body and cannot deform or rotate within the overburden soil at the critical state of failure. According to Fig. 1a, the force equilibrium of the boulder before excavation can be expressed as follows:

After excavation, the earth pressure is partly released on the right of the boulder, resulting in the reduction of resistant force along the slope inclination to N'_2 , as shown in Fig. 1b. If the overall resistant force is less than the downslope component of gravity, N'_2 , may turn into a downward thrust, and the boulder will slide downwards along the bedrock. Meanwhile, when the rainfall is active, it will increase the soil weight and reduce the soil strength and the soil-boulder interface friction to S' which further intensifies the boulder

It can be seen from the analysis that the possible failure mode of the boulder is sliding along the bedrock layer. Under rainfall, the sliding resistant force of the boulder is the lowest, and it is prone to slide. Before excavation, the soil plays an anti-sliding effect by exerting embedded earth pressure and basal friction on the boulder. After excavation, the original force balance cannot be held, and part of the earth pressure is transformed into a downward active loading, leading to the initiation of boulder sliding.

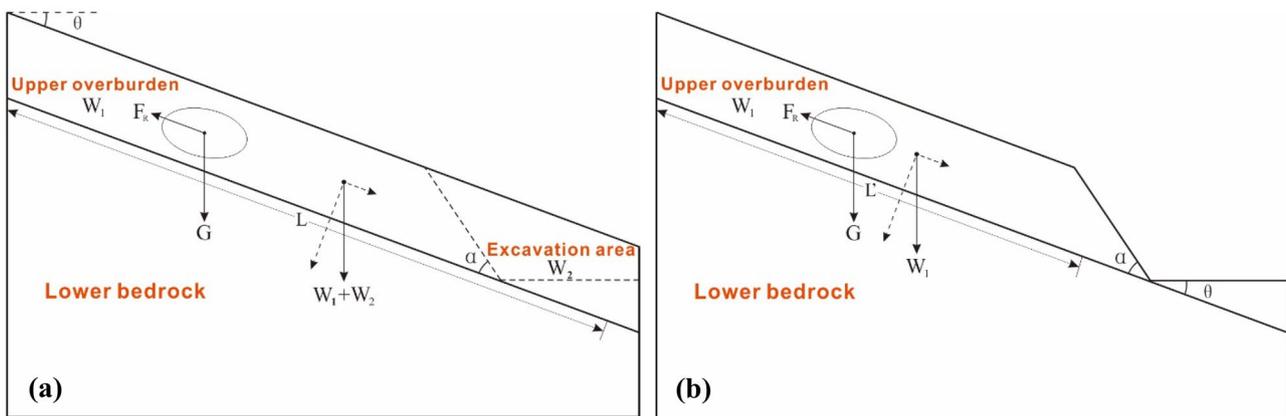
Fig. 2 Stability analysis of the boulder-embedded slope: **a** before excavation and **b** after excavation

The straight-line fracture surface method has been employed to analyze the overburden soil stability, which assumes that the sliding surface is approximately straight, as shown in Fig. 2a. In this research, the fracture surface

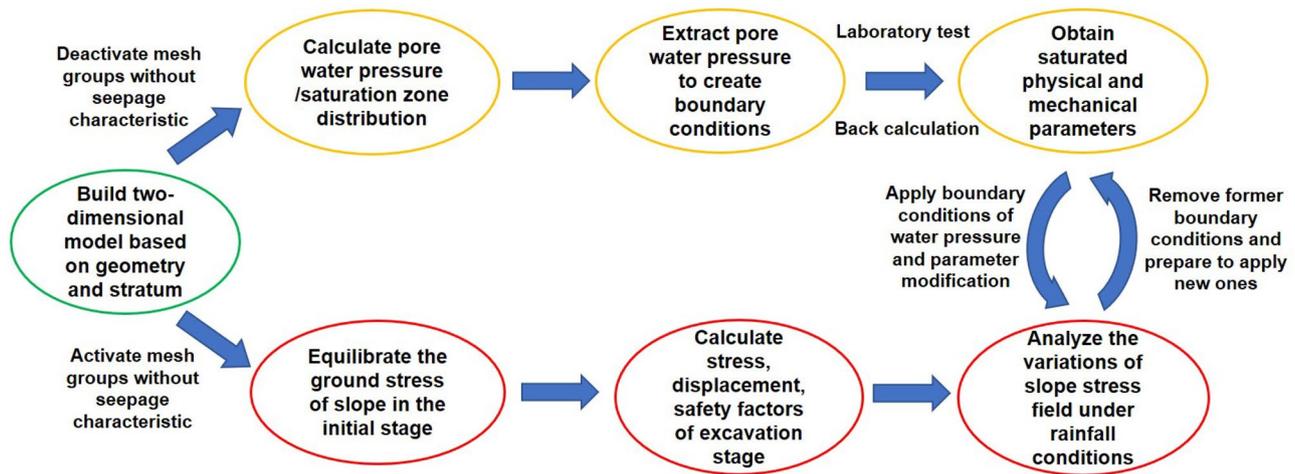
Fig. 3 The simulation process of boulder-embedded slope under excavation and rainfall

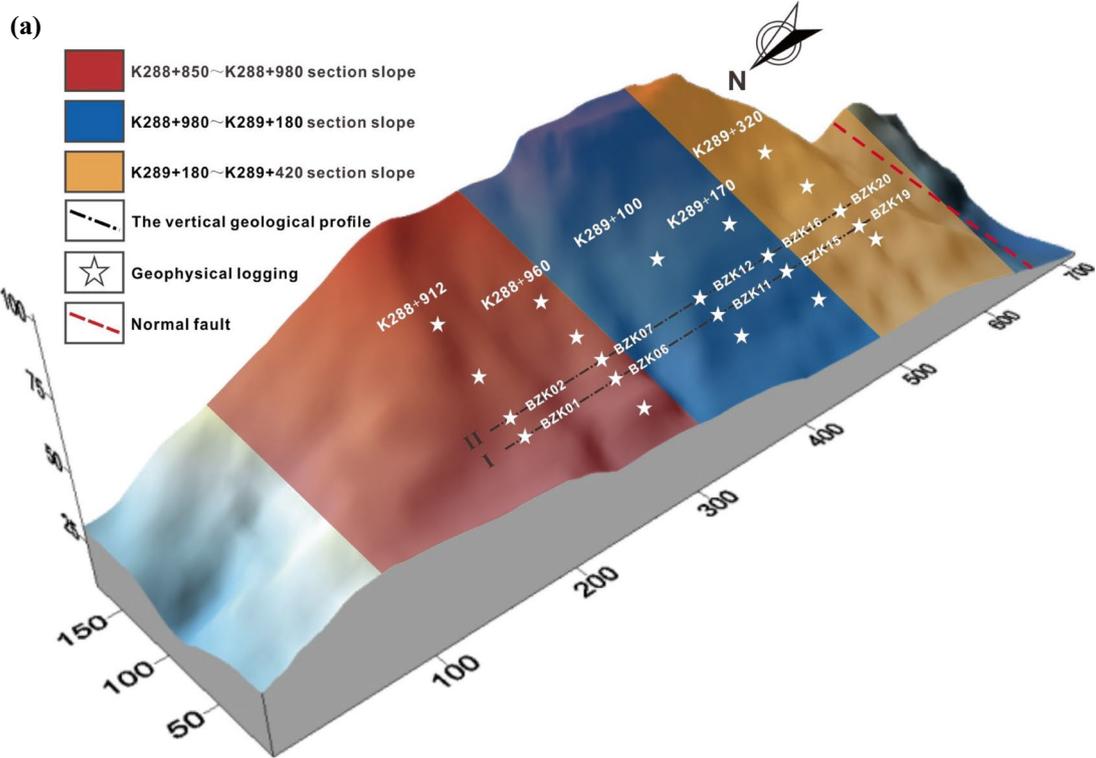
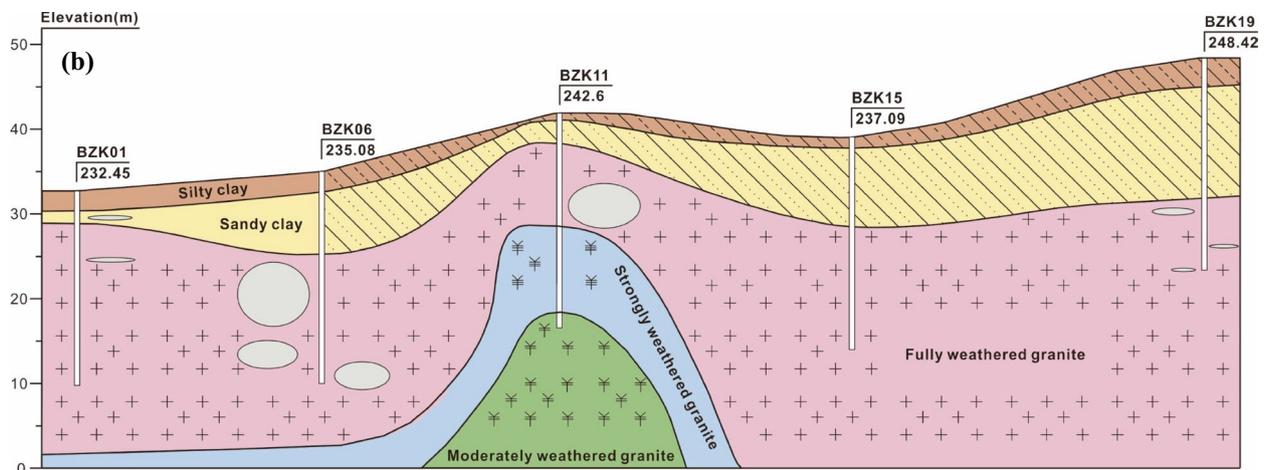
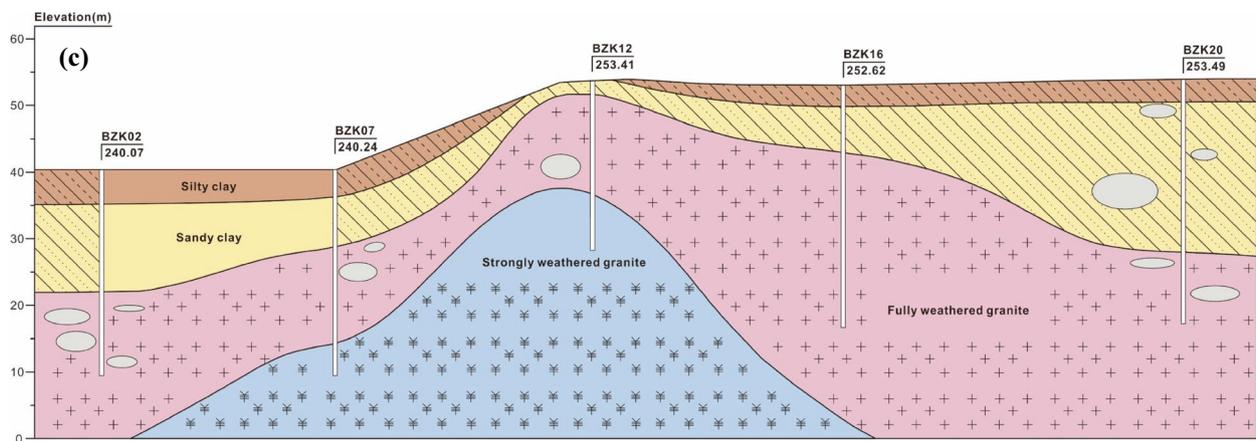
Fig. 4 The topography and geology of the slope before excavation **a** terrain and section division, **b** the vertical geological profile I, and **c** the vertical geological profile II (the gray filling represents granite boulders)

The highway slope is located in Guangdong Province, China. It contains three main sections, i.e., K288 + 850 ~ 980, K288 + 980 ~ K289 + 180, and K289 + 180 ~ 420 as shown in Fig. 4a, which are situated at the junction of the Guangdong-Hunan fold belt with a typical geological structure of syncline. A normal fault with an occurrence of $177^\circ \angle 87^\circ$ passes through the southeast part. According to the measurement of the exposed bedrock, the attitude of the stratum is $73 \sim 80^\circ \angle 15 \sim 37^\circ$, which belongs to the gently anti-dip stratum and is conducive to slope stability. The annual rainfall in this area is 1400–2000 mm and mainly occurs in spring and summer. No groundwater is found in the slope during drilling exploration. The geological data shows that boulders are deposited in the slope area. To determine the location and dimension of boulders, 5-geophysical prospecting lines containing 22-logging wells (BZK01 ~ 22) are set along the slope strike direction. Meanwhile, the high-density electrical method is used in these wells for exploration. The results

show that the slope is covered entirely by silty clay, sandy clay, and fully to moderately weathered granites from top to bottom. The boulders are mainly located in sandy clay and fully weathered granite strata. Their shapes are basically ellipsoid or sphere, and their sizes vary from 0.8 to 15 m, as shown in Fig. 4b, c.

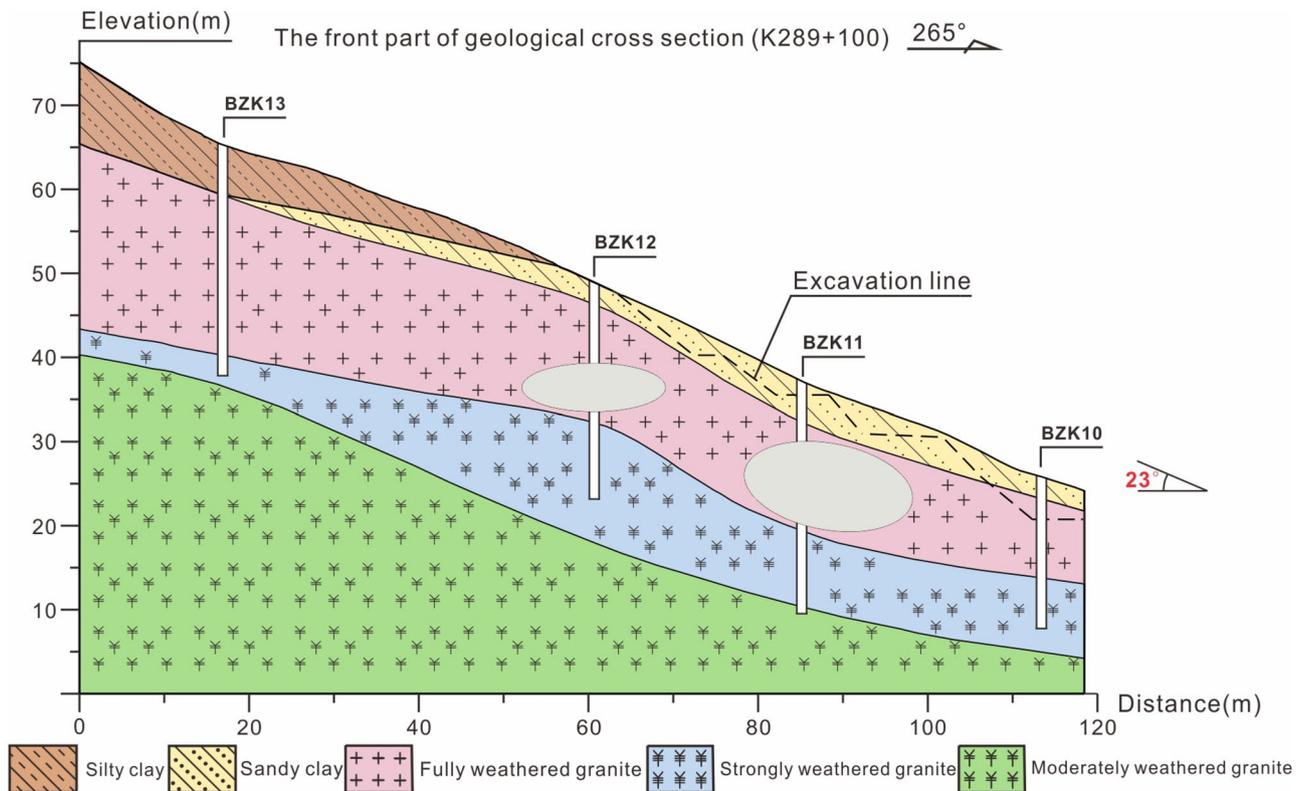
Fig. 5 The K289 + 100 geological cross section (the gray filling represents granite boulders)

Since sliding failures occurred in the middle of the K288 + 980 ~ K289 + 180 slope section under excavation and rainfall and the boulders are mainly distributed near the K289 + 100 section, the K289 + 100 section is selected as the slope case for the study. The slope has a height of 54 m, an inclination of 265° , and a natural slope ratio of 1:2.5. The initial design involved the four-level excavations. The ratios of the lower first and second slopes are 1:1 and 1:0.8 with the height of 10 m and 4.7 m, respectively. The ratios of the upper third and fourth slopes are 1:1.2 and 1:1.3 with the designed height of 4.7 m and 7.2 m. The platforms are gradually narrowed from low to high with the widths of 9.5 m, 6.2 m, and 3.5 m. The slope morphological and geological conditions are shown in Fig. 5, in which the weathering degree of granite is classified according to the standard for engineering classification of rock mass (GB/T50218) published by the Ministry of Housing and Urban-Rural Development, of the People's Republic of China (2014). Two large elliptic boulders exist in the fully weathered layer. The upper one is smaller and close to the interface between strongly weathered granite and fully one. The lower one is twice times larger than the upper boulder and locates near the toe of the second slope.

In this study, the two-dimensional finite element software Midas GTX (MIDAS Information Technology Co. Ltd. 2020) was used to analyze the slope failure. The numerical model consisting of 11,067 elements was configured according to Fig. 5. The vertical sliding bearings were applied to the left and right boundaries, and the fixed bearings were applied to the bottom boundary. The slope safety factor was calculated by the strength reduction method. Since the traditional failure criterion of numerical convergence or plastic zone penetration may cause infinite displacement or plastic zone discontinuity to the boulder-embedded slope, the displacement mutation was used as the failure criterion in this research. It is challenging to calculate the seepage analysis under rainfall conditions when affected by materials with

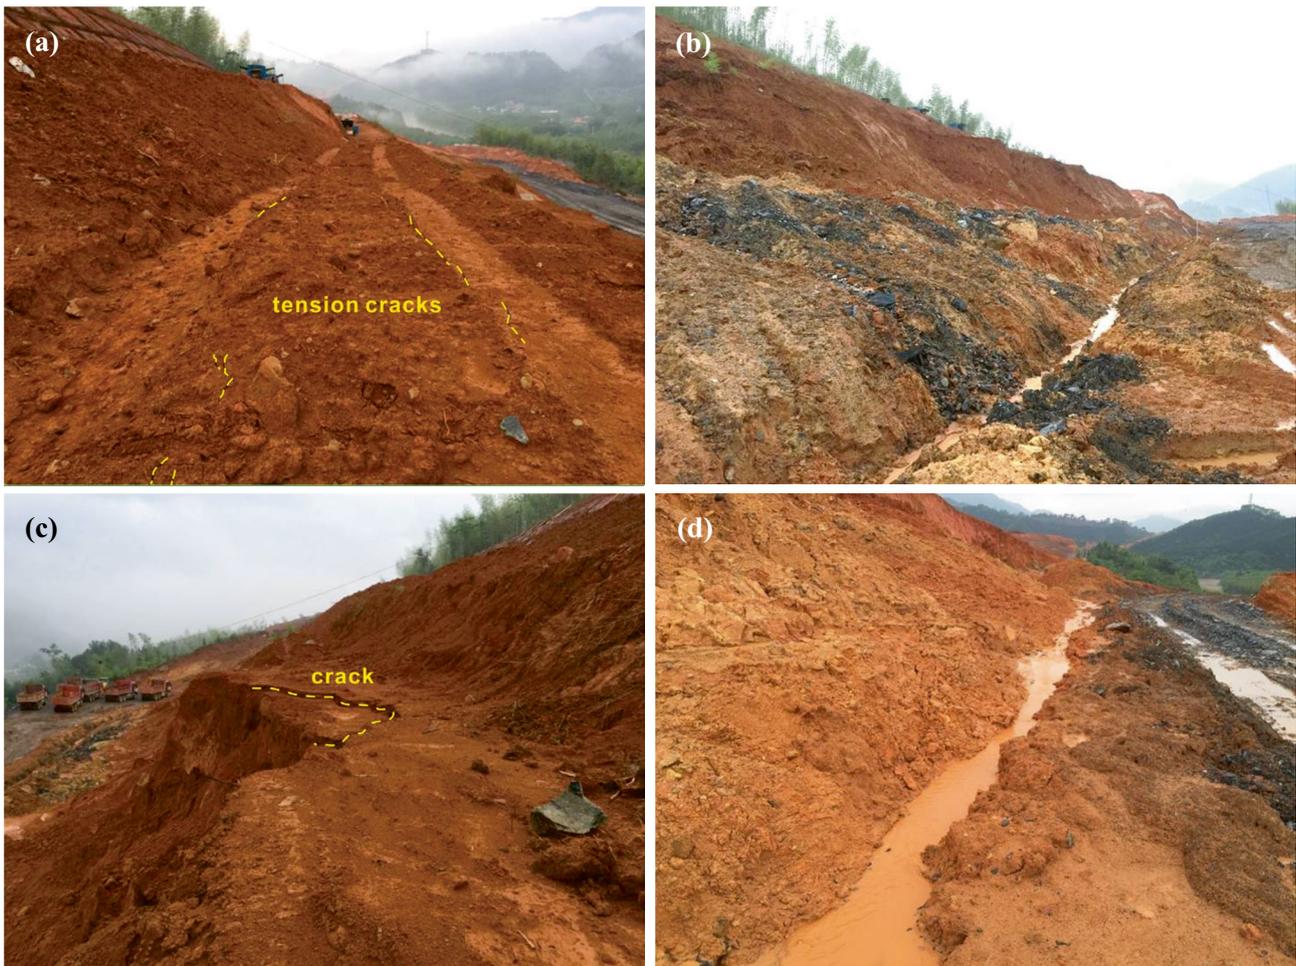
Fig. 6 Deformation and rain seepage of the first slope: **a** tension cracks (March 2016), **b** rain seepage at the slope toe (March 2016), **c** failure pattern (April 2016), and **d** rain seepage at the slope toe (April 2016)

The K288 + 980 ~ K289 + 180 slope section exhibited a typical progressive failure induced by rainfall infiltration on the exposed slope after the excavation, which delayed the progress of slope supporting and protection. The slope construction started in December 2015, and all four slope excavations were completed at the end of February 2016. In mid-March of the same year, the continuous rainfall occurred. After 5 days of continuous rainfall, the slight tension cracks appeared on the first platform, as shown in Fig. 6a. On March 27, 2016, rainwater began to seep out at the slope toe and formed a small ditch, as shown in Fig. 6b.

When April comes, the rock and soil masses were softened and deformed due to the heavy rainfall infiltration. The water accumulated gradually at the slope toe, and the soils on both sides of the ditch were in the

saturated state, as shown in Fig. 6c. On April 18, a shallow landslide occurred in the first slope. The sliding area extended from the toe to the top platform, but did not reach the lower boulder, as shown in Fig. 6d. On April 20, the lower part of the second slope was dragged and damaged by the sliding bodies, with the cracks appearing on the second platform. By the end of the rainfall on April 30, the sliding area developed to the upper part of the second slope.

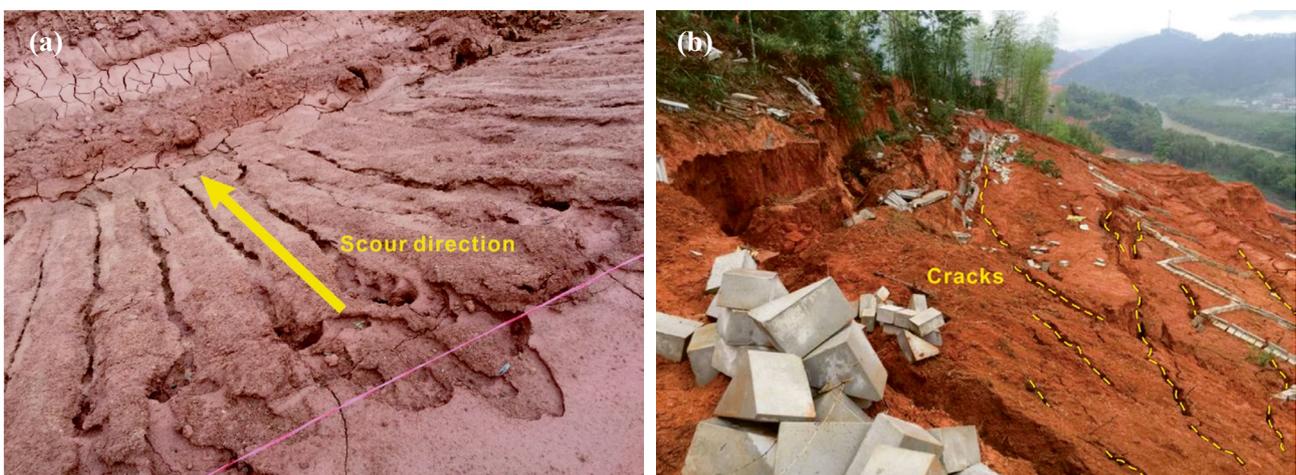
Fig. 7 Deformation and sliding of the fourth slope: **a** rain erosion (March 2016) and **b** cracks at the slope crest (April 2016)

Landslides were also observed in the fourth slope. During rainfall, the surface runoff from the slope top continuously scoured the fourth slope. The field survey on March 25 showed that part of the soils had been washed away, as shown in Fig. 7a. Affected by continuous rainfall, many tension cracks appeared on the slope crest in April and continued to expand and develop. By April 21, the fourth slope slid as a whole. The sliding area started from the tension crack at the slope crest and extended to the toe of the fourth slope. The edge dislocation formed at the original tension crack, as shown in Fig. 7b. Simultaneously, the deformation and extrusion of the landslide body promoted the initiation of shear cracks on both sides of the slope.

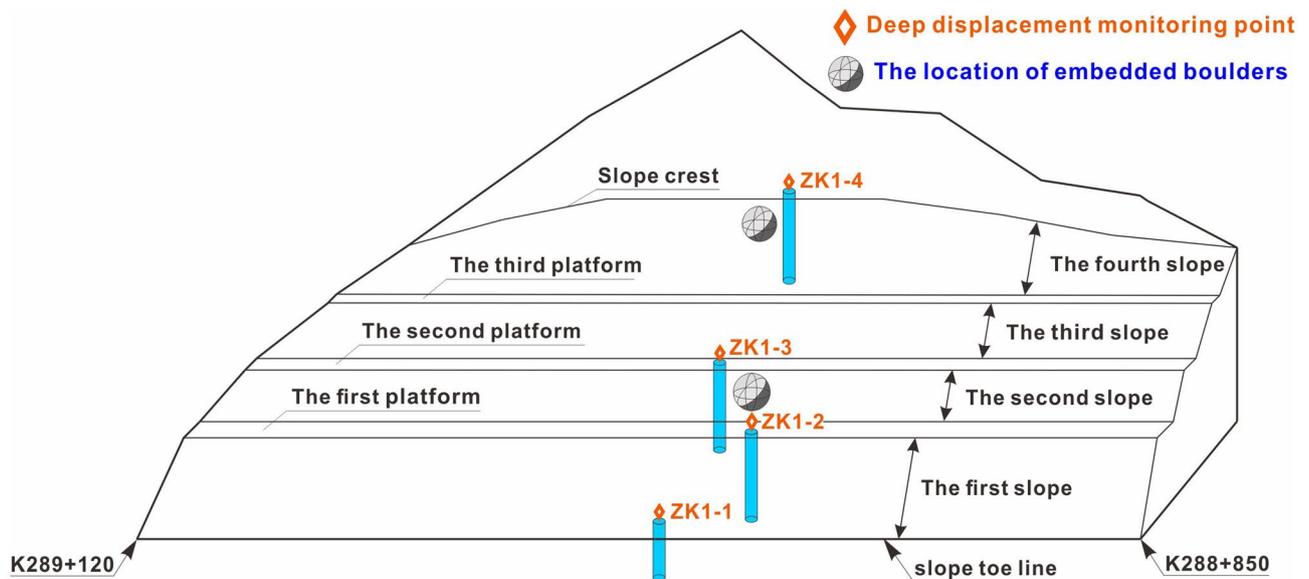
Fig. 8 Layout of the deep displacement-measuring pipes

The slope monitoring was conducted from March 18 to April 29, 2016. The inclinometers were buried with the logging wells to investigate the stability of boulders and soil masses by measuring the horizontal displacement along the slope dip direction. Four measuring points were arranged at the K289 + 100 section, among which ZK1-1, ZK1-3, and ZK1-4 were located at the slope toe, secondary platform, and slope crest, corresponding to the BZK10, BZK11, and BZK12 logging wells, respectively. The lower boulder is situated at the south of the ZK1-1 pipe, with the depth of 6 ~ 16 m. The upper boulder is located at the north of the ZK1-4 pipe, with the depth of 10 ~ 15 m. ZK1-2 is an additional measuring point, and the inclinometer pipe was buried at the middle of the first platform. The four measuring points are used to monitor the displacement of slope toe, first slope, second slope, and fourth slope. The layout of the measuring points and the relative positions of boulders and pipes are shown in Fig. 8.

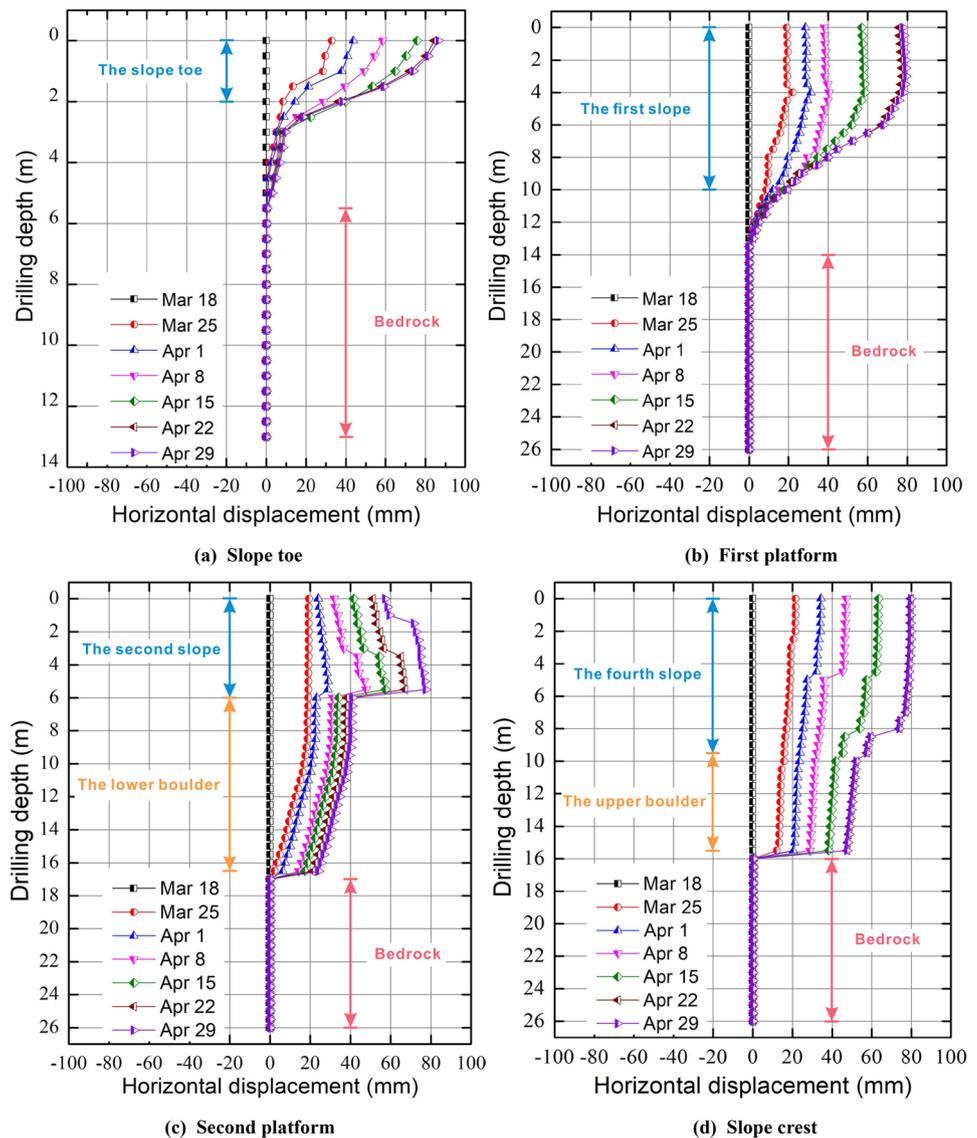
Fig. 9 The deformation curves of the four inclinometers from March 18 to April 29, 2016

As illustrated in the displacement curves, although the rainfall started on March 15, 2016, apparent slope deformations only occurred after 10 days on March 25, 2016. The slope toe deformed significantly, and the largest deformation reached 32.88 mm on the surface. The maximum displacement at the first, second, and fourth slopes were 22.11 mm, 19.32 mm, and 21.62 mm. The soil around the boulder also began to deform, and its displacement gradually decreased with the depth, which indicates that the slide and deformation were activated. When April came, the heavy rainfall aggravated the slope deformation. The monitoring data on April 1, 2016, show that the average displacement at the slope toe and the middle-upper part of the first slope were 40.89 mm and 29.15 mm, respectively. The curves of the second and the fourth slopes change significantly. The displacement of the second slope increases gradually with the depth, demonstrating the traction deformation of the first slope. A data gap occurred at the middle fourth slope, indicating the shallow area of the fourth slope began to slide. By April 8, 2016, the traction sliding in the middle-lower part of the second slope was intensified, two data gaps appeared at the middle and the junction between the lower part and the boulder area. Meanwhile, the data

On April 18, 2016, the first slope collapsed. On April 20 and 21, 2016, the lower parts of the second and fourth slopes slid. The monitoring results on April 22 show that the average displacements of the collapsing area on the slope toe and the first, second, and fourth slopes were 83.9, 78.78, and 78.97 mm, respectively. The damage range of the fourth slope was extended from 0~5m to 0~8m, and the second data gap also appeared at the junction between the lower part and the boulder area. The displacement at the depth of the two boulders is significantly lower than the upper area, shows that the boulders play an anti-sliding effect. By the end of the monitoring, the deformation area of the second slope expanded to the upper part with the average displacement of 74.84 mm.

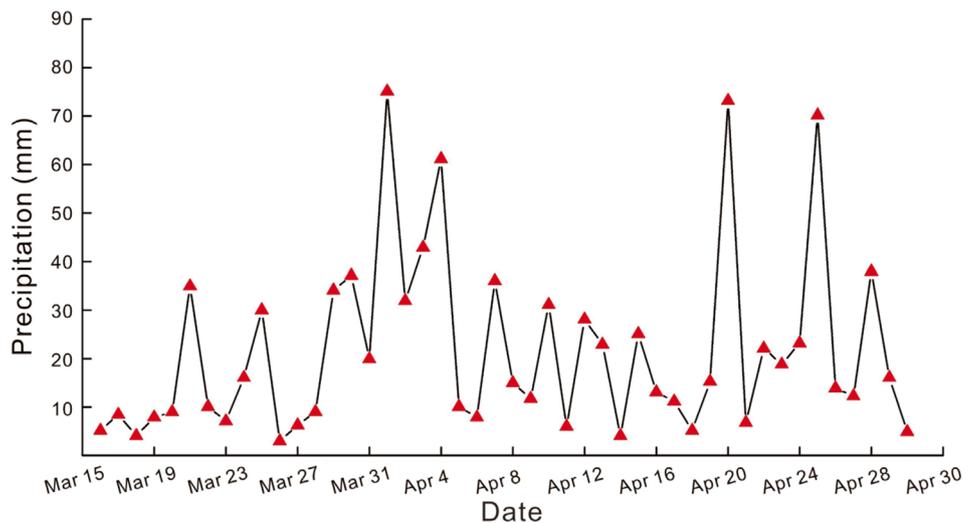
Fig. 10 The daily precipitation recorded from March 15 to April 30, 2016

According to the steps of the developed simulation approach, the Midas GTX transient seepage module was used to analyze the rainfall process. The daily precipitation of the simulated rainfall was input into the software. Since no groundwater was found on site, the initial groundwater level was set at the bottom of the slope model to meet the transient seepage analysis conditions without affecting the results. The rainfall lasted for 46 days, and the accumulated

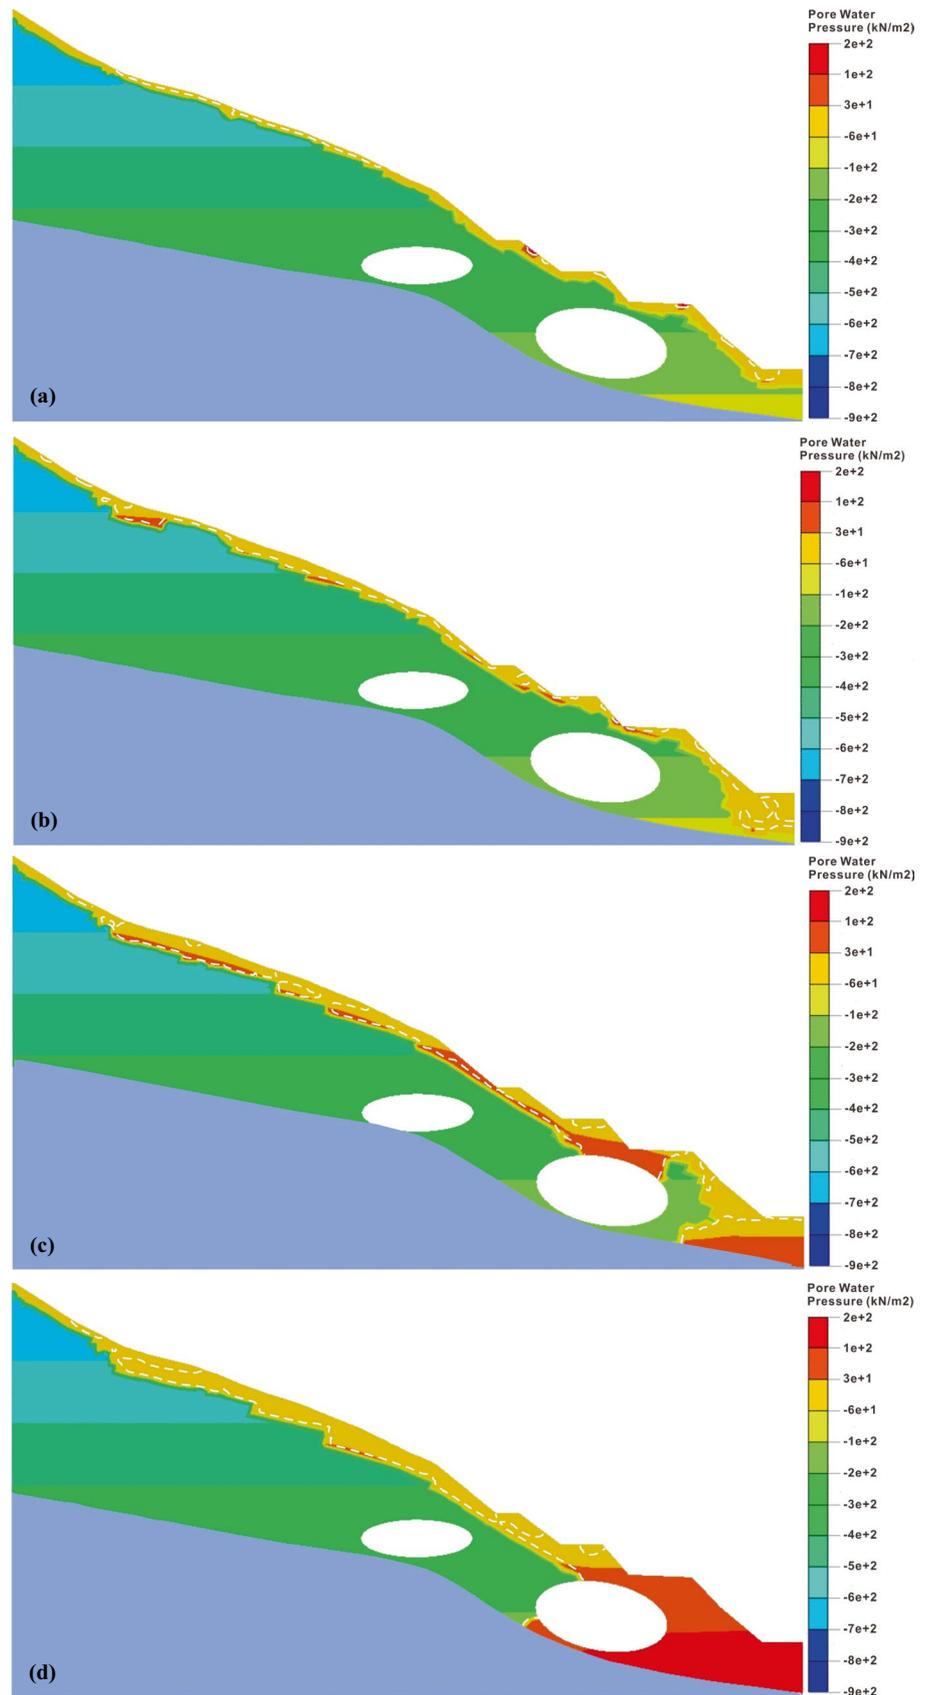
Fig. 11 Evolution of pore water pressure field: **a** March 25, 2016; **b** April 6, 2016; **c** April 18, 2016; and **d** April 30, 2016

Figure 11 shows the distribution of pore water pressure in the early, middle, late, and final stages of the rainfall. Due to the low rainfall intensity, the infiltration of rainwater only formed a transient saturated zone on the surface in the early stage (March 25, 2016). Below this zone, the pore water pressure of the soil was all negative. In the middle stage (April 6, 2016), the rainfall intensity gradually increased, and the loss of slope matrix suction caused the transient saturation zone to extend downward. When entering the late stage (April 18, 2016), the rain began to subside, but the previously infiltrated rainwater gathered in the silty clay layer and formed a saturated zone on the slope top. Affected by the steep slope inclination, most rainwater flowed down to the middle and lower part of the slope through the shallow area, which is also consistent with the phenomenon that the upper fourth grade slope was scoured by surface runoff, as shown in Fig. 7a. This rainwater infiltrated into the fully weathered granite through the high permeability silty and sandy clay, making the expansion of the transient saturation zone in this area much higher than the others. In the final stage, the rainfall intensity increased again. The lower boulder blocked the infiltration of rainfall at the slope front, so that the soil below the first and second platforms was all saturated. This can be confirmed by the phenomenon that a large amount of rainwater seeped out at the slope toe, as shown in Fig. 6d. Influenced by the surface runoff and infiltration capacity of rock and soil, the matric suction of the soil mass at the slope front rapidly dissipated and turned to a positive value during the entire rainfall process. However, the middle and upper soils did not change after forming a transient saturated zone in the shallow area.

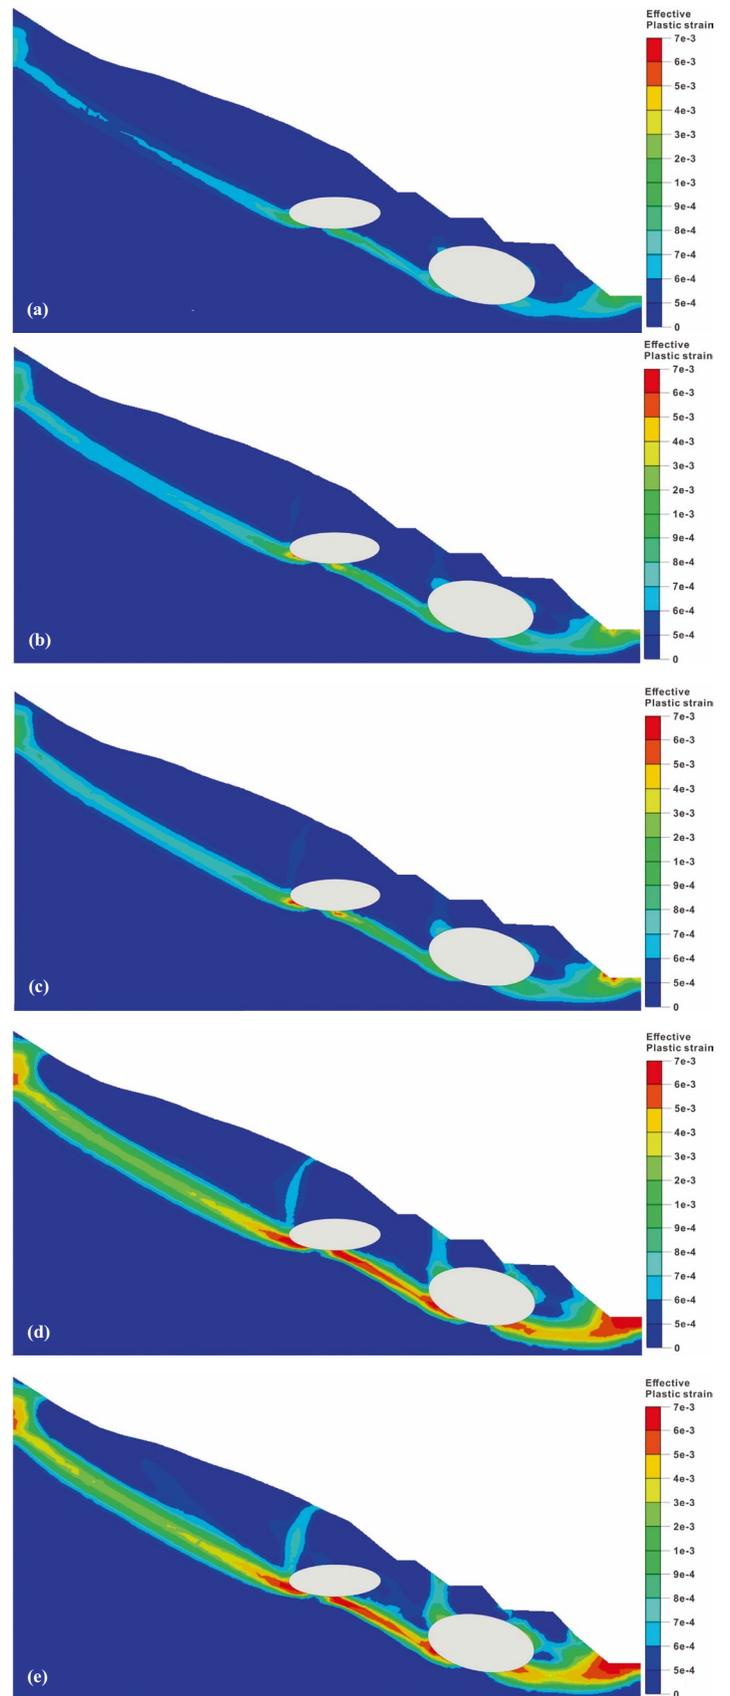
Fig. 12 Evolution of the plastic strain in the slope under different analysis condition: **a** excavation; **b** rainfall on March 25, 2016; **c** rainfall on April 6, 2016; **d** rainfall on April 18, 2016; and **e** rainfall on April 30, 2016

Figure 12 shows the evolution of the slope effective plastic strain under the excavation and the subsequent rainfall of March 25 to April 30, 2016. For clarity of the presentation, the areas without obvious plastic strain below the fully weathered layer are not displayed in the figure. It can be seen from the figure that the potential failure mode of the slope is deep-seated sliding. After the excavation, two unconnected plastic zones from the slope toe to the lower boulder and to the upper boulder formed inside the slope. The sliding surface shows a trend to bypass the boulders and extend along the interface between fully and strongly weathered granite, indicating the hindering effect.

formed and were separated by the two boulders, as shown in Fig. 12b. Apart from the first and second slopes, large displacements were at the shallow area from the slope crest to the upper fourth slope. At this point, three deformation areas initially formed: the middle-lower parts of the first and second slopes and the slope crest to the upper fourth slope, as shown in Fig. 15a. The maximum displacement values of the three areas were 31.5 mm, 20.1 mm, and 21.8 mm, respectively, which are basically close to the maximum values of 32.9 mm, 22.11 mm, and 19.32 mm of the monitoring points at the slope toe, the second platform and the slope crest on the same day, indicating that the simulation captured the main features of the slope failure effectively.

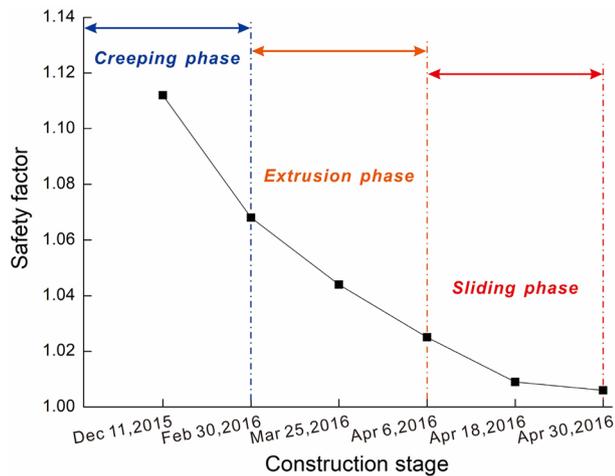
Fig. 13 The factor of slope safety at each phase

Figure 13 shows the variation of the factor of slope safety in each modeling stage. The slope stability gradually decreased under the influence of rainfalls. According to Wang et al. (2017), the slope deformation can be divided into the creeping phase ($1.05 < F_s < 1.1$), the extrusion phase ($1.02 < F_s < 1.05$), the sliding phase ($0.98 < F_s < 1.02$), and the sudden slip phase ($0.95 < F_s < 0.98$). Under the initial and excavation conditions, the slope was in the creeping deformation phase. Because of the rainfall infiltration, the slope transformed into extrusion deformation and finally slid.

After the rainfall infiltration, the slope reached the extrusion deformation stage, characterized by the rapid extension of the plastic zone in soils. On the March 25, 2016, the factor of safety was reduced to 1.044. Three deep sliding surfaces

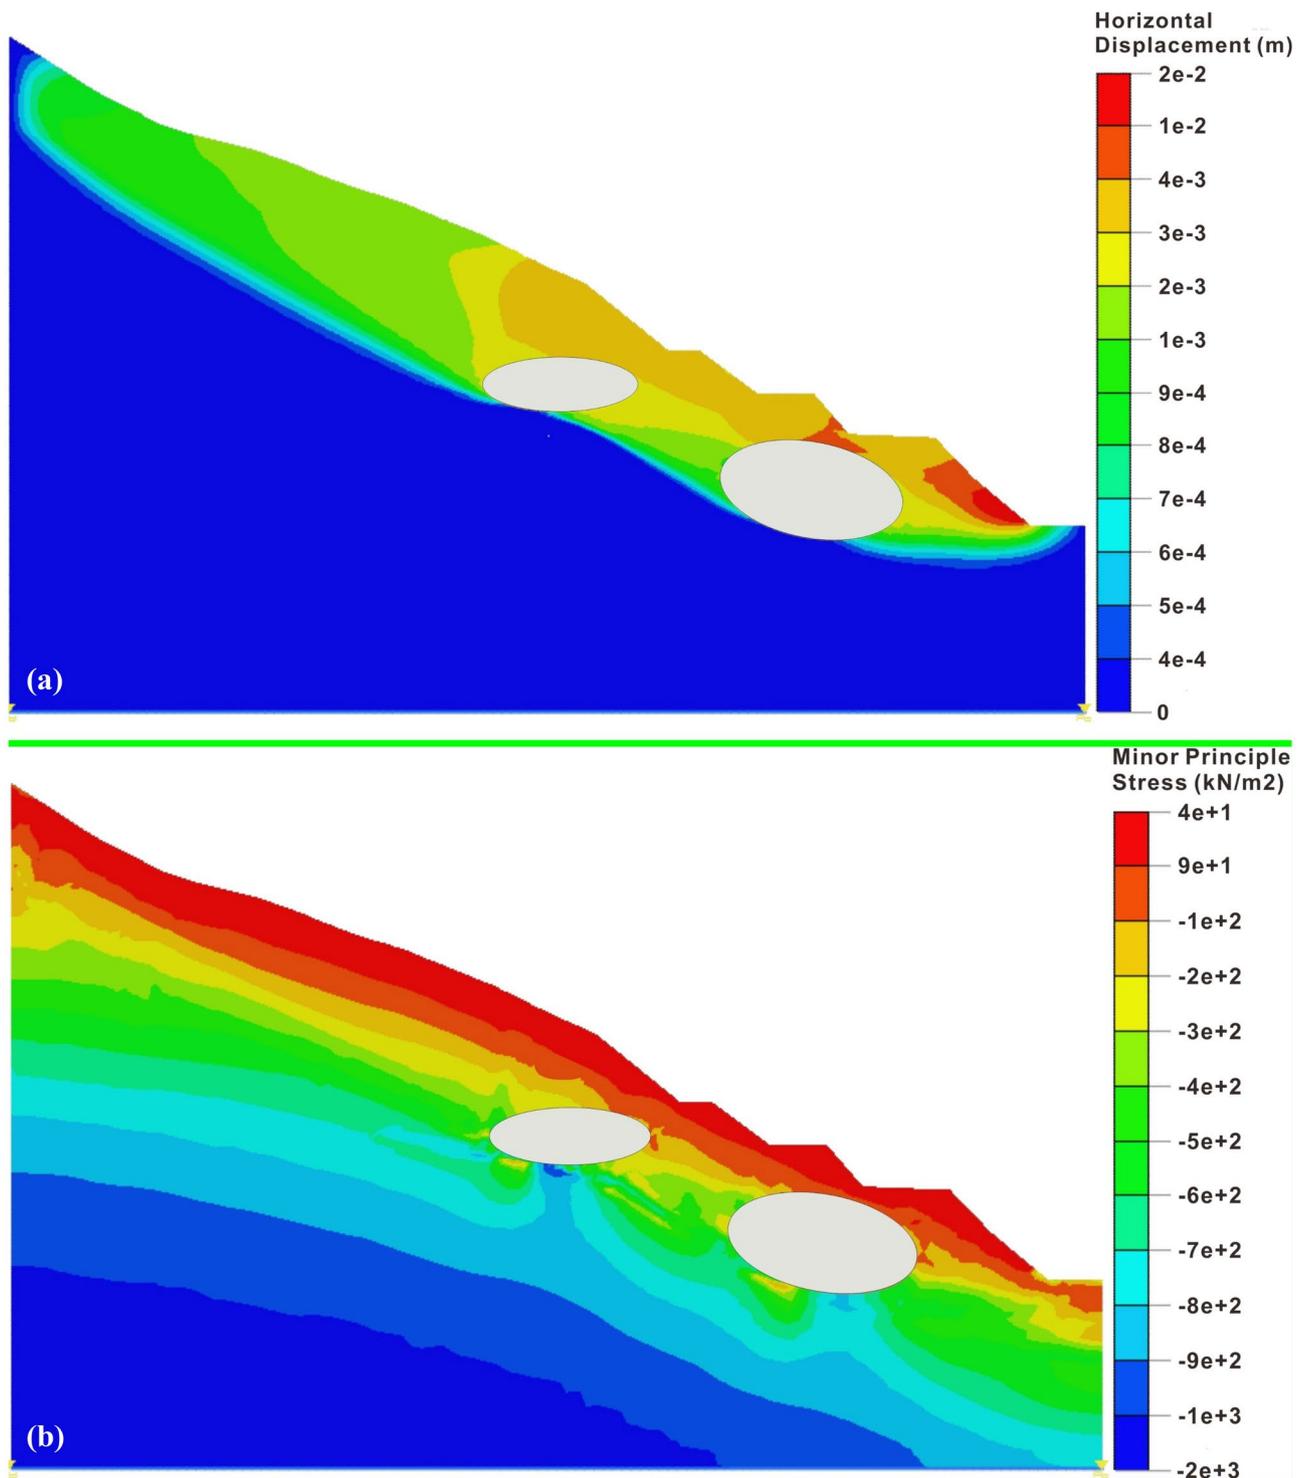
Fig. 14 Displacement and stress distribution after excavation: **a** horizontal displacement and **b** minor principle stress

masses makes the slope form a free face and lose effective mechanical support, causing the stress concentration at the excavated slope surface and the exposure of the weak zone at the slope toe and further resulting in the deformation of the middle-lower first and second slopes. At the early stage

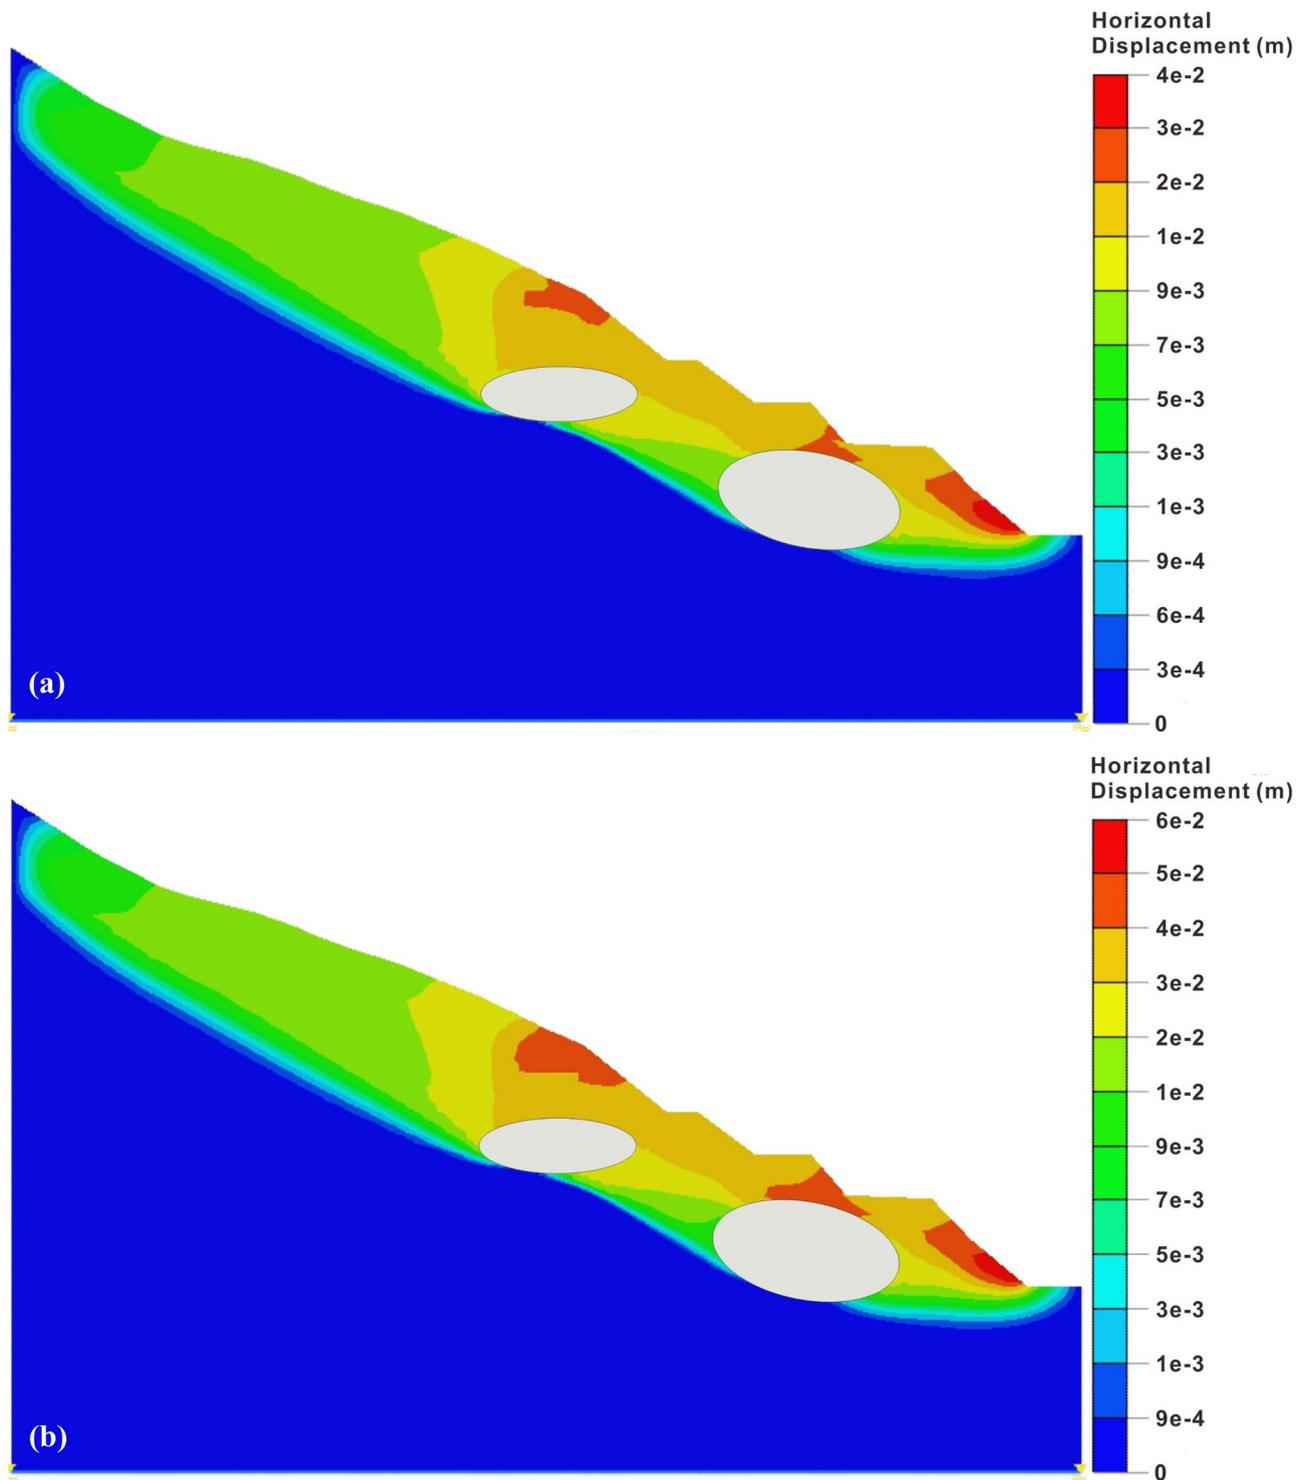
Fig. 15 Horizontal displacement characteristics of the slope in the initial and middle rainfall stages: **a** rainfall on March 25, 2016, and **b** rainfall on April 6, 2016

of rainfall, the rainwater infiltrates into the shallow areas and forms a transient saturation zone, which increases the unit weight of soil mass and reduces its effective stress and shear strength and therefore causes the deformation of the slope crest to the upper fourth slope. In the middle

of rainfall, the enhanced rainfall intensity makes the soil matrix suction lose rapidly. With the expansion of the saturation zone, the deformation area of the first and second grade slopes also extends to the middle, showing typical

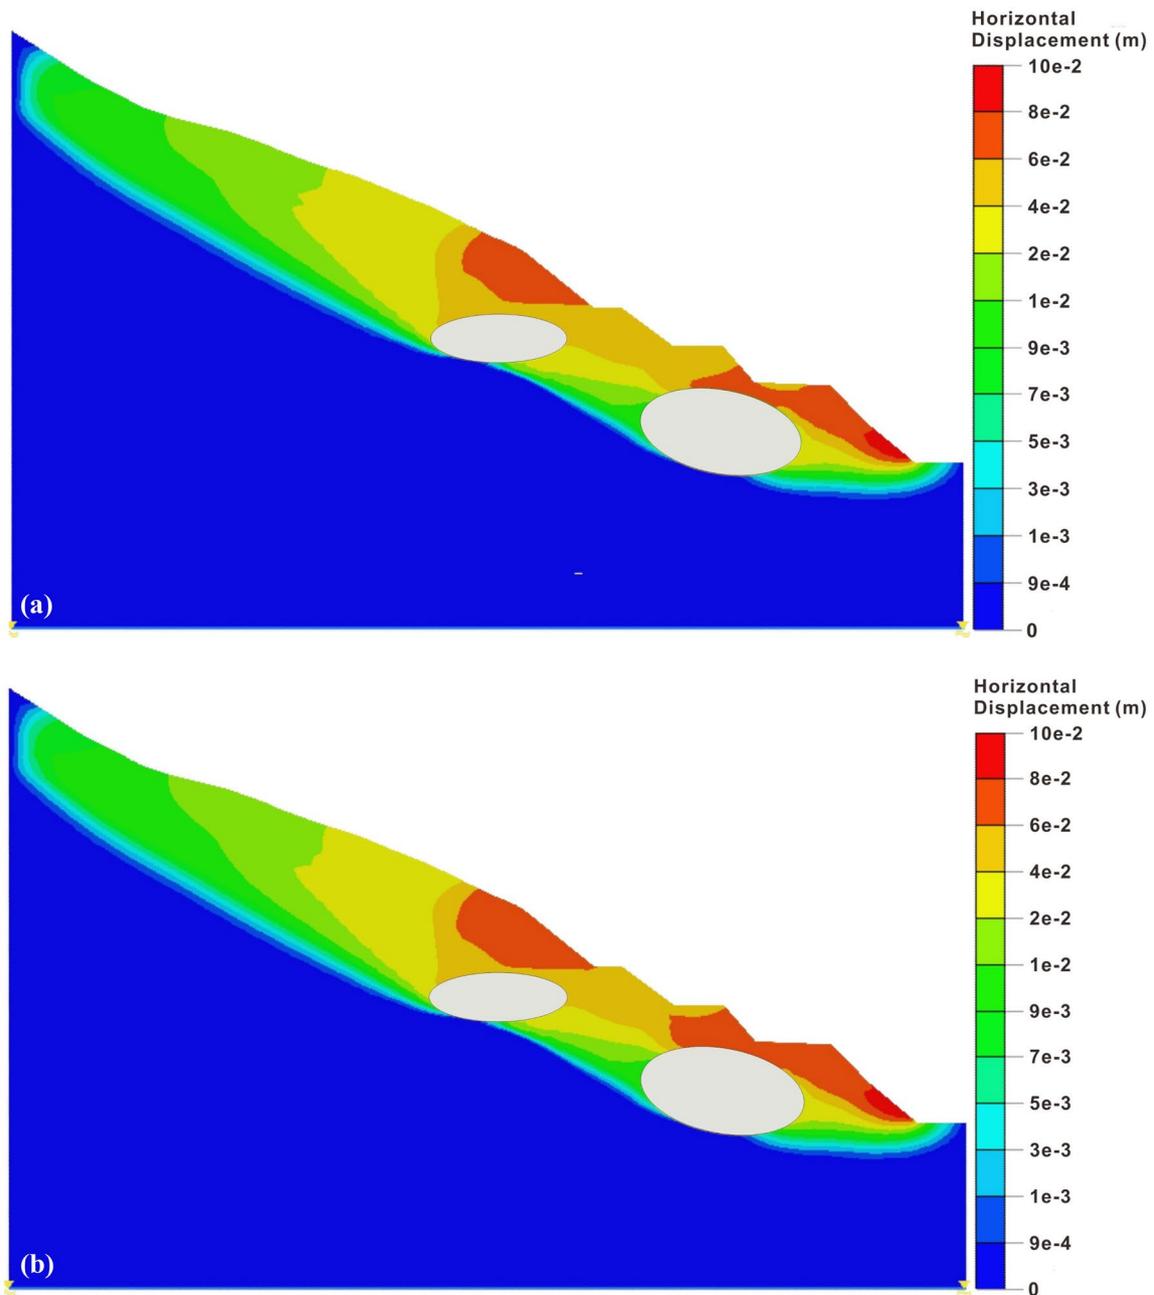
Fig. 16 Horizontal displacement characteristics of the slope in the late and final rainfall stages: **a** rainfall on April 18, 2016, and **b** rainfall on April 30, 2016

By the end of the rainfall (April 30, 2016), the horizontal displacement did not change. The damage area of the second slope extended to the upper part, as shown in Fig. 16b. The deformation of the fully weathered granite on the sides of boulders is 3.71 ~ 38.9 mm, which is much lower than the 59.9 ~ 97.3 mm of the three damage areas. The soil displacement in these ranges gradually decreased with the depth, which is consistent with the measured displacement curves at the depth of the boulders. The boulders effectively restrain the deformation of deep soil mass.

collapse of the first slope and the traction failure of the second slope. At the same time, the runoff continues to scour the fourth slope and erodes the soil on the surface, making the deformation area extend downward and a landslide occurs from the crest to toe.
