ROLLING CONTACT FATIGUE OF THERMAL SPRAY COATINGS

A Thesis submitted for the degree of

Department of Mechanical Engineering
Brunel University
February 1998

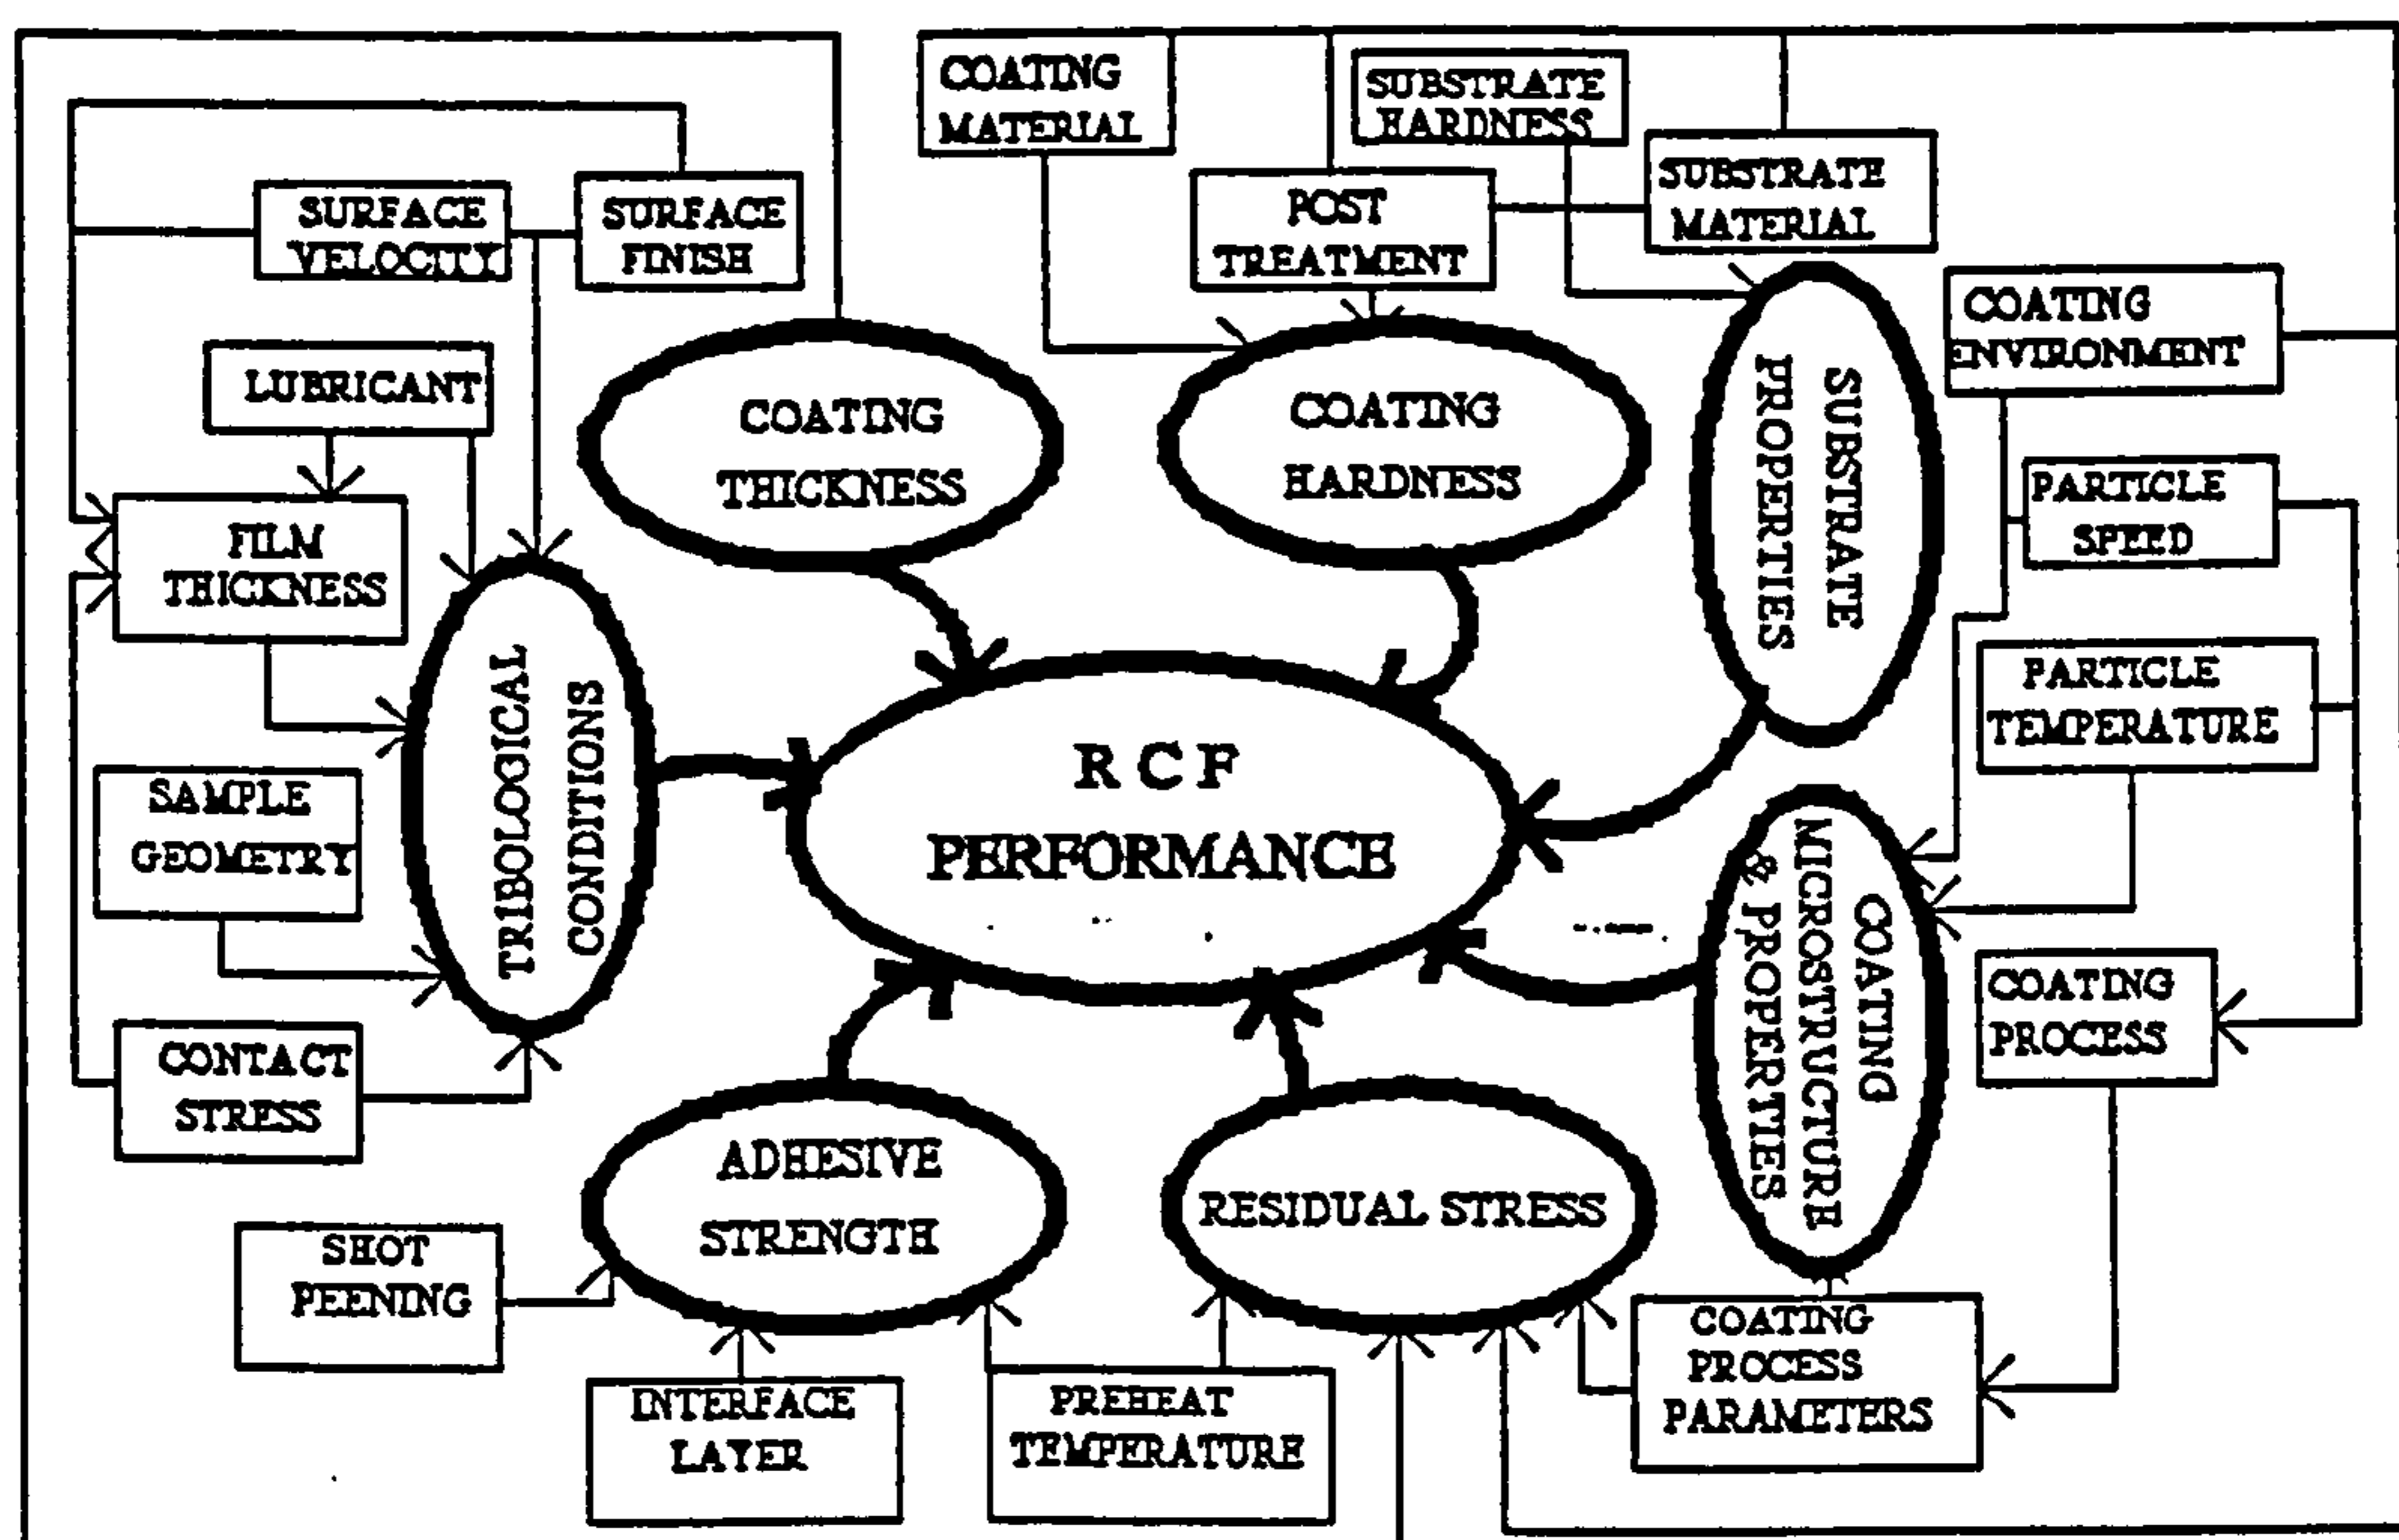
Figure 1.1, Multiple cause diagram

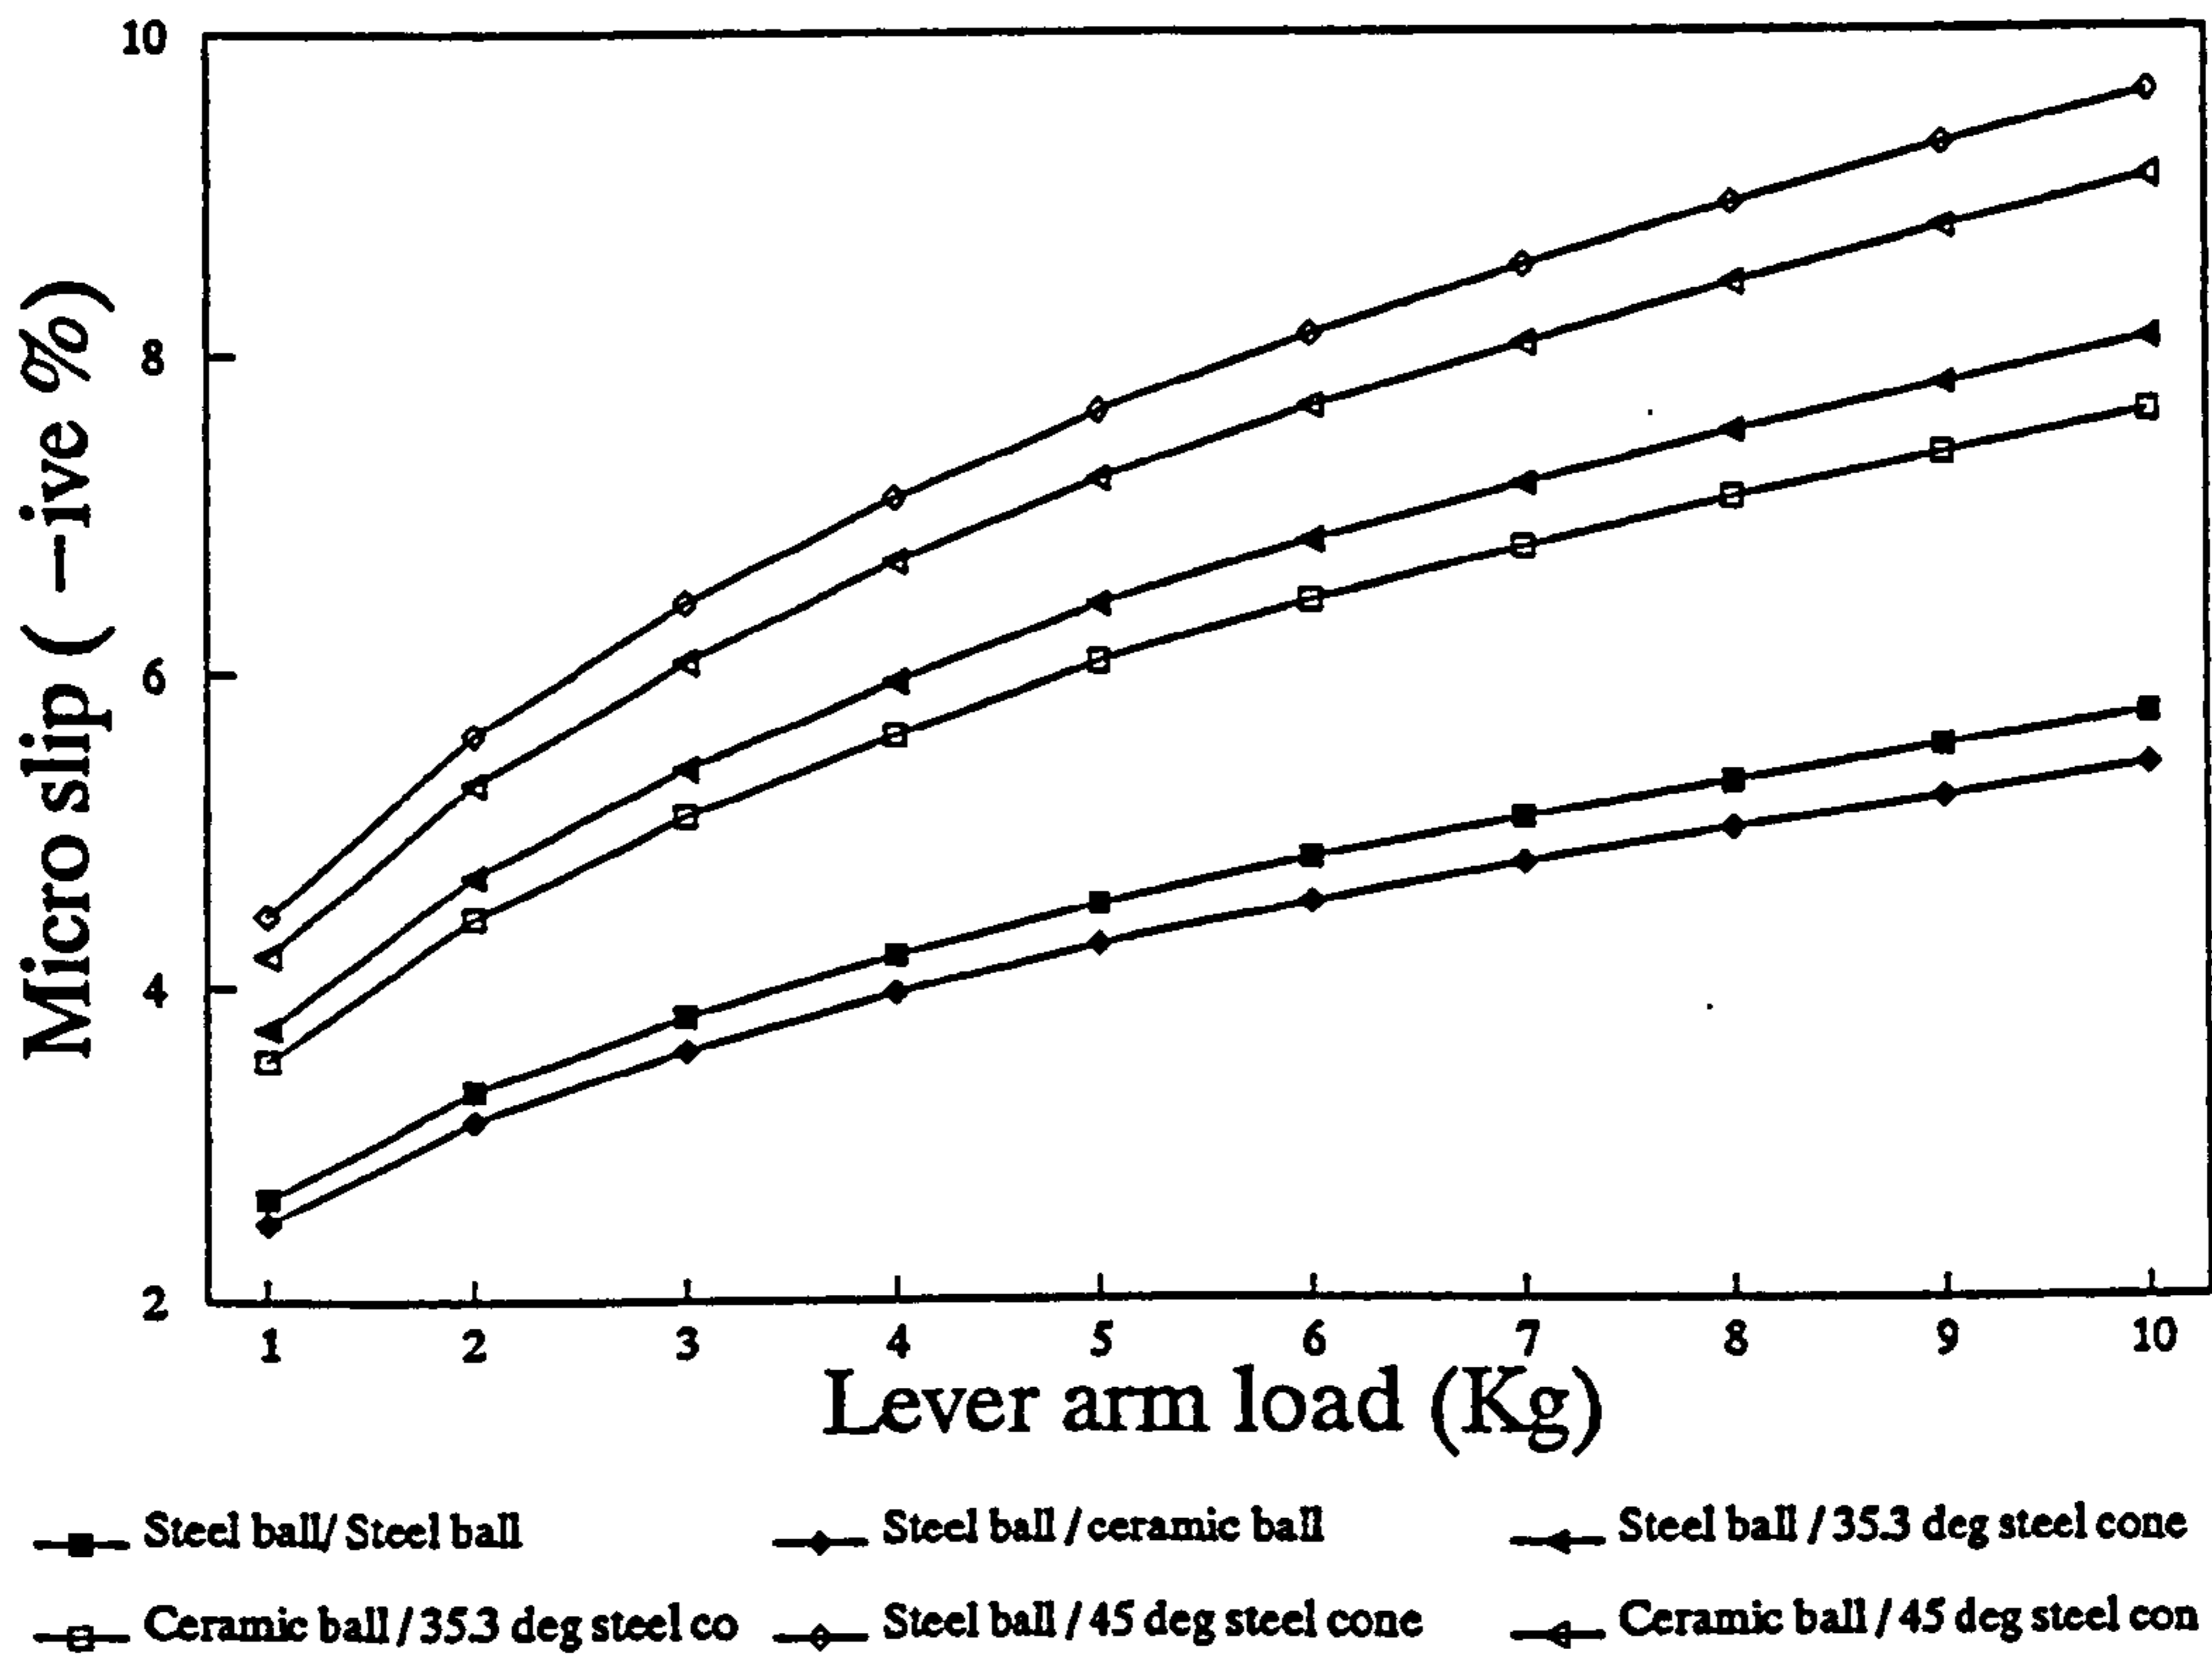
contact area used for the slip analysis has been calculated for the uncoated case of rolling elements which can change for different coatings. Techniques like FEM can be used to evaluate these differences in the contact dimensions in the coated and uncoated case of contacting bodies. Some of these cases have been discussed in section 3.3 of the thesis. Also, there can be appreciable sliding between the driver and the driven balls under the given test conditions which can effect the friction, microslip and in general performance of the rolling elements by making the contact rolling/sliding. The magnitude and direction of this sliding will now be analyzed on the basis of experimental observations.

Figure 3.10, Negative slip due to contact conformity

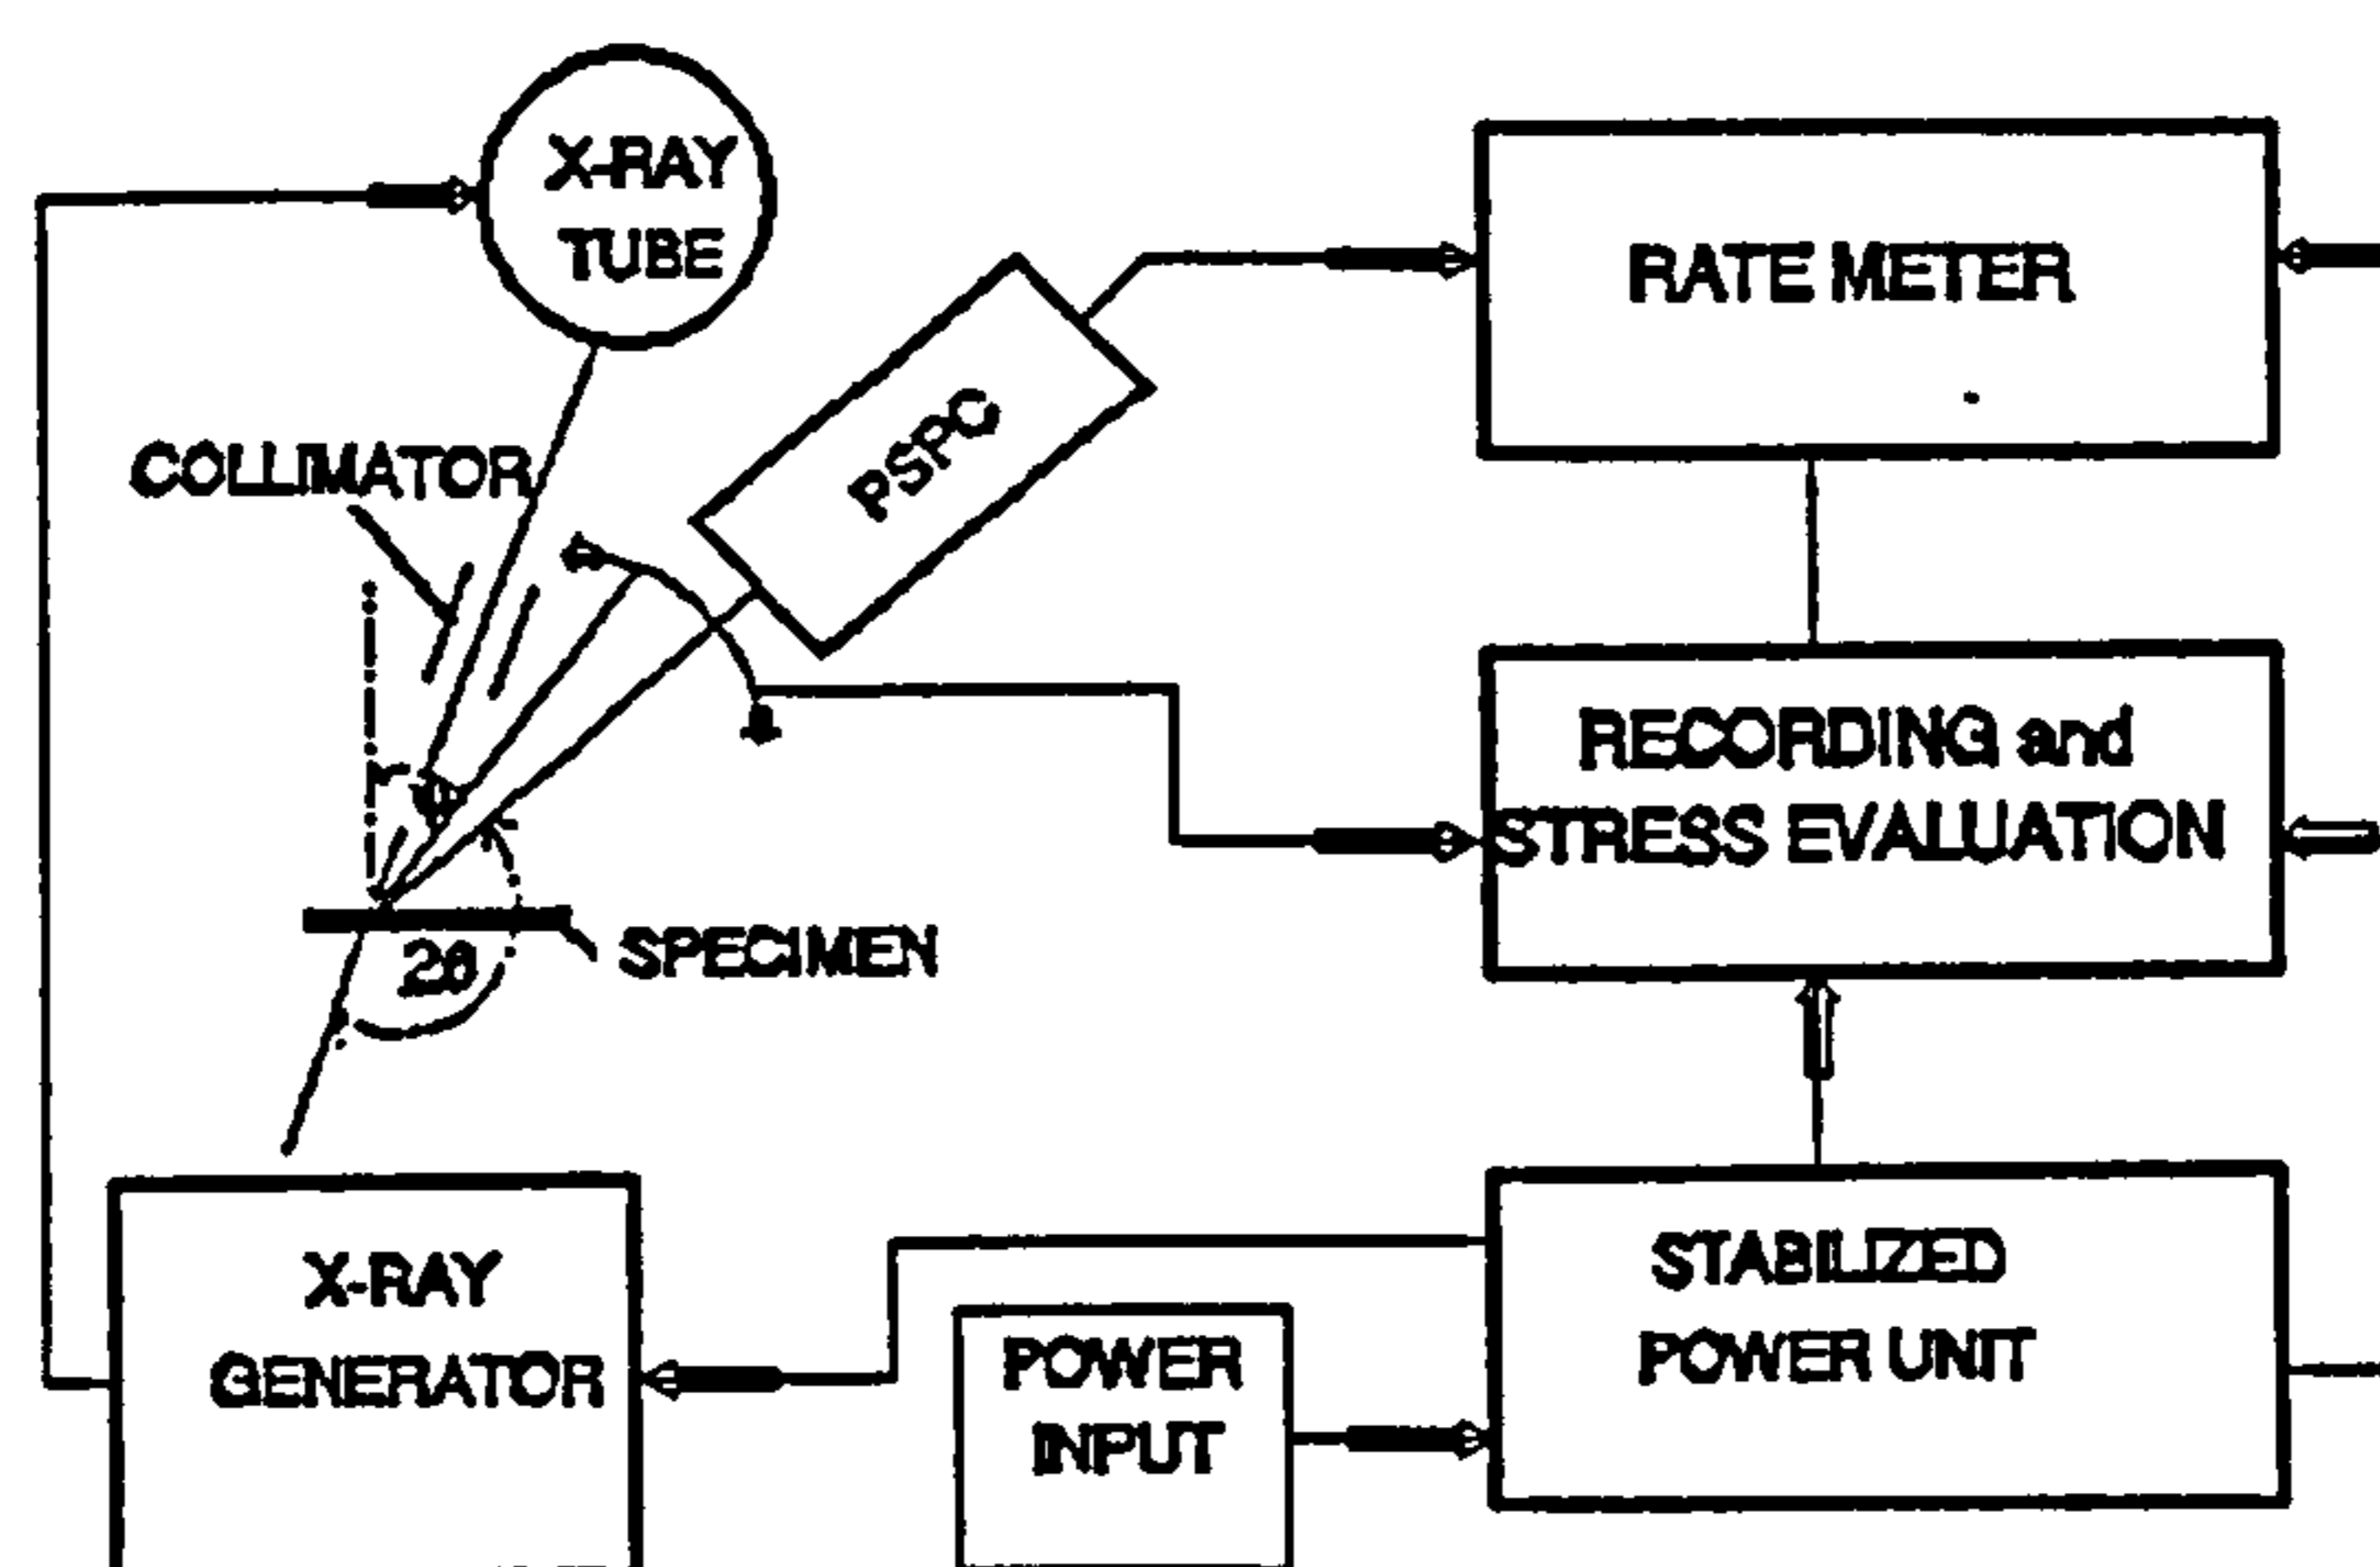
The orientation of the sample was found to have an influence on the stress results. For this purpose, an optical microscope was used to position the sample for each measurement. Considering the shape of the specimen and the anisotropy of the thermally sprayed coatings, residual stress measurements were made in three different directions. This enabled the investigation of the effect of measurement direction on the residual stress results. The residual stress measurements were made at 0° (Fa), 45° (Fb) and, 90° (Fc) to the direction of rolling. An attempt was also made to measure the through thickness residual stress field of the coating cross section but the diffraction profile was not significant enough to provide a statistical confidence in the residual stress results.

Figure 4.2, Schematic of the X-rays measurement

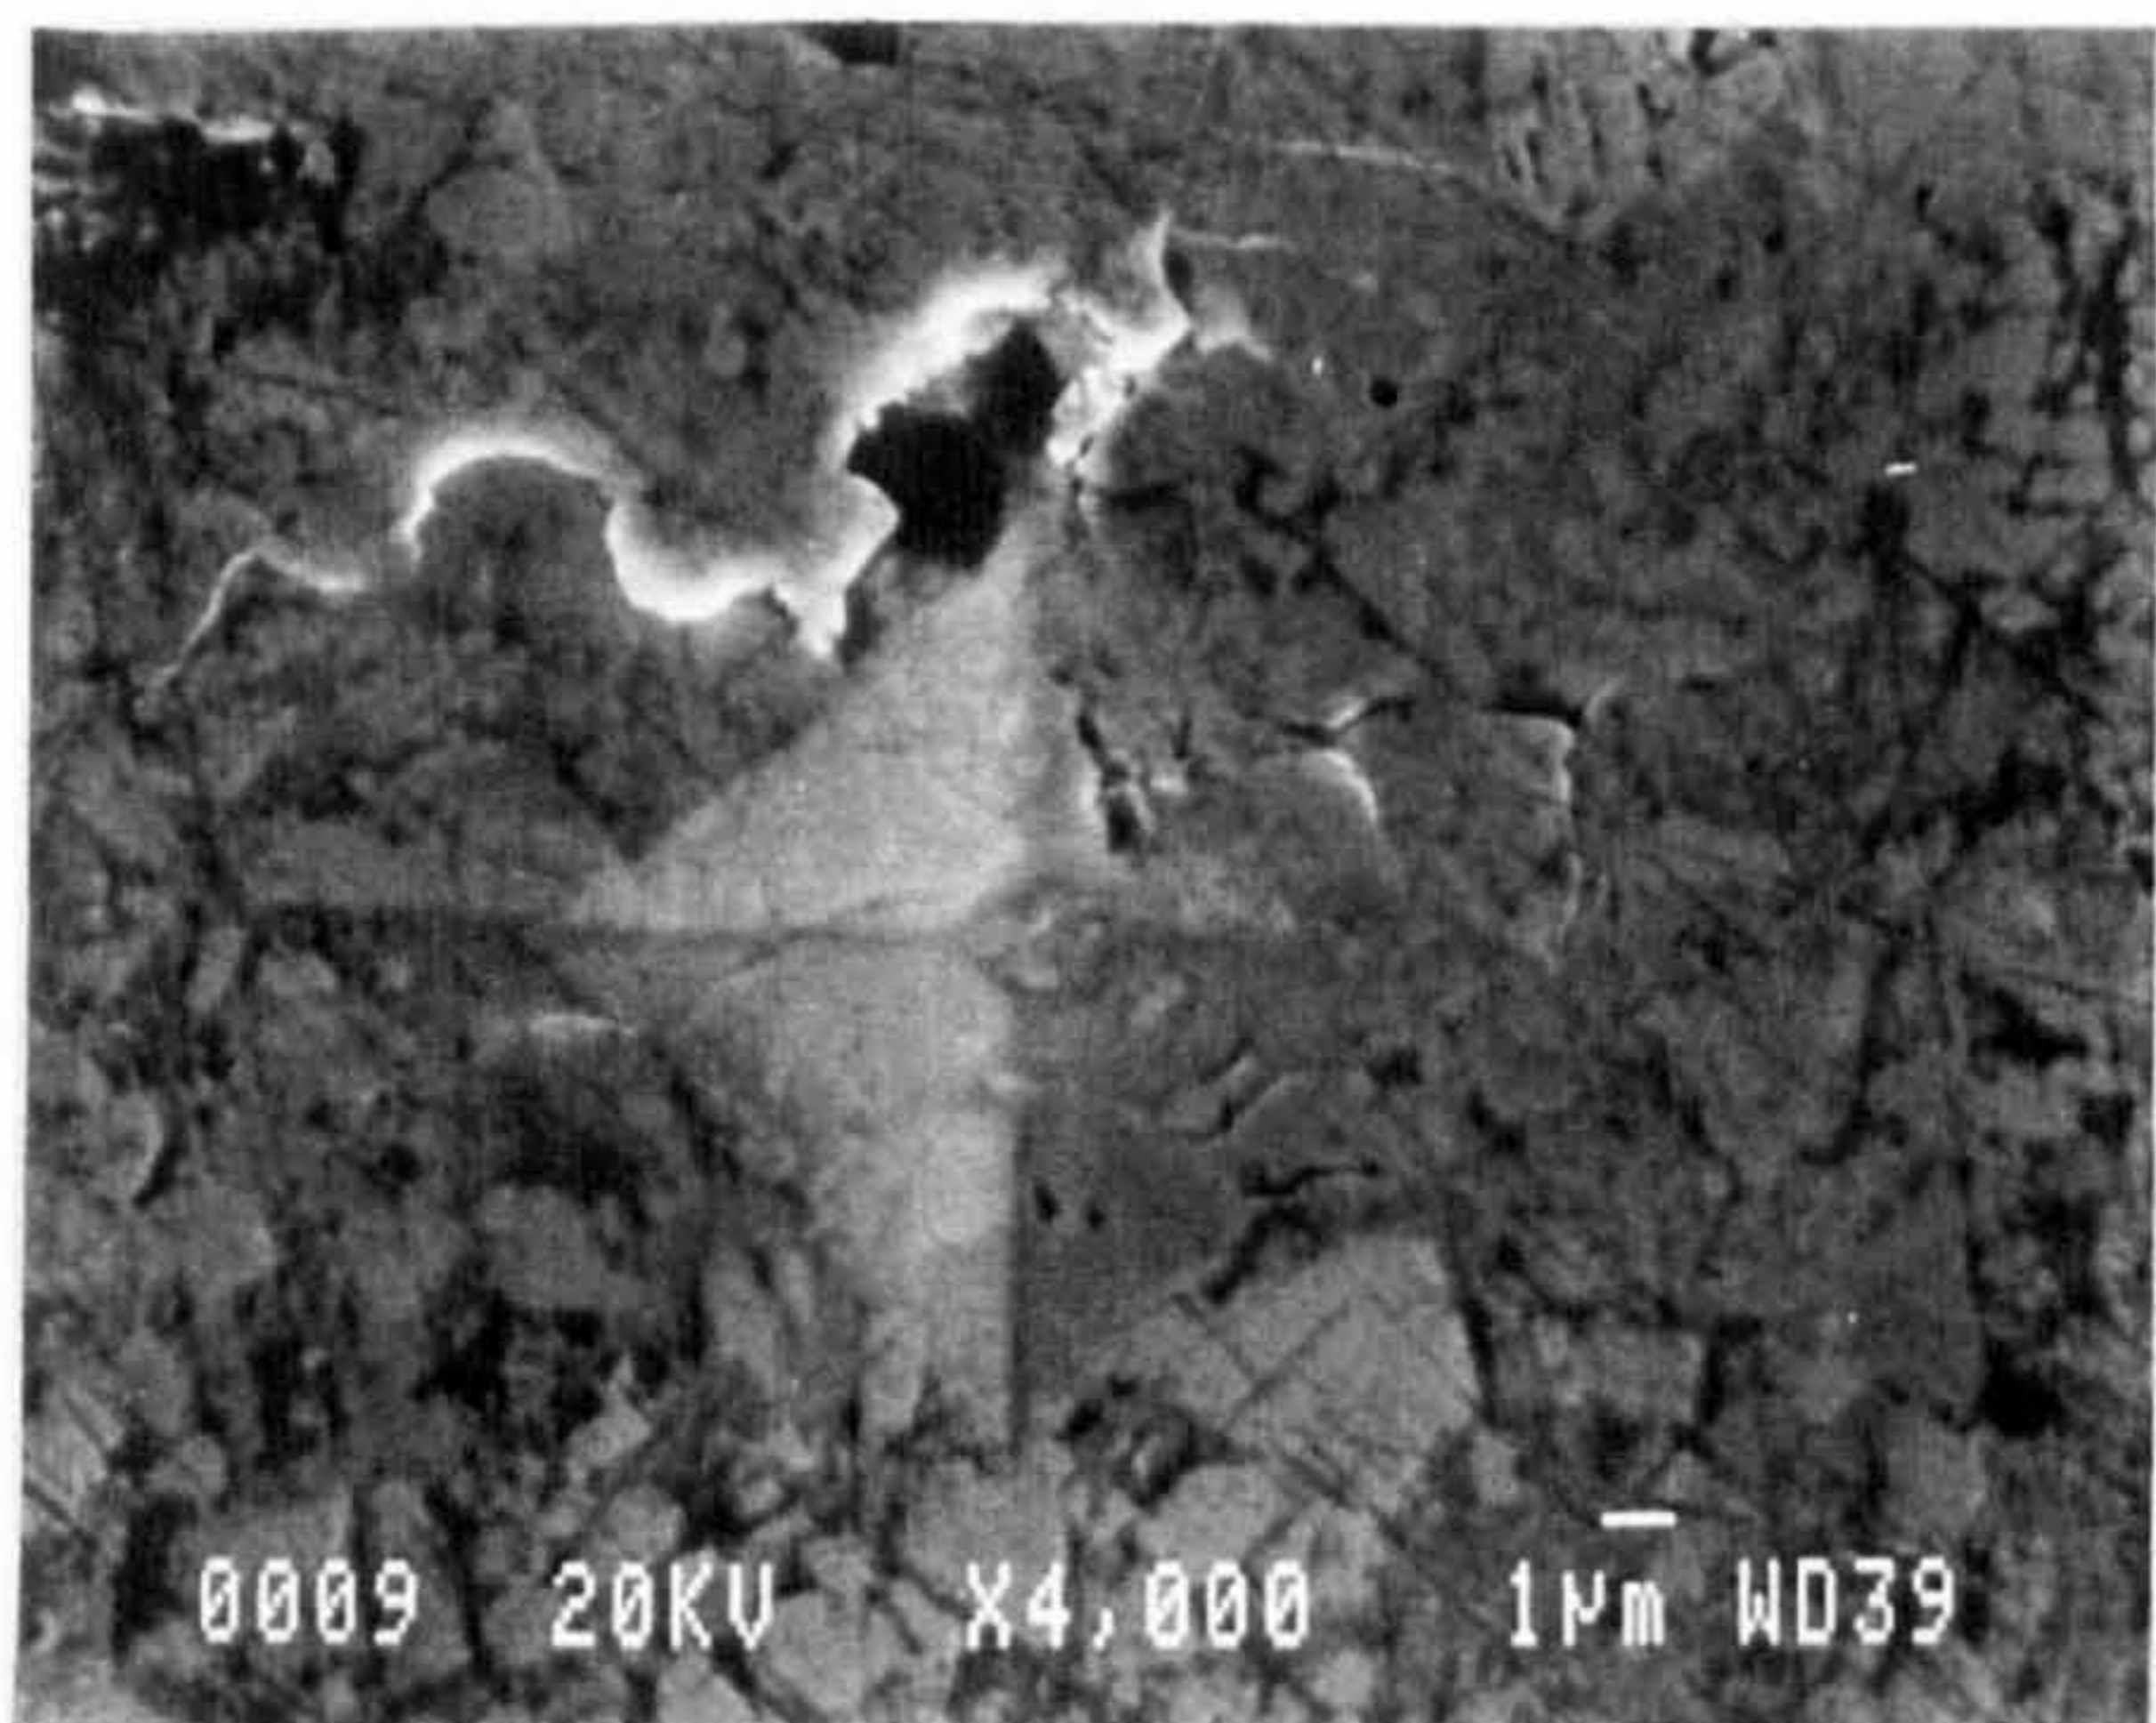
(a) indentation (100p)

The weakness in the coating microstructure was also seen in a simple compression test in the four ball machine. The coated rolling element cone was loaded at a Hertz contact stress of approximately 6 GPa in a clean, dry contact with the stationary planetary steel balls of the four ball machine. The load was removed and it was observed that the surface of the rolling element cone peeled as shown in Figure 5.3.7 (b). The coating particles adhered to the ball surface. This shows that the deformation resistance of the coating substrate combination was low. Moreover, the cohesive strength between the lamellas is low and the coating is prone to peeling in the absence of shear force. This can indicate the weakness and brittleness of the coating microstructure. The cracks can also be seen on the edge of the contact area due to the tensile stress.

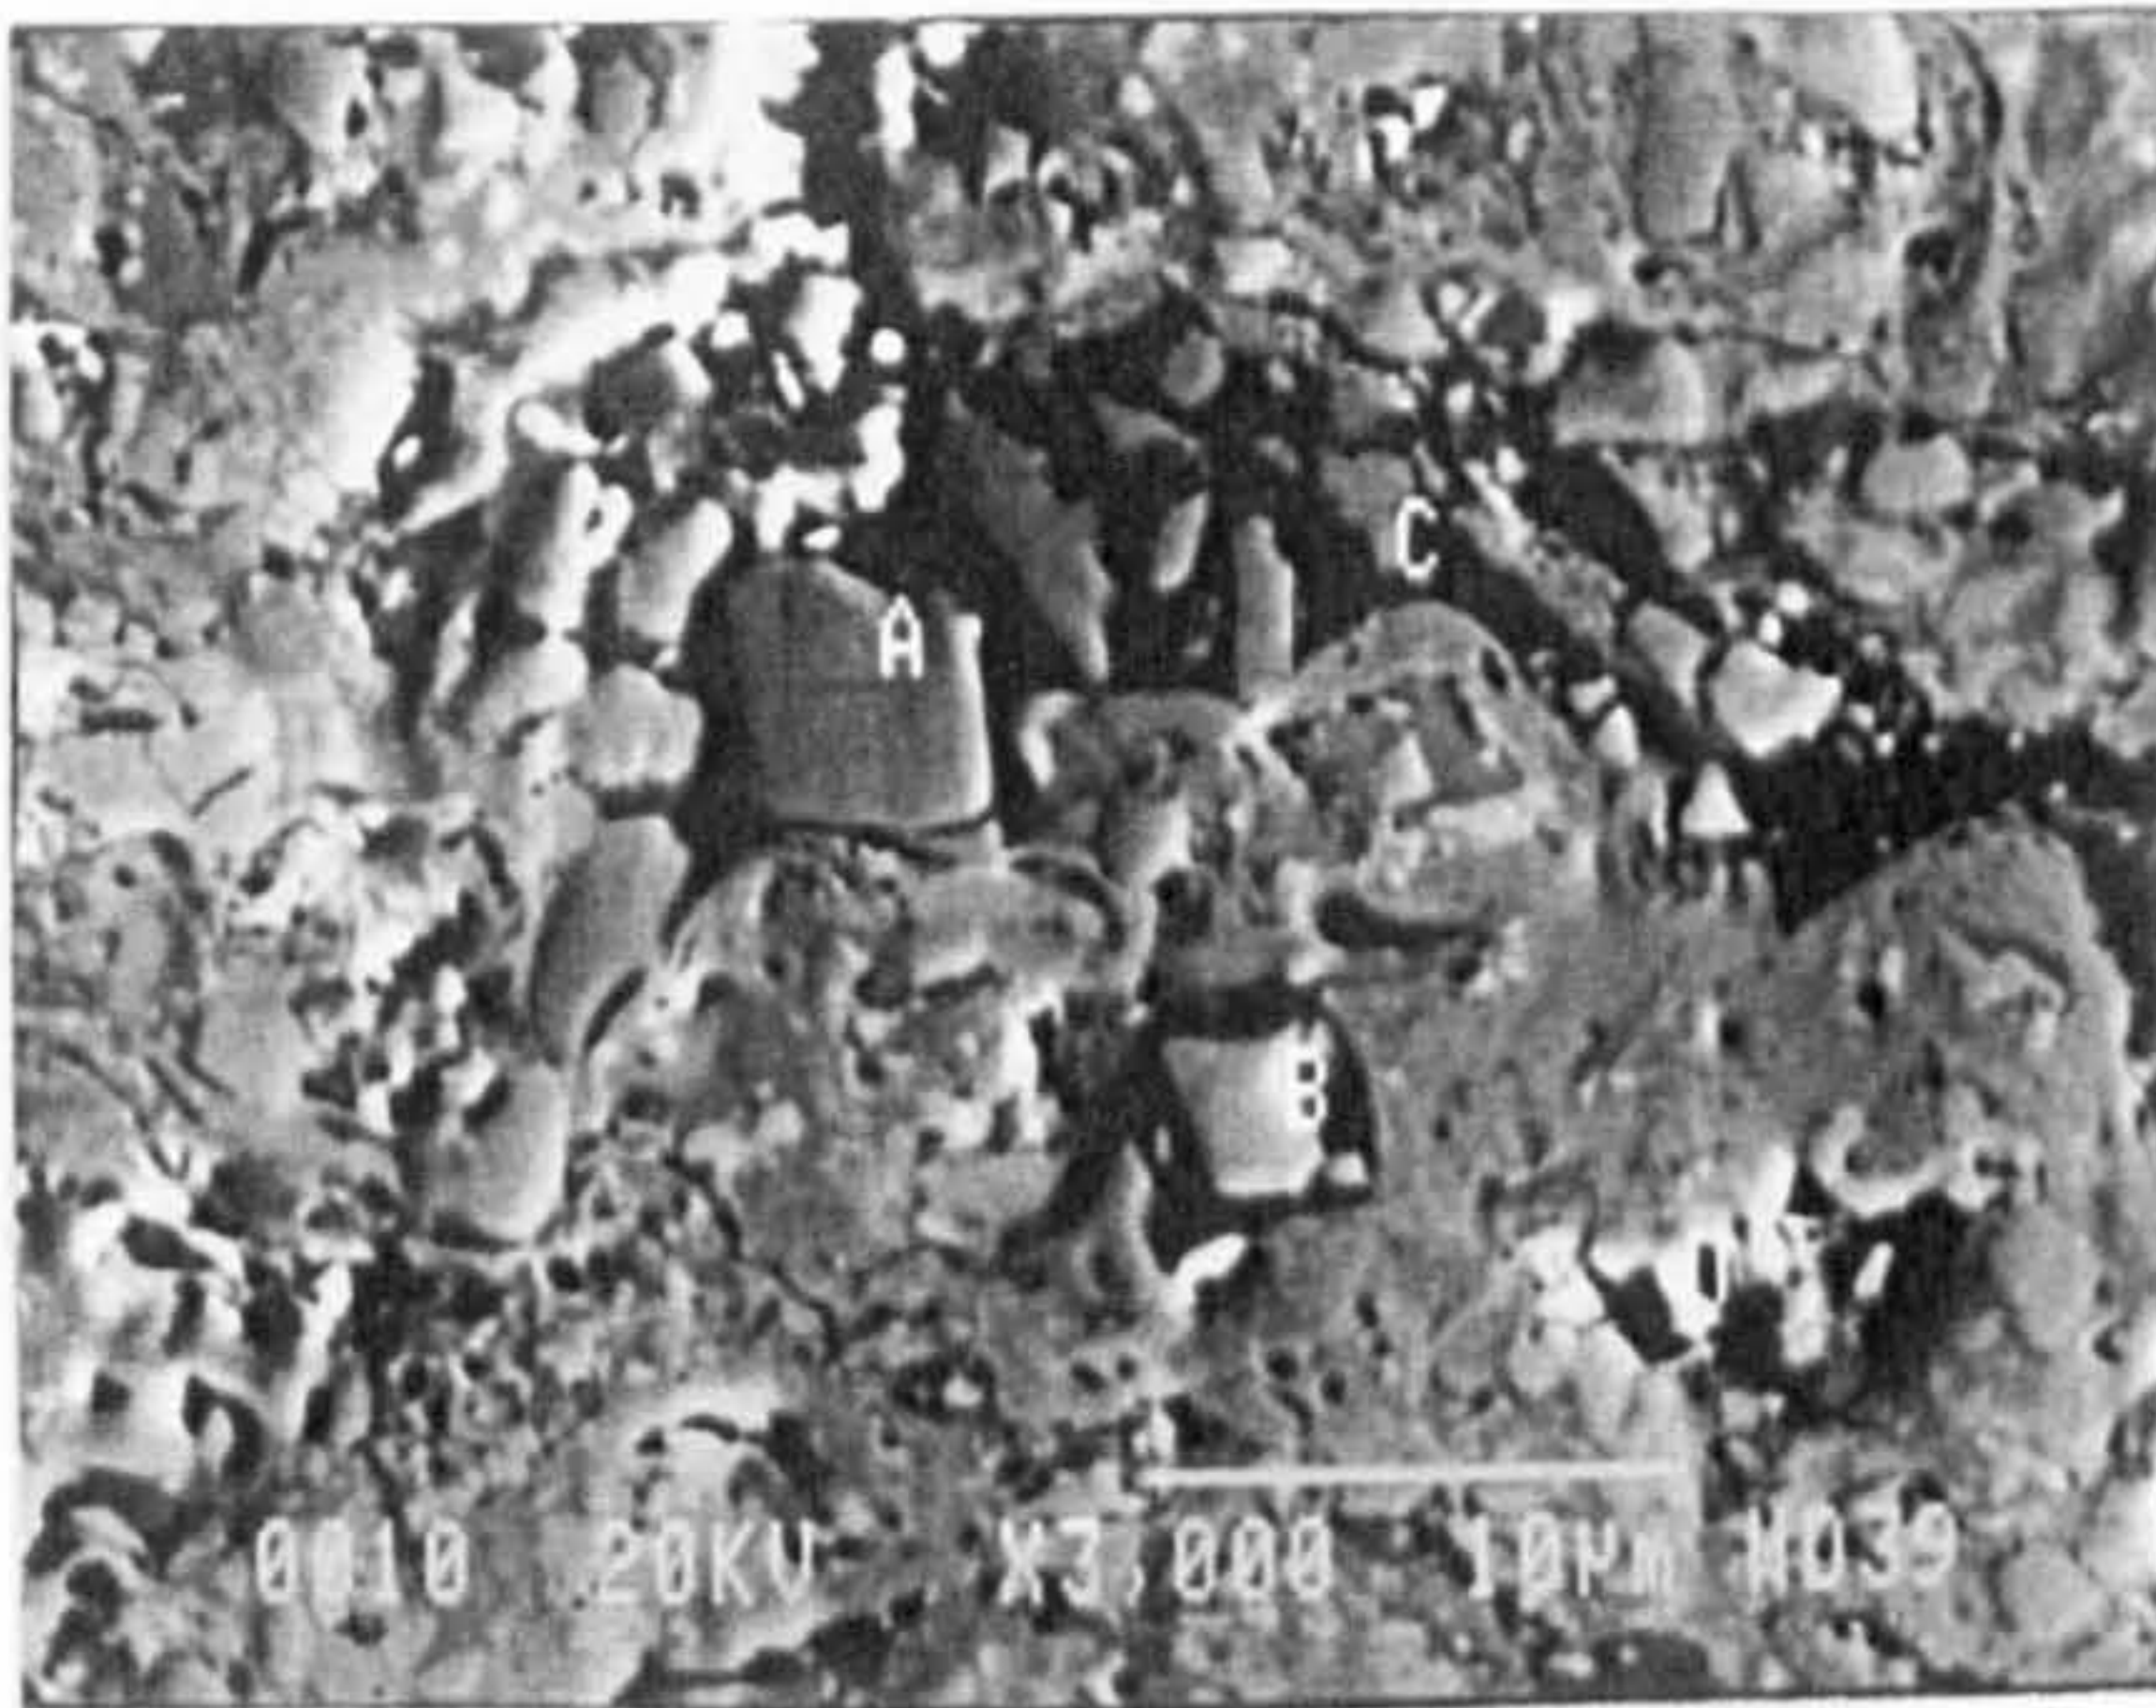
(a) coating microstructure (SEI)

Figure 5.5.12 shows the coating microstructure revealed after polishing the coating cross section using conventional polishing techniques. Figure 5.5.12(a) shows the coating microstructure in SEI whereas figure 5.5.12(b) shows the microstructure in BEI. Figure 5.5.12(c) shows the coating microstructure at another location in which significant amount of porosity is visible. Figure 5.5.12(d) shows the BEI of the coating microstructure. It can be appreciated that the microstructure contains numerous pores and micro-cracks which can be seen within the WC particles. The atomic contrast images in the BEI indicate that there are secondary phase particles in the coating microstructure. The presence of secondary phase particles was further confirmed by the EPMA analysis taken at points A, B, C and D in figure 5.5.12(b). The darker WC particles seen as shown at point A indicate a strong peak of W and Co whereas, at location B which is a much brighter phase shows a strong W peak only. This indicates that some of W reacted with Co during the plasma spraying process. This behaviour of WC-Co coatings was also studied by (Harvey et. al. 1995) in which the formation of an amorphous W-Co-C phase was observed due to the melting of WC-Co particles. At location B, however, it appears that plain WC particles are present, which can be indicative either of retained WC in the coating microstructure or the presence of W_2C particles. The EPMA analysis at location C indicated a strong Co peak, whereas at location D there were weak peaks of W, Co, etc. with a high background noise in the signal which is typical of porosity in the coating microstructure. The size of angular WC or W_2C particles can be approximated as being in the range of $2\ \mu\text{m} \times 2\ \mu\text{m}$ to $10\ \mu\text{m} \times 5\ \mu\text{m}$. Micro-cracks can also be seen in some of these angular particles. All these observations indicate that the coating microstructure is a combination of micro-pores, micro-cracks and secondary phase particles etc. No attempt was made to quantify the level
