ROLLING CONTACT FATIGUE OF THERMAL SPRAY COATINGS

A Thesis submitted for the degree of

Department of Mechanical Engineering
Brunel University
February 1998

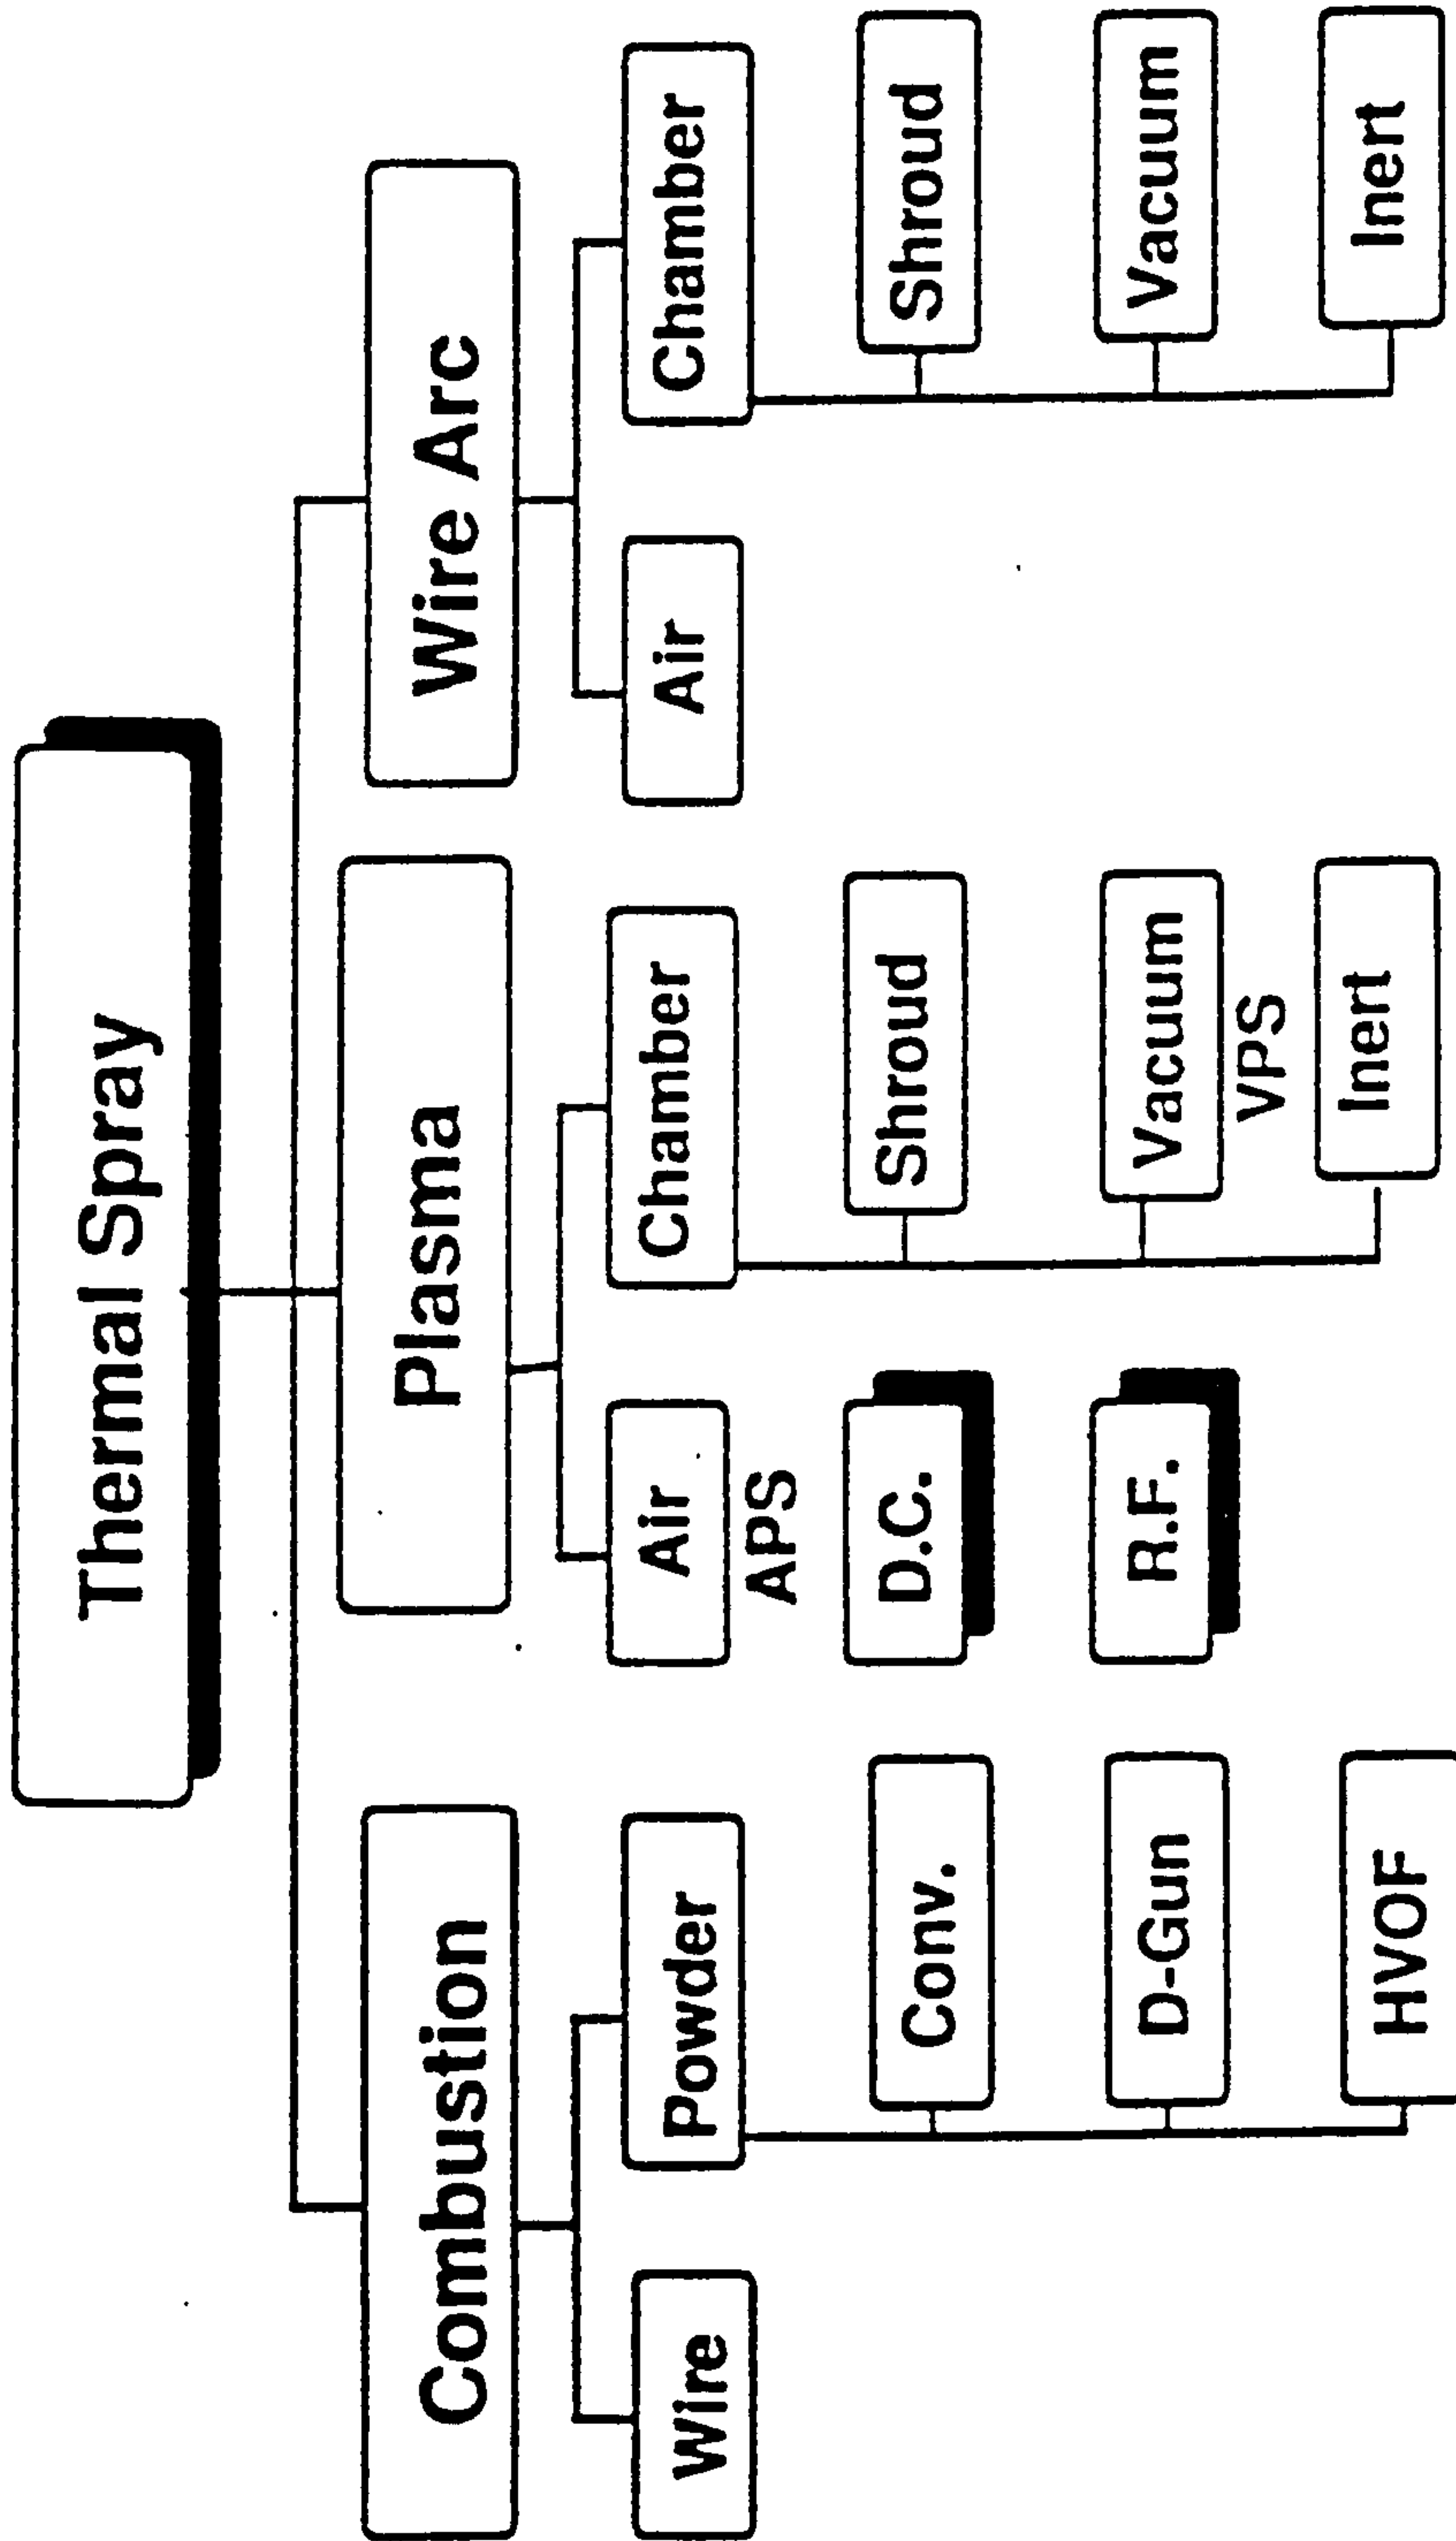
Figure B-1, Thermal spraying methods.
 [Ref: Basics of thermal spraying, 1990]

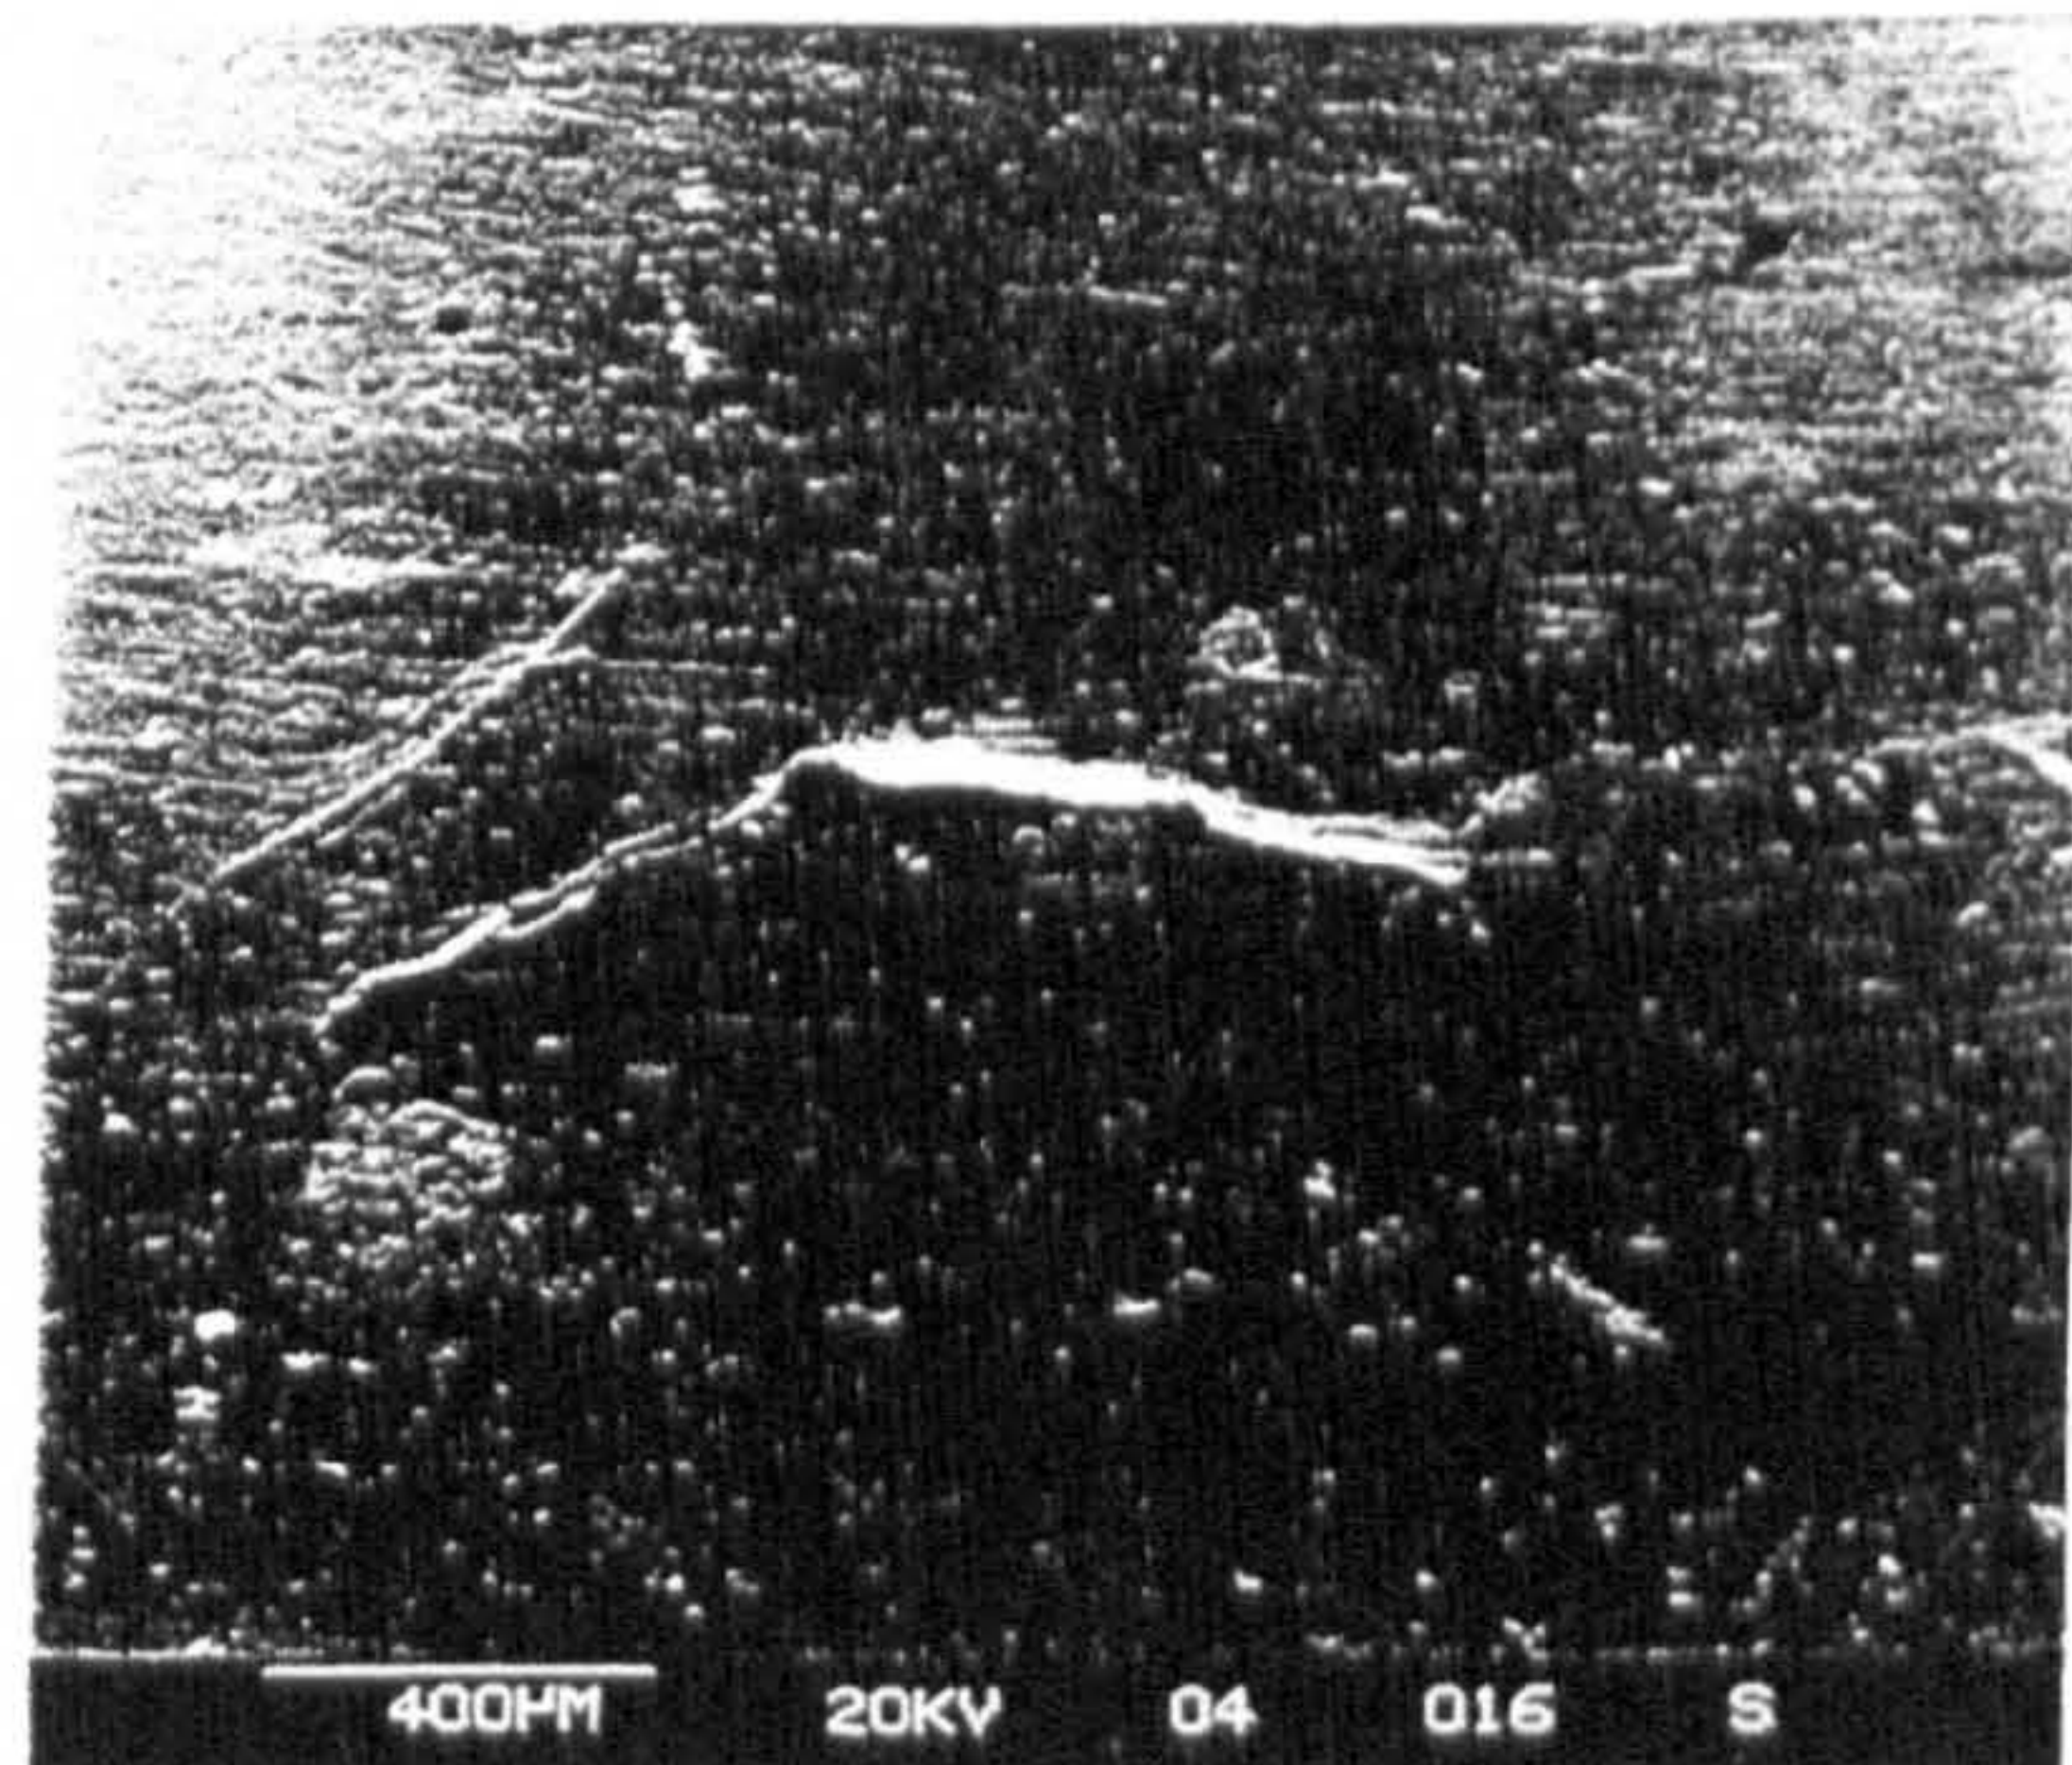
(d) edge crack end

Figure F1, Surface observations of tungsten carbide/steel contact (Exxon-2389)
