ROLLING CONTACT FATIGUE OF CERAMICS

**A Thesis submitted for the degree of
Doctor of Philosophy**

Department of Mechanical Engineering

Brunel University

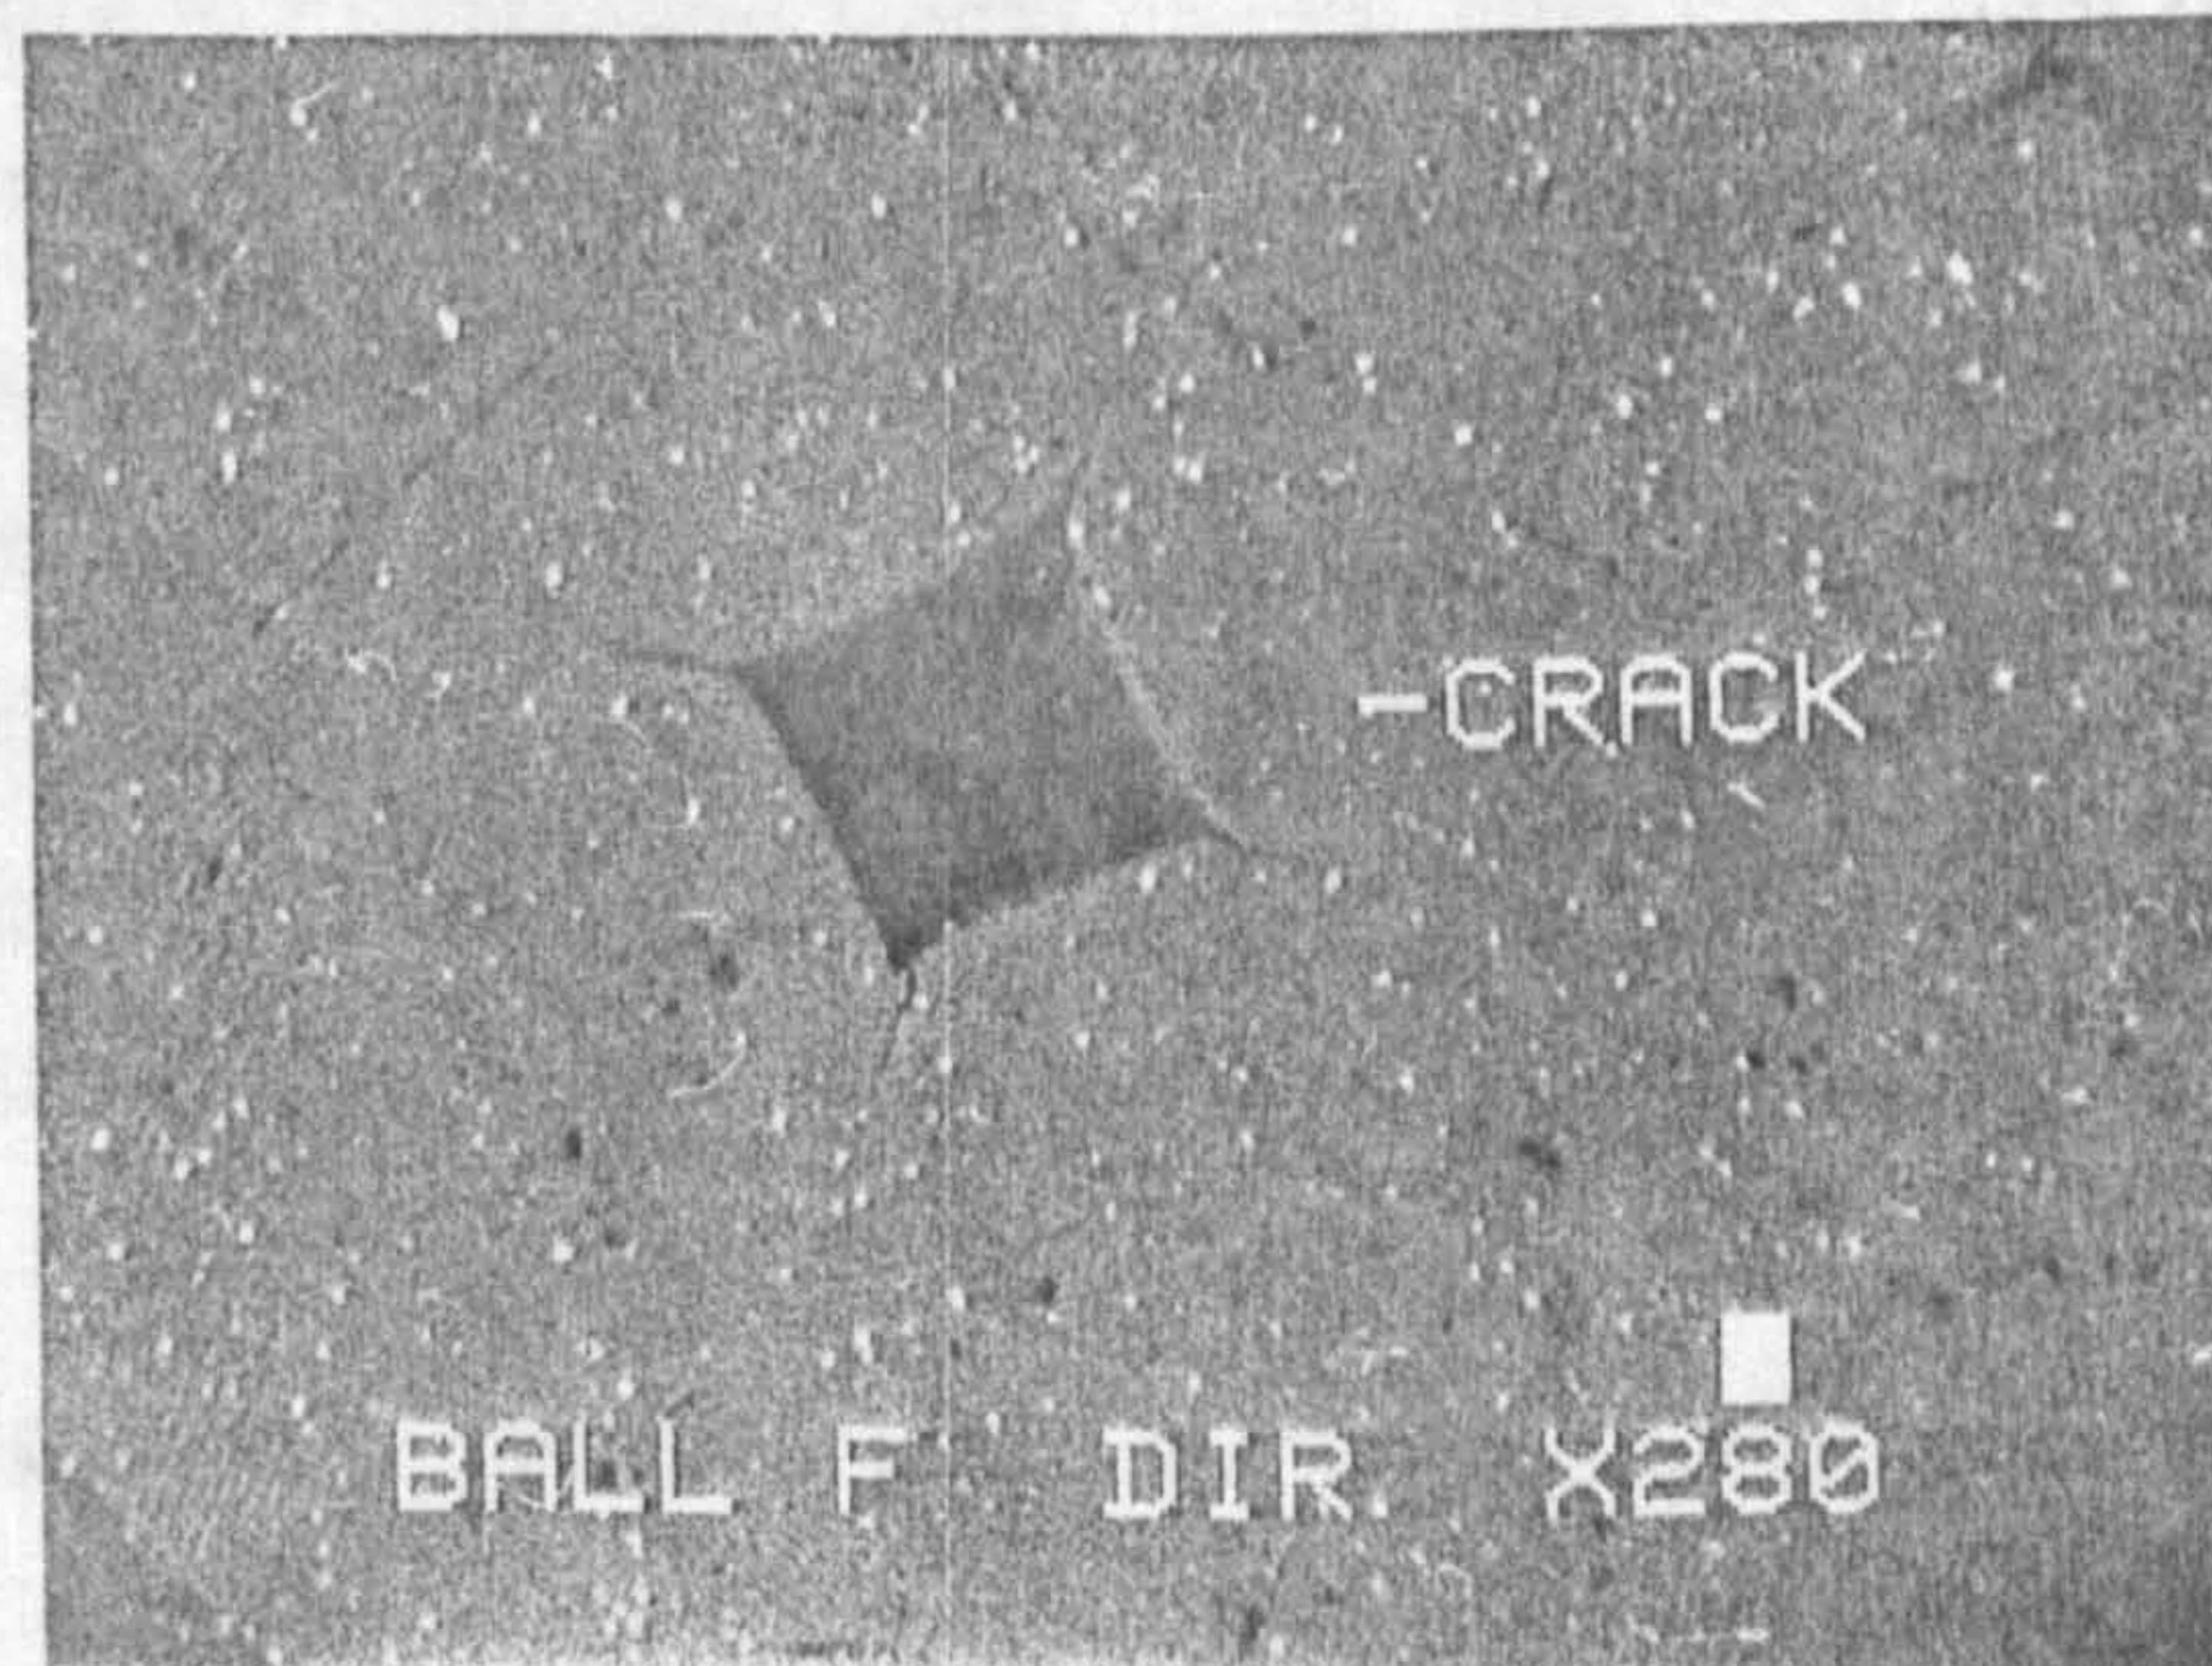
The surface cracks described, were artificially created so their influences on the fatigue failure mode could be studied, under controlled conditions. Radial and lateral cracks were produced on the ball surface by using a Vickers diamond pyramid indenter. Standard hardness test procedure was adopted according to ISO 146, various loads (5, 2.5 and 0.5 kg) were applied for 5 seconds. The indentations caused both radial and lateral cracks. At low loads, however, no cracks were apparent. Figure 4.6 shows typical radial cracks caused by a 5.0 kg indenter load. The figure 4.6 is a microscopic photograph of the impression under normal light conditions.

Figure 4.6 Radial and lateral cracks: normal light (x280)

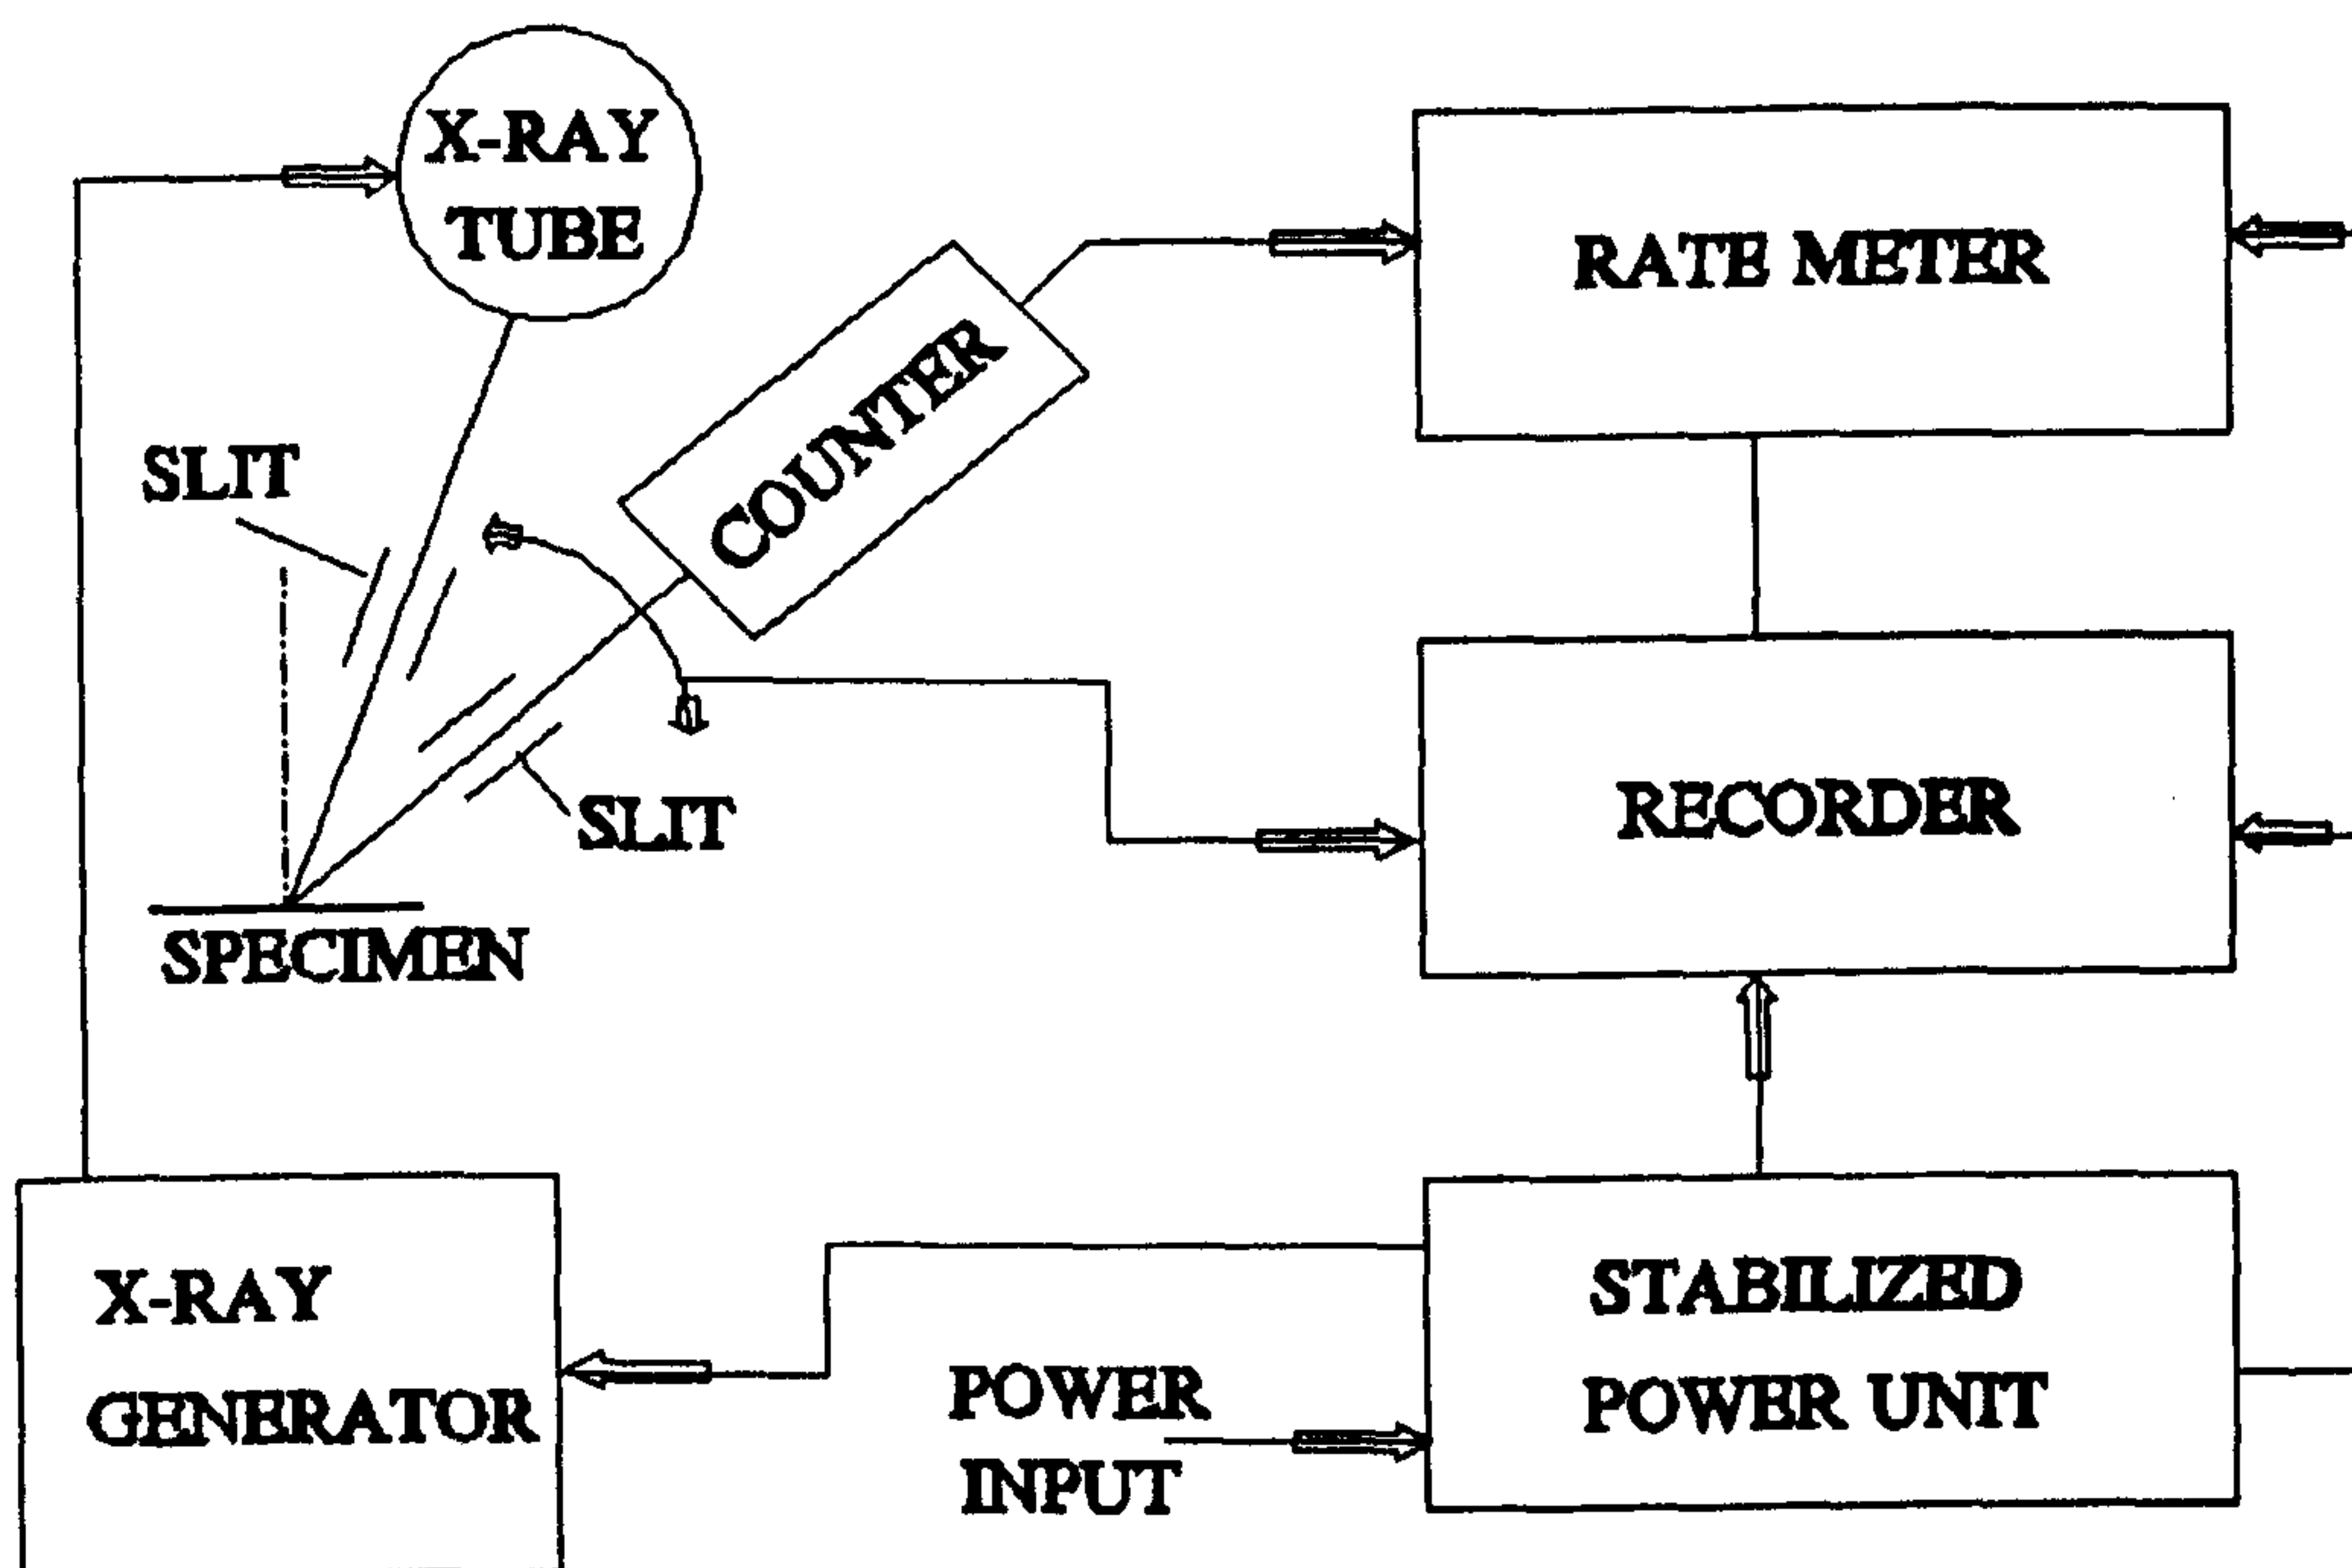
The measurement of residual stress was performed on a 'Rigaku Strainflex MSF-2M' machine. The basic measurement principles are described in appendix 8, and a machine schematic diagram is shown as figure 4.12. The X-ray tube is typically copper or chromium, with maximum load of 30 kV and 8 mA, incident and receiving parallel slits direct the beam. A goniometer enables a detector scanning range of 120 to 170 degrees and, with standard stepper motor control, accuracy is within standard tolerances. The detector is a scintillation counter probe type, in which the rate meter transforms the count rate to direct current voltage which is fed into the recorder.

Figure 4.12 Diagram of x-ray apparatus

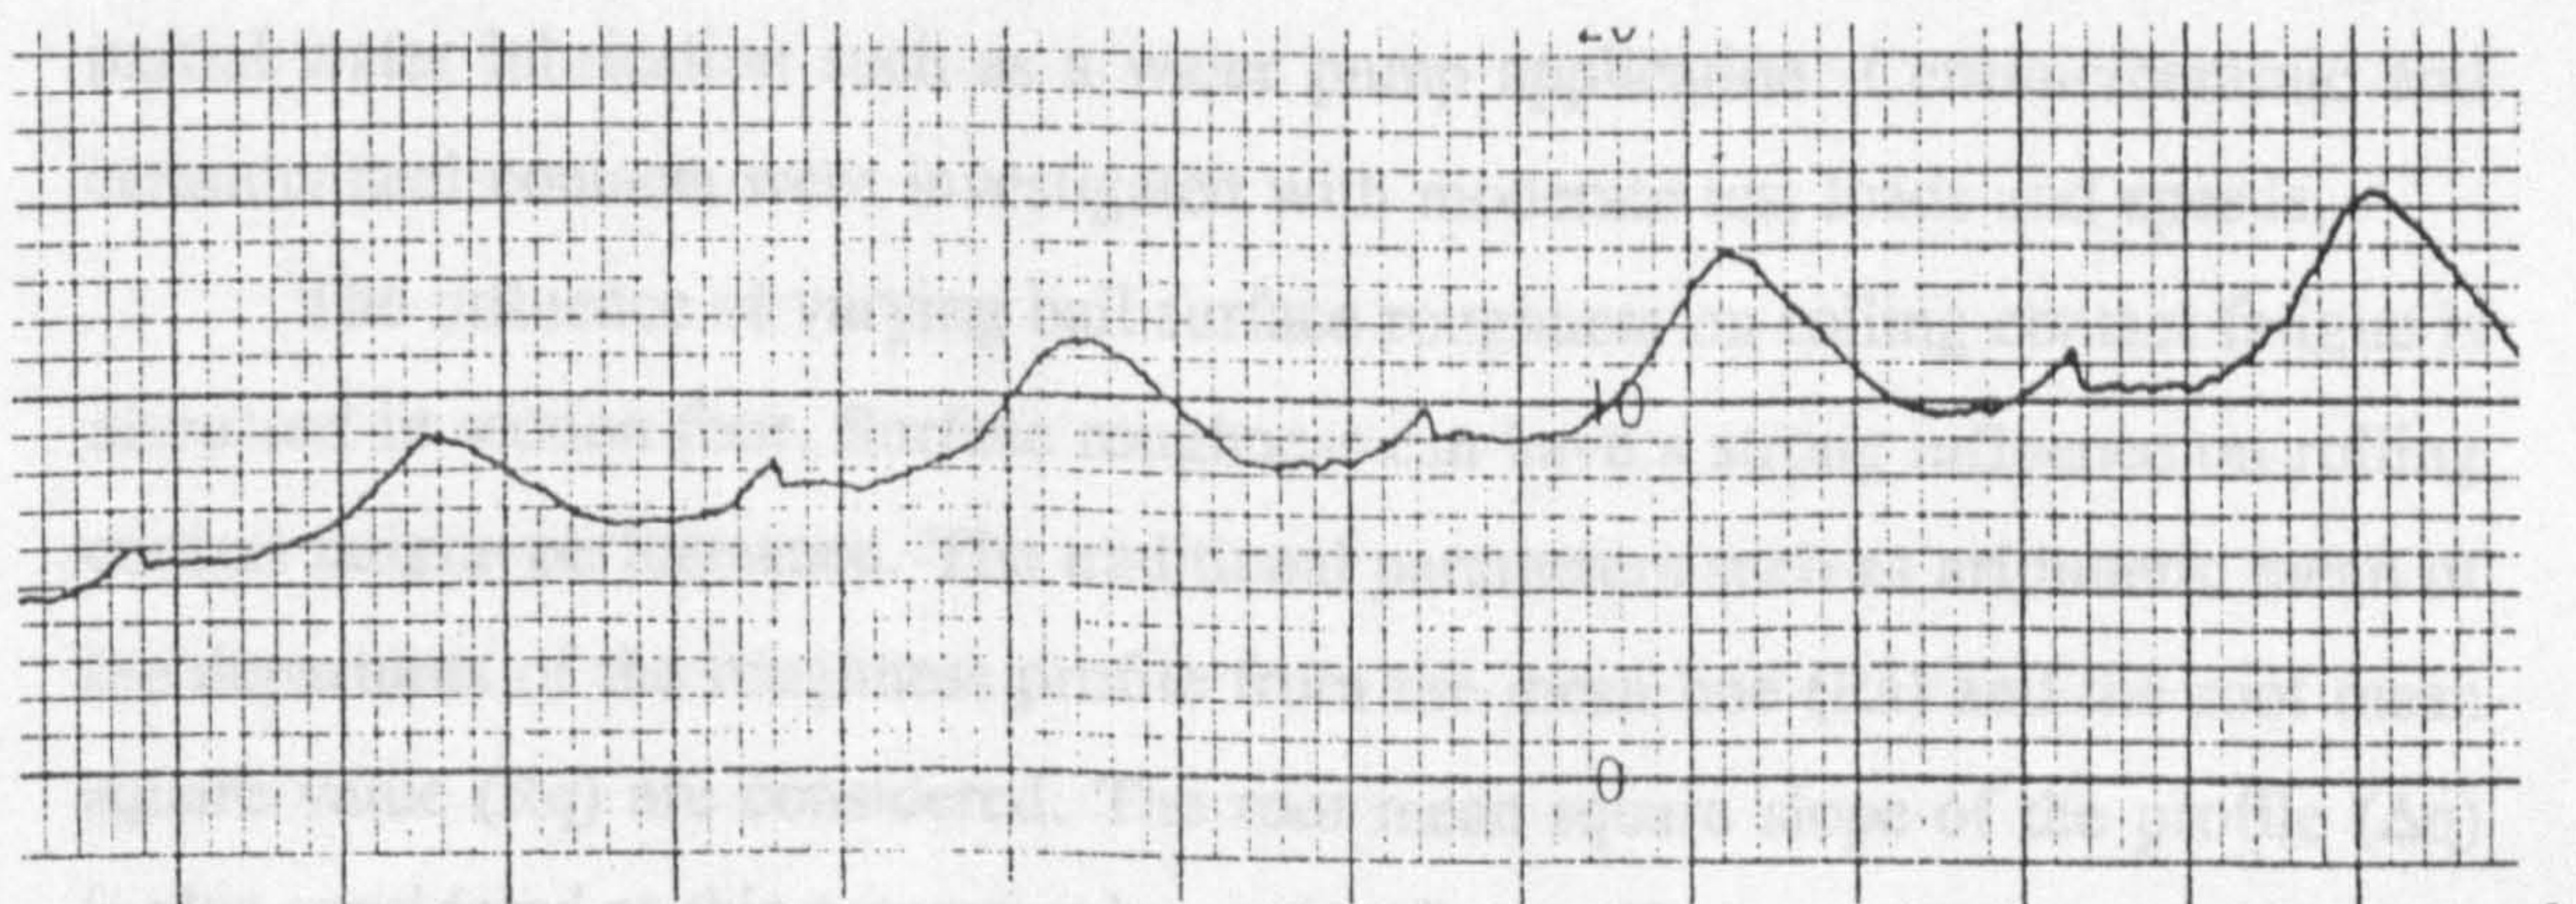
(c)

Figure 4.13 X-ray diffraction scans

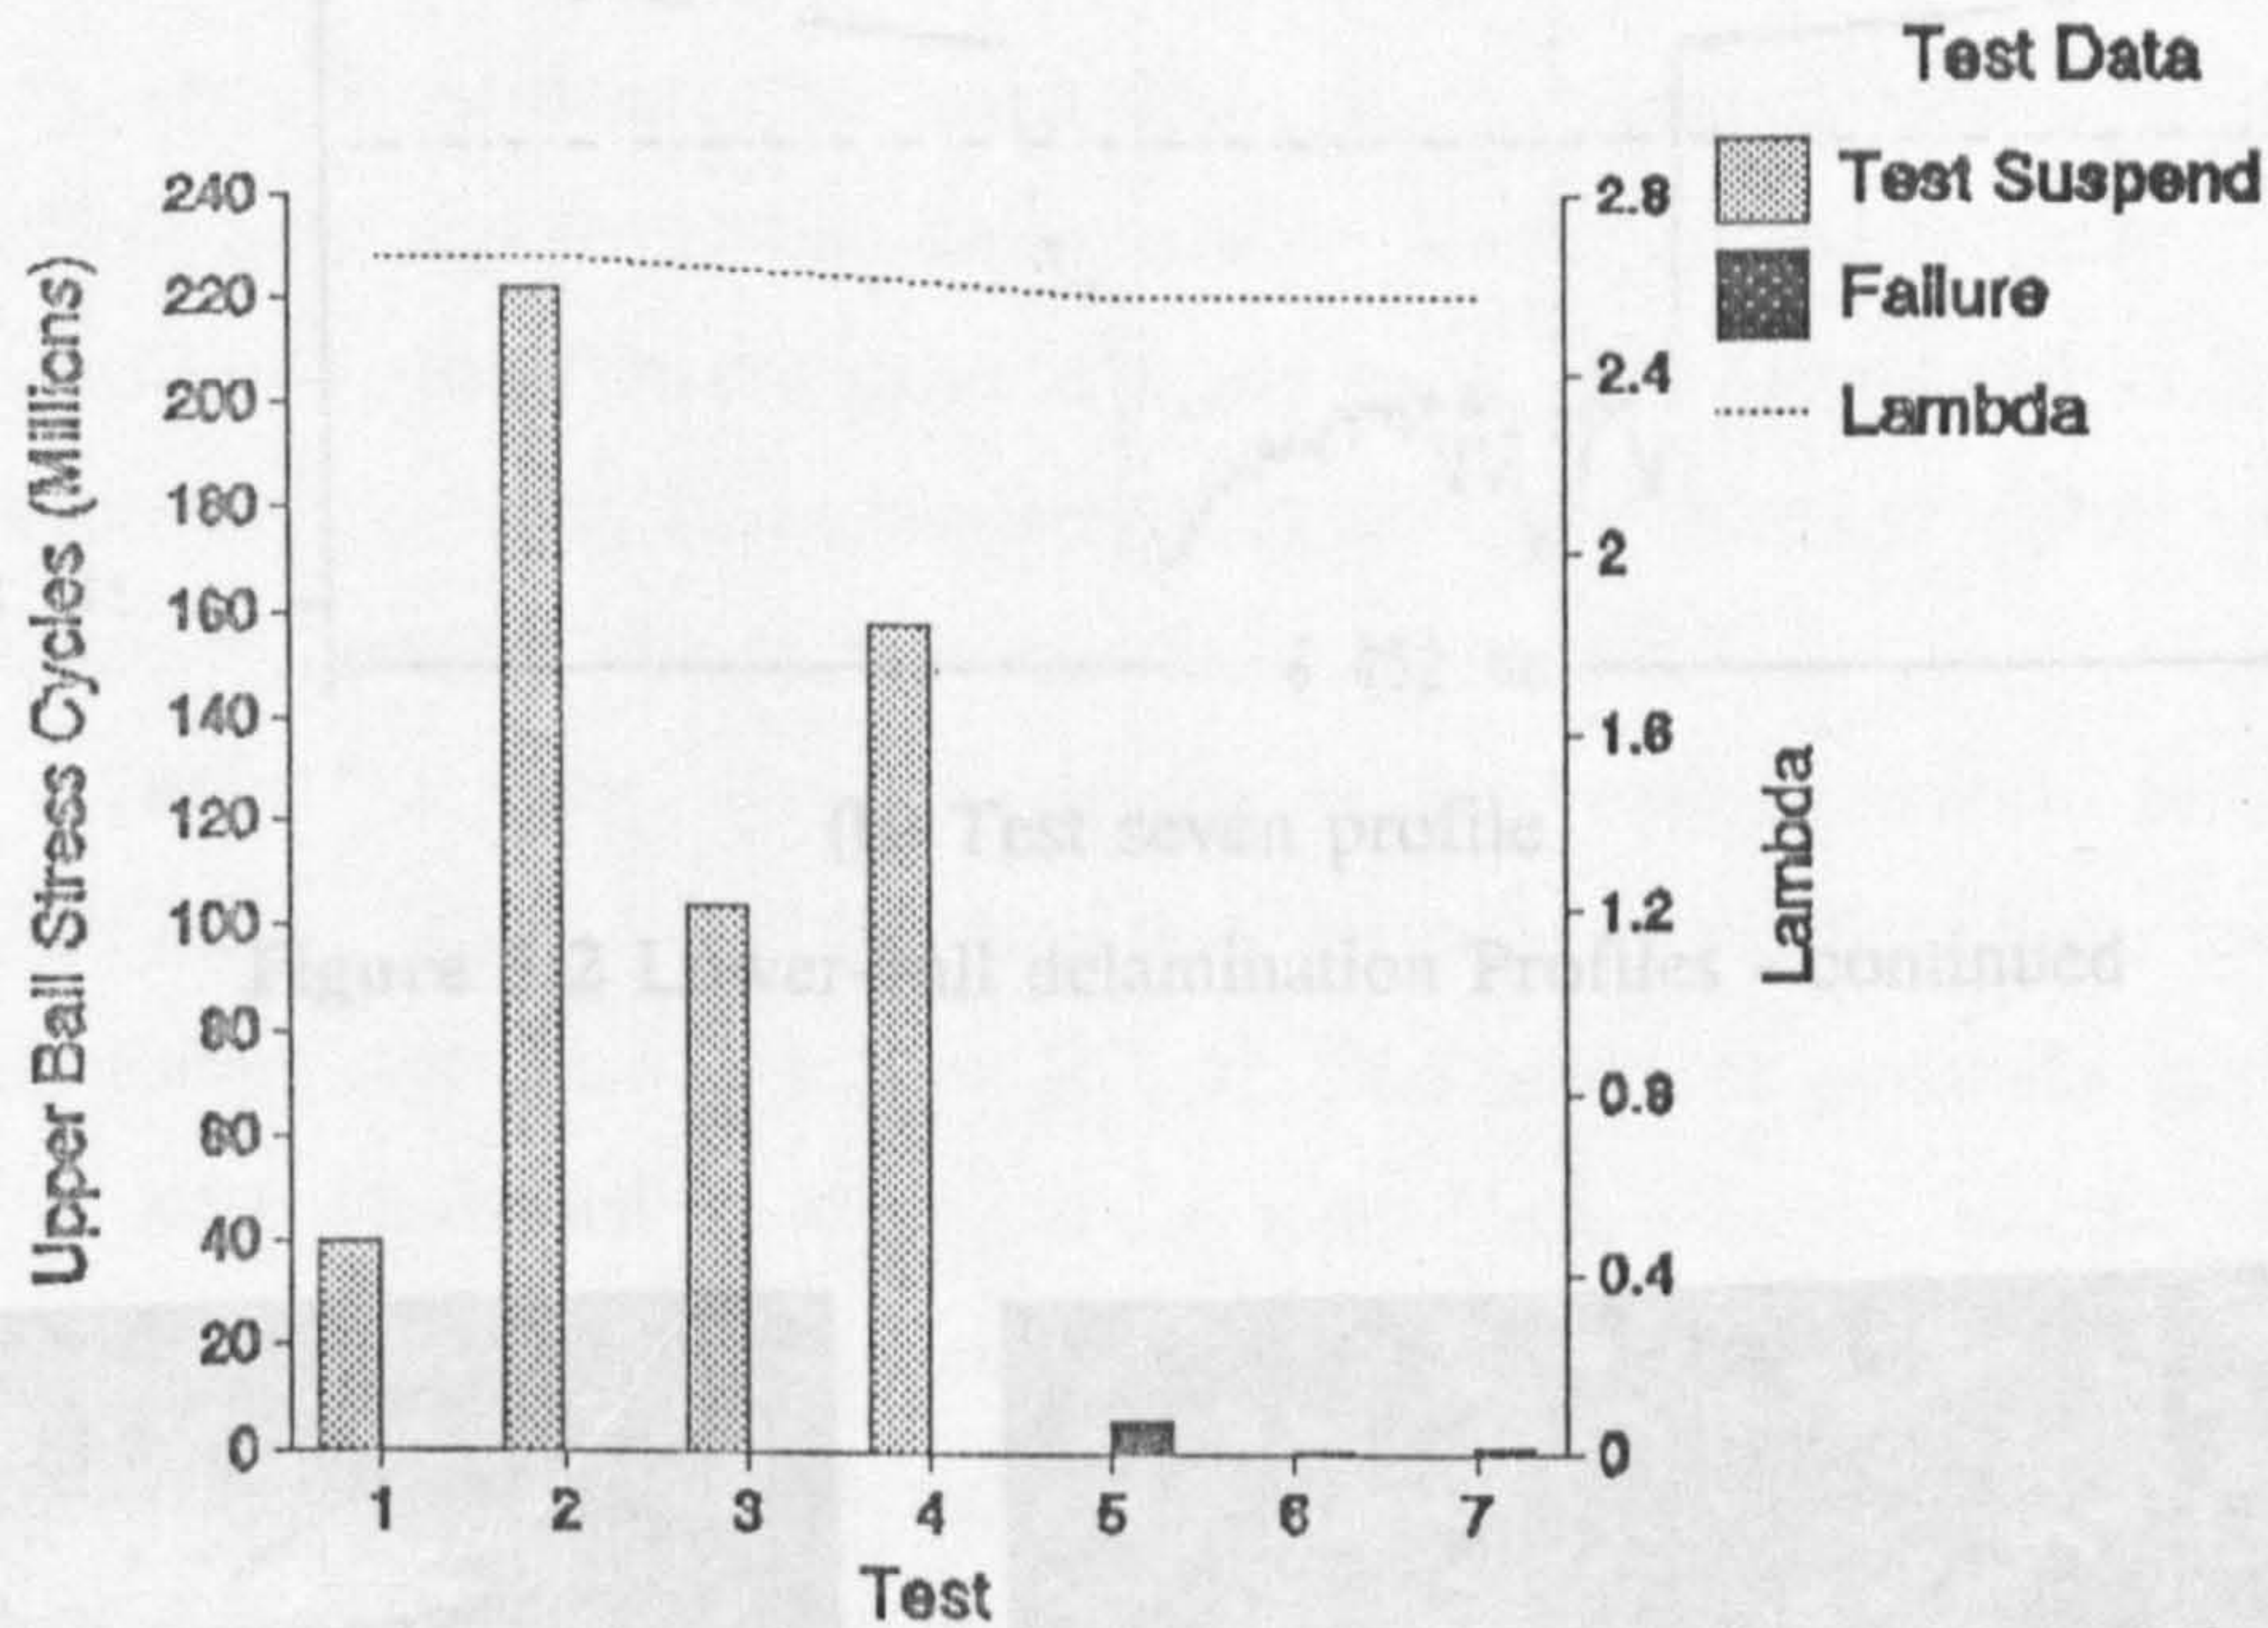
The failure in test five failure was due to an upper-ball wear path and lower-ball delamination after six million upper-ball stress cycles. As temperature gradually increases with load, film thickness reduces due to viscosity effects. The lubricant is pre-heated to sixty degree celsius, to enable examination of lubricant film thickness sensitivity to temperature. Lubricant pre-heating resulted in much earlier failures, in tests six and seven, at approximately one million stress cycles. Lubricant viscosity effects and the absence of lubricant extreme pressure additives results in the ball surfaces being particularly vulnerable to partial film separation and hence causing a wear type failure mode. Roughness measurements of all lower-balls of tests five to seven showed no sign of damage to the highly polished ceramic surfaces, despite delamination and hence debris present within the lubricant.

Figure 5.1 Base oil lubrication results

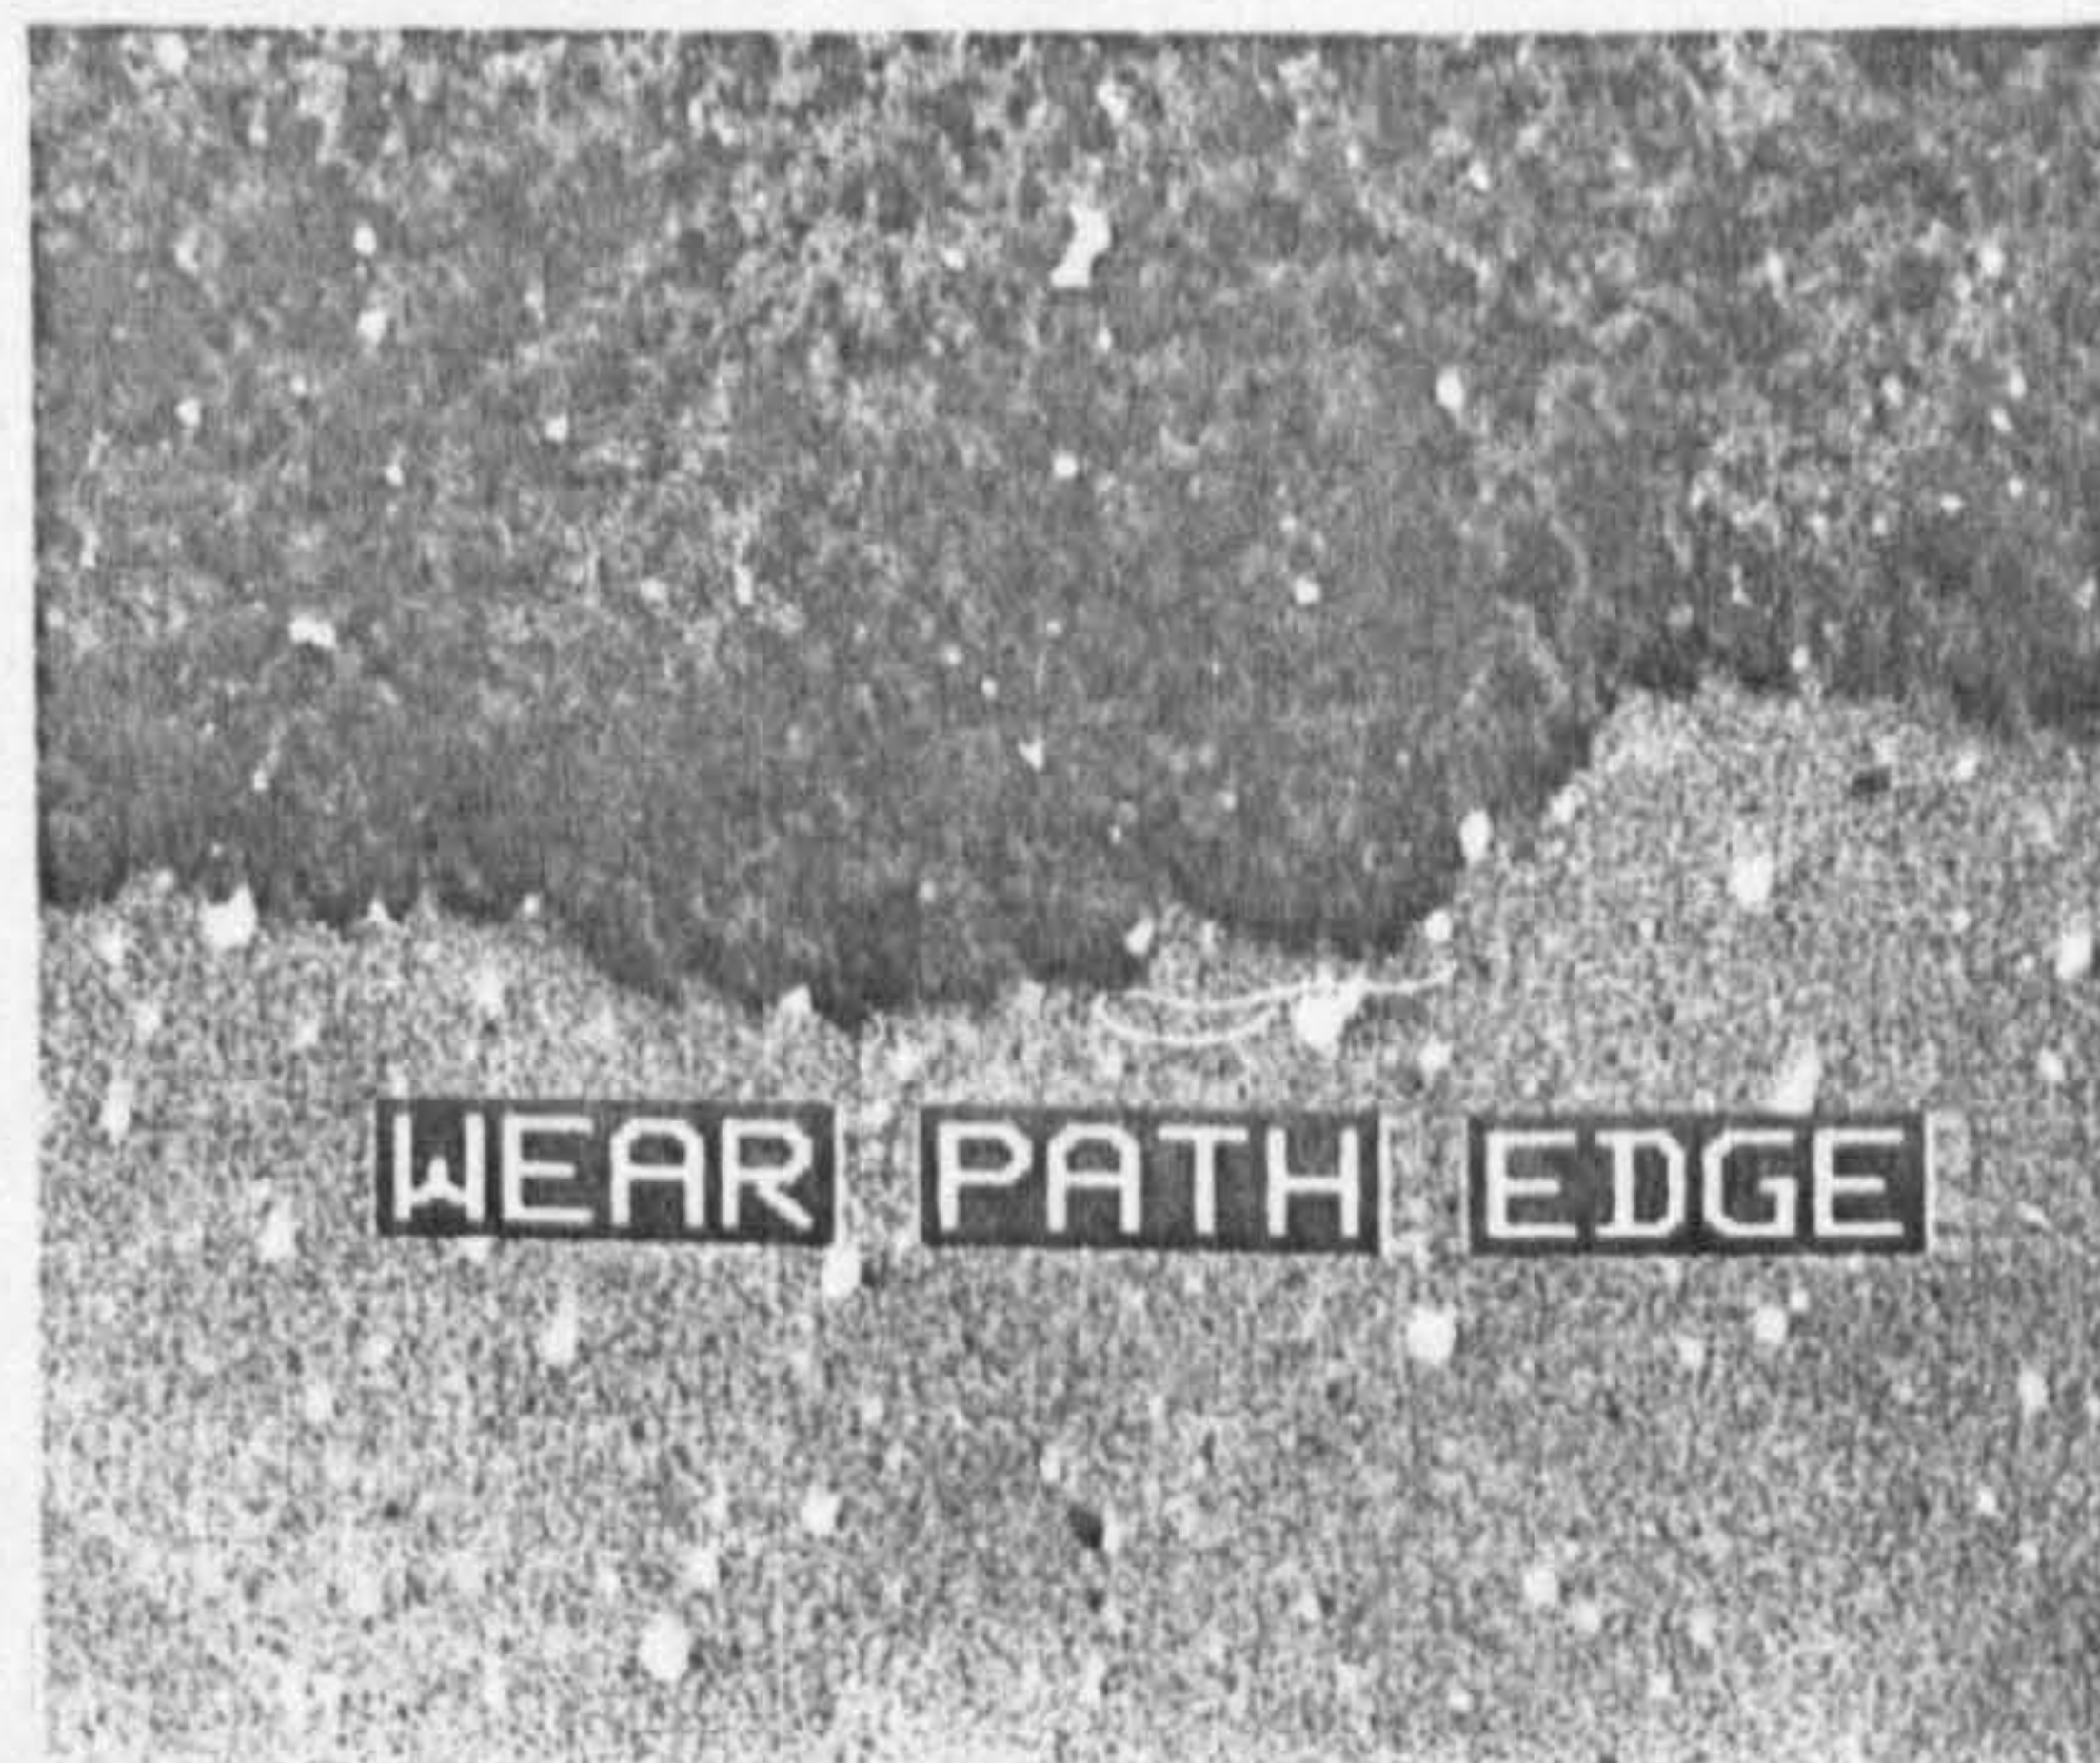
(c) Contact path edge detail, x700

Figure 5.3 Microscopic analysis of test six contact path

Figure 5.2 shows lower-ball profiles of delamination from test six, caption (a) and test seven, caption (b). Depth of delamination is shallow, averaging four microns; maximum theoretical shear stress position is approximately one hundred microns below the ball surface. Microscopic examination of test six upper-ball wear path is shown in figure 5.3. Caption (a) shows upper-ball wear path overview, minor spalling is shown in caption (b). High magnification of contact path edge, caption (c), shows no evidence of subsurface damage or micro-cracks.

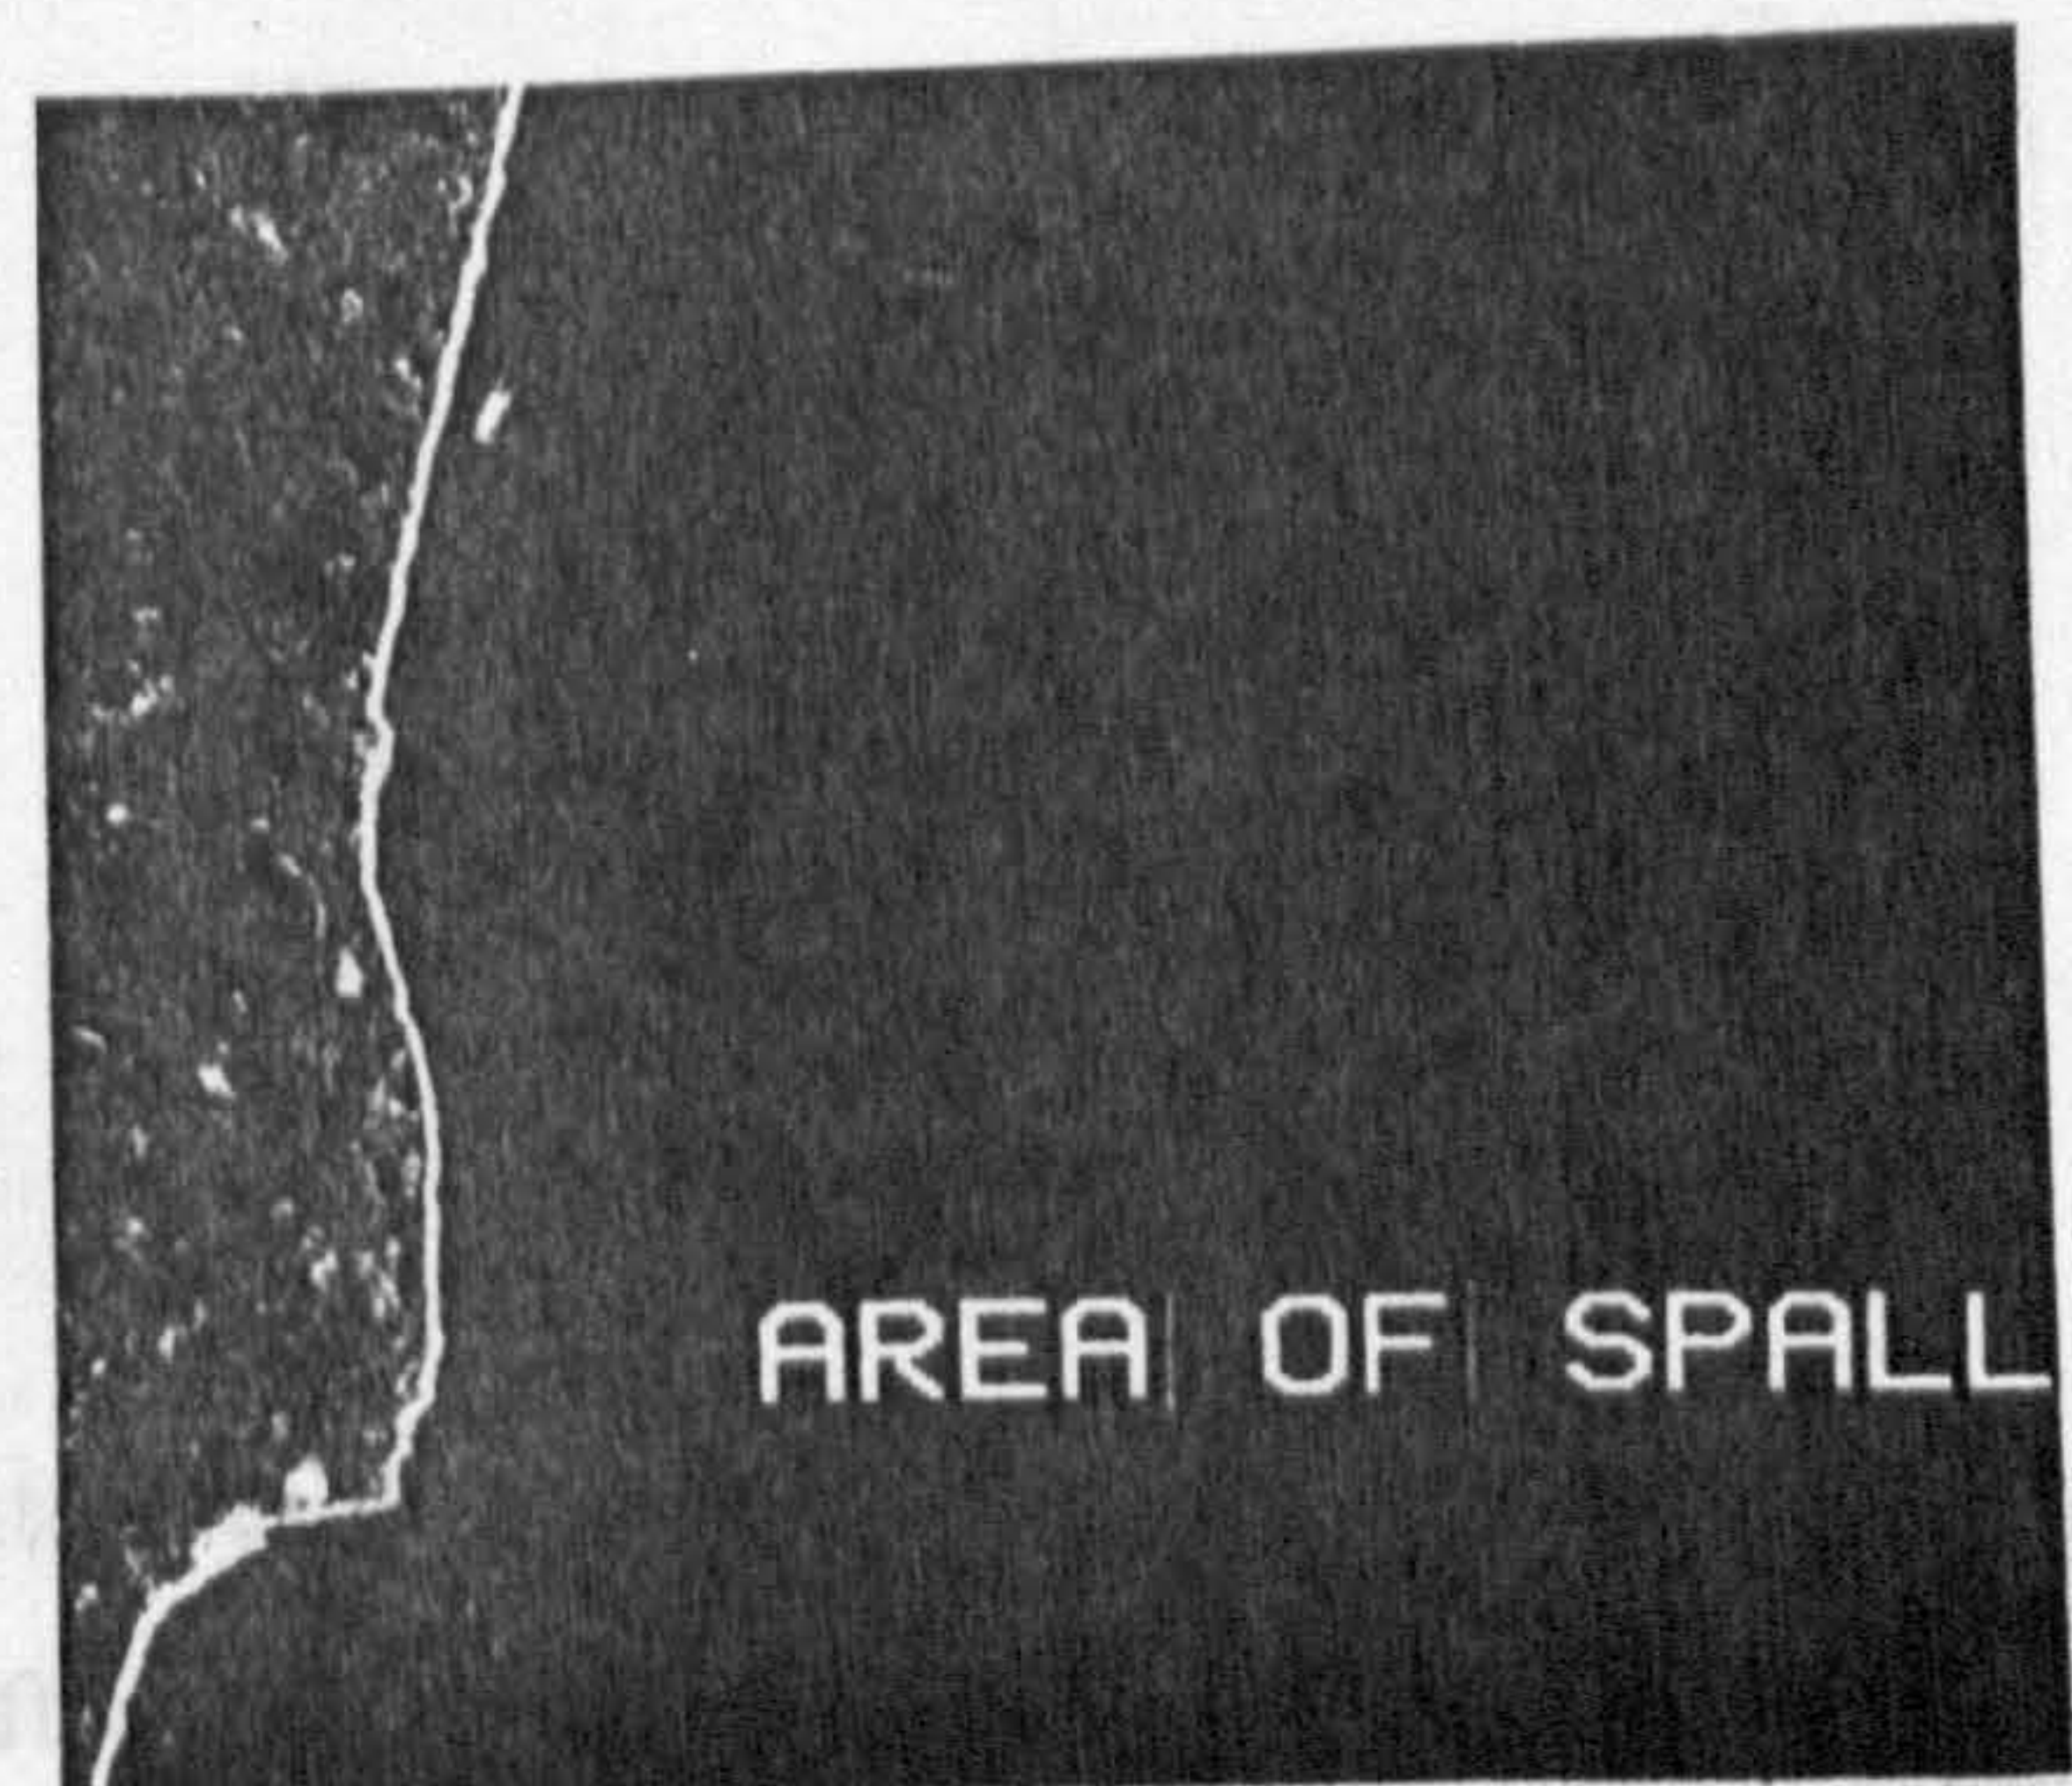
(d) Spall section - dark field, x140

Figure 5.7 Microscopic and section analysis of test five upper-ball

delamination was the same as in the case of tests two and three. Test four result was confirmed by test five, failure occurring after seventeen million upper-ball stress cycles. Upper-ball wear occurred during test five. In addition to lower-ball delamination, spalling was also apparent on the upper-ball wear path. Test five upper-ball contact path and spall analysis is shown as figure 5.7, captions (a) to (d). Caption (a) shows the wear path overview and spall, caption (b) the spall overview. Caption (c) shows the mounted ball section after cutting, grinding and polishing operations. Caption (d) shows the spall section, measured at sixty microns depth and 0.243 millimetres length.
