ROLLING CONTACT FATIGUE OF CERAMICS

**A Thesis submitted for the degree of
Doctor of Philosophy**

Department of Mechanical Engineering

Brunel University

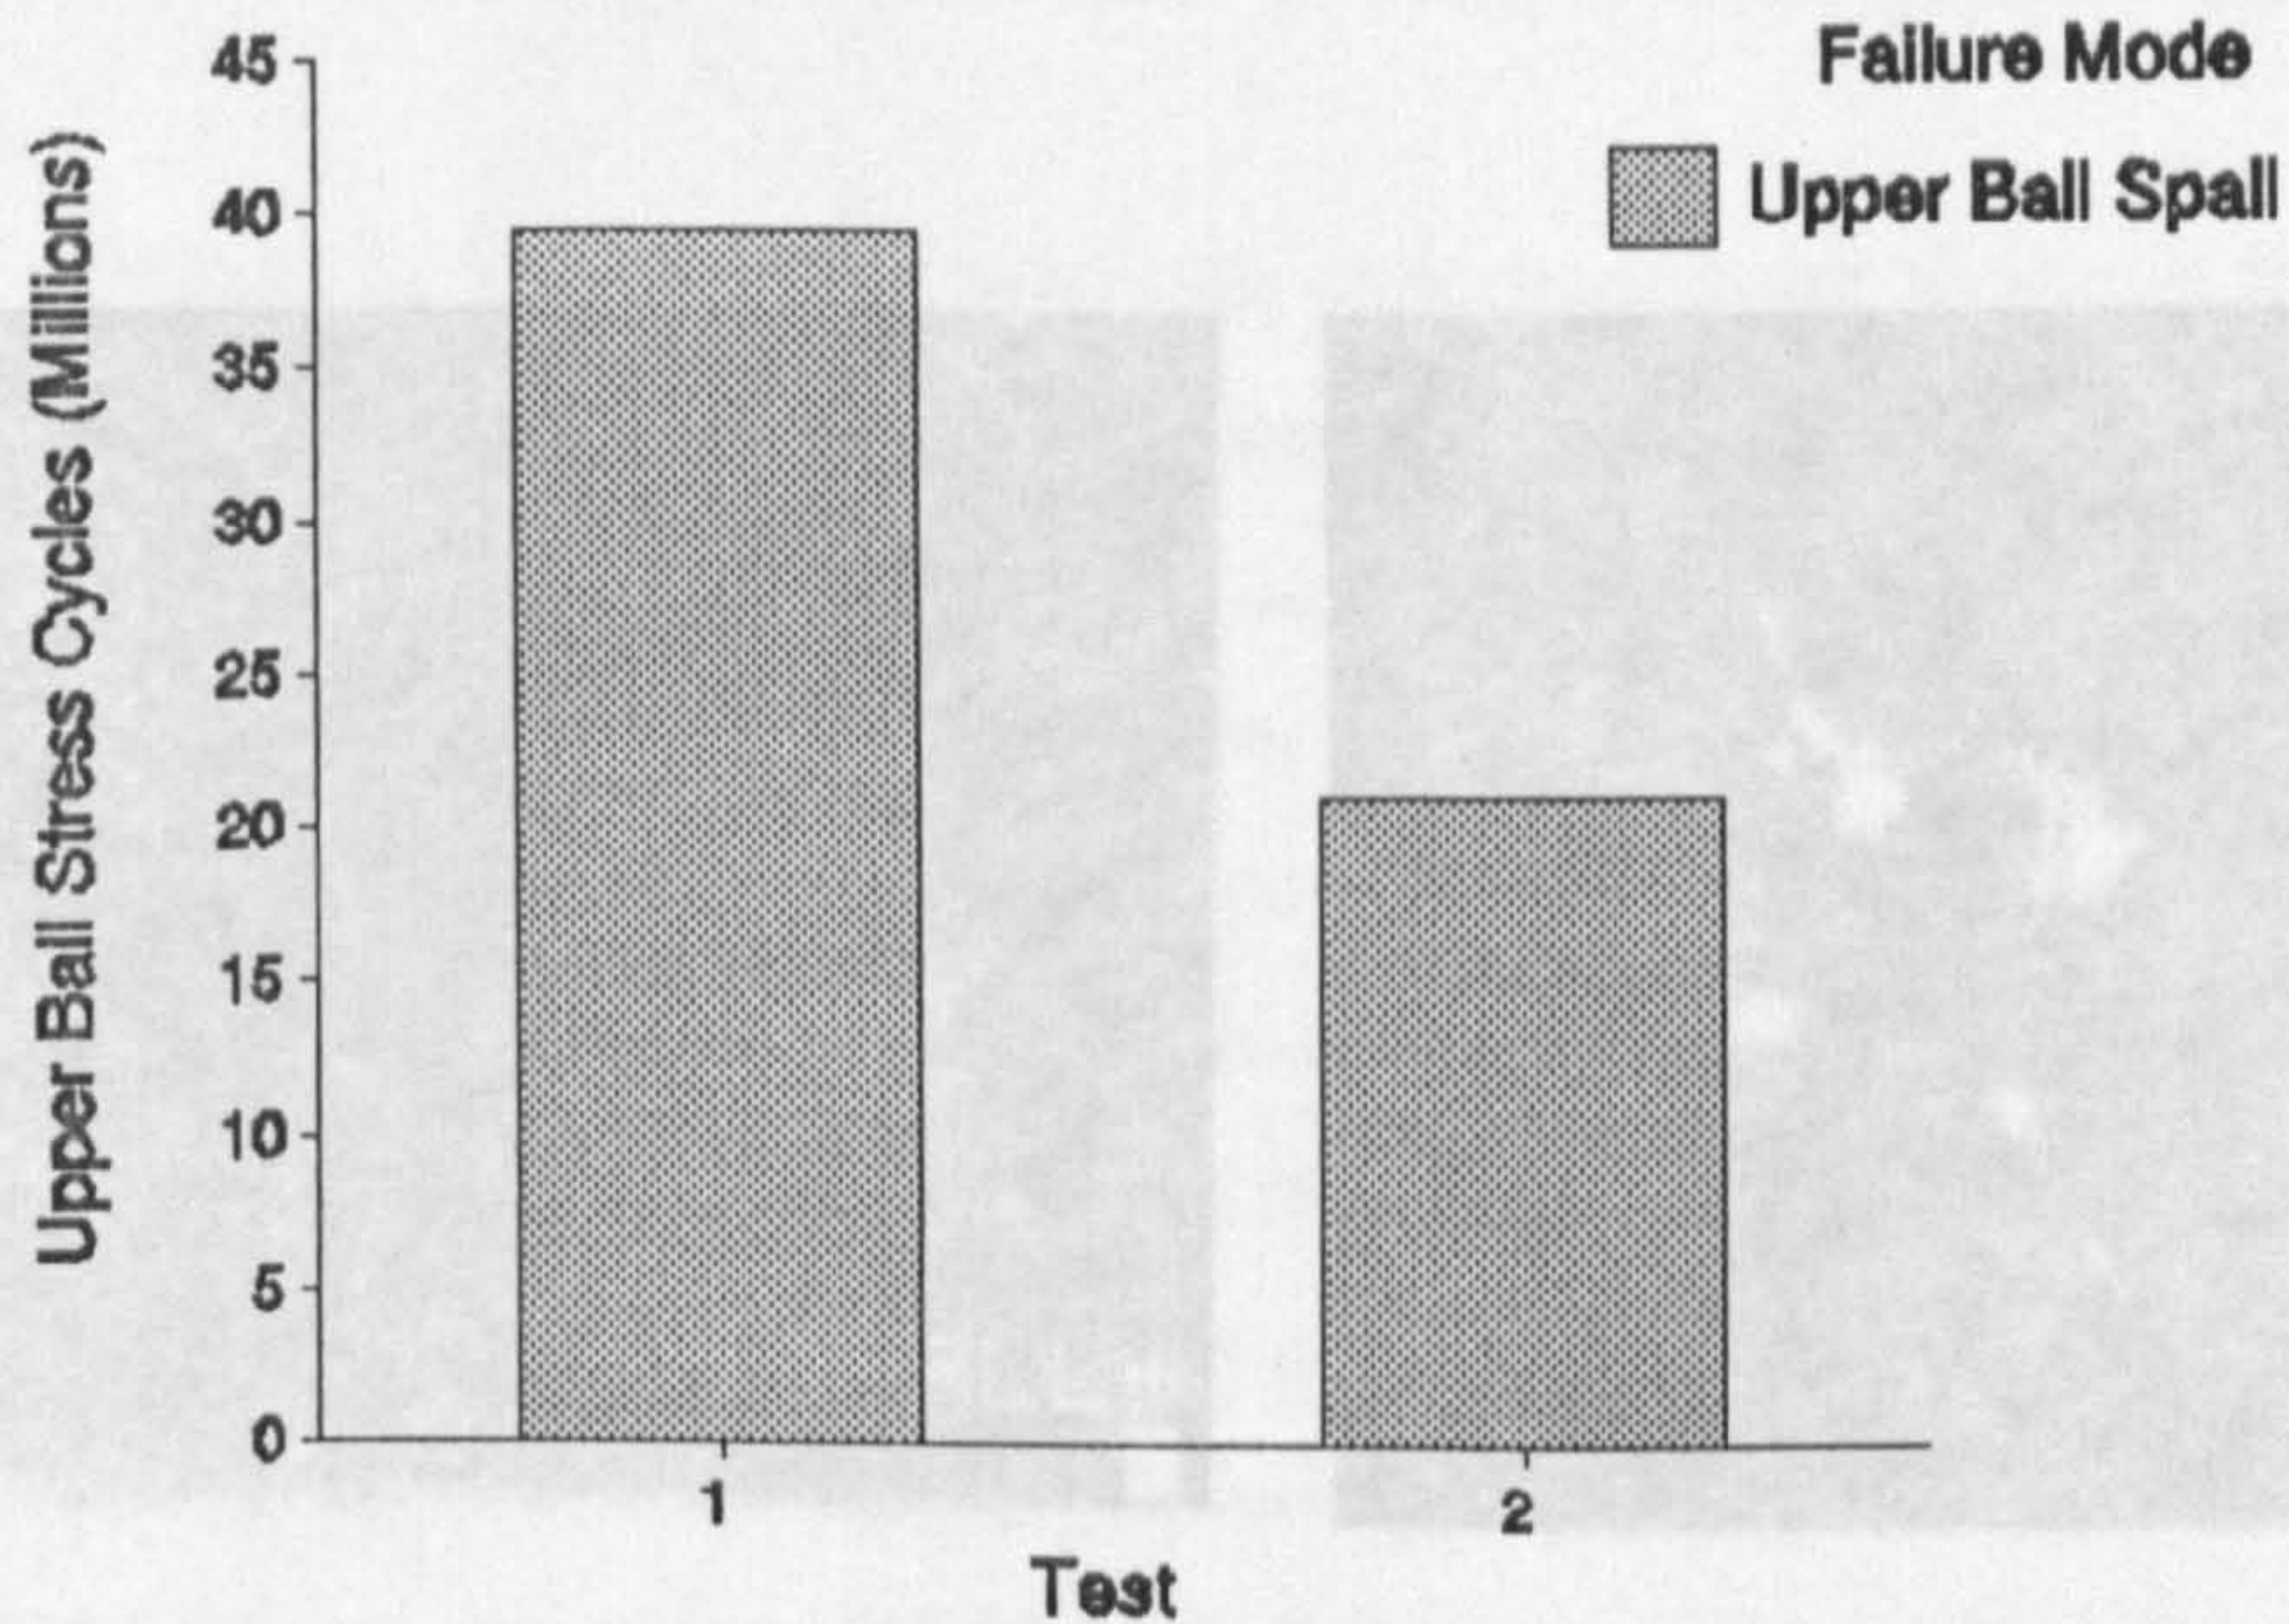
Figure 5.17 Sharp indenter preliminary results

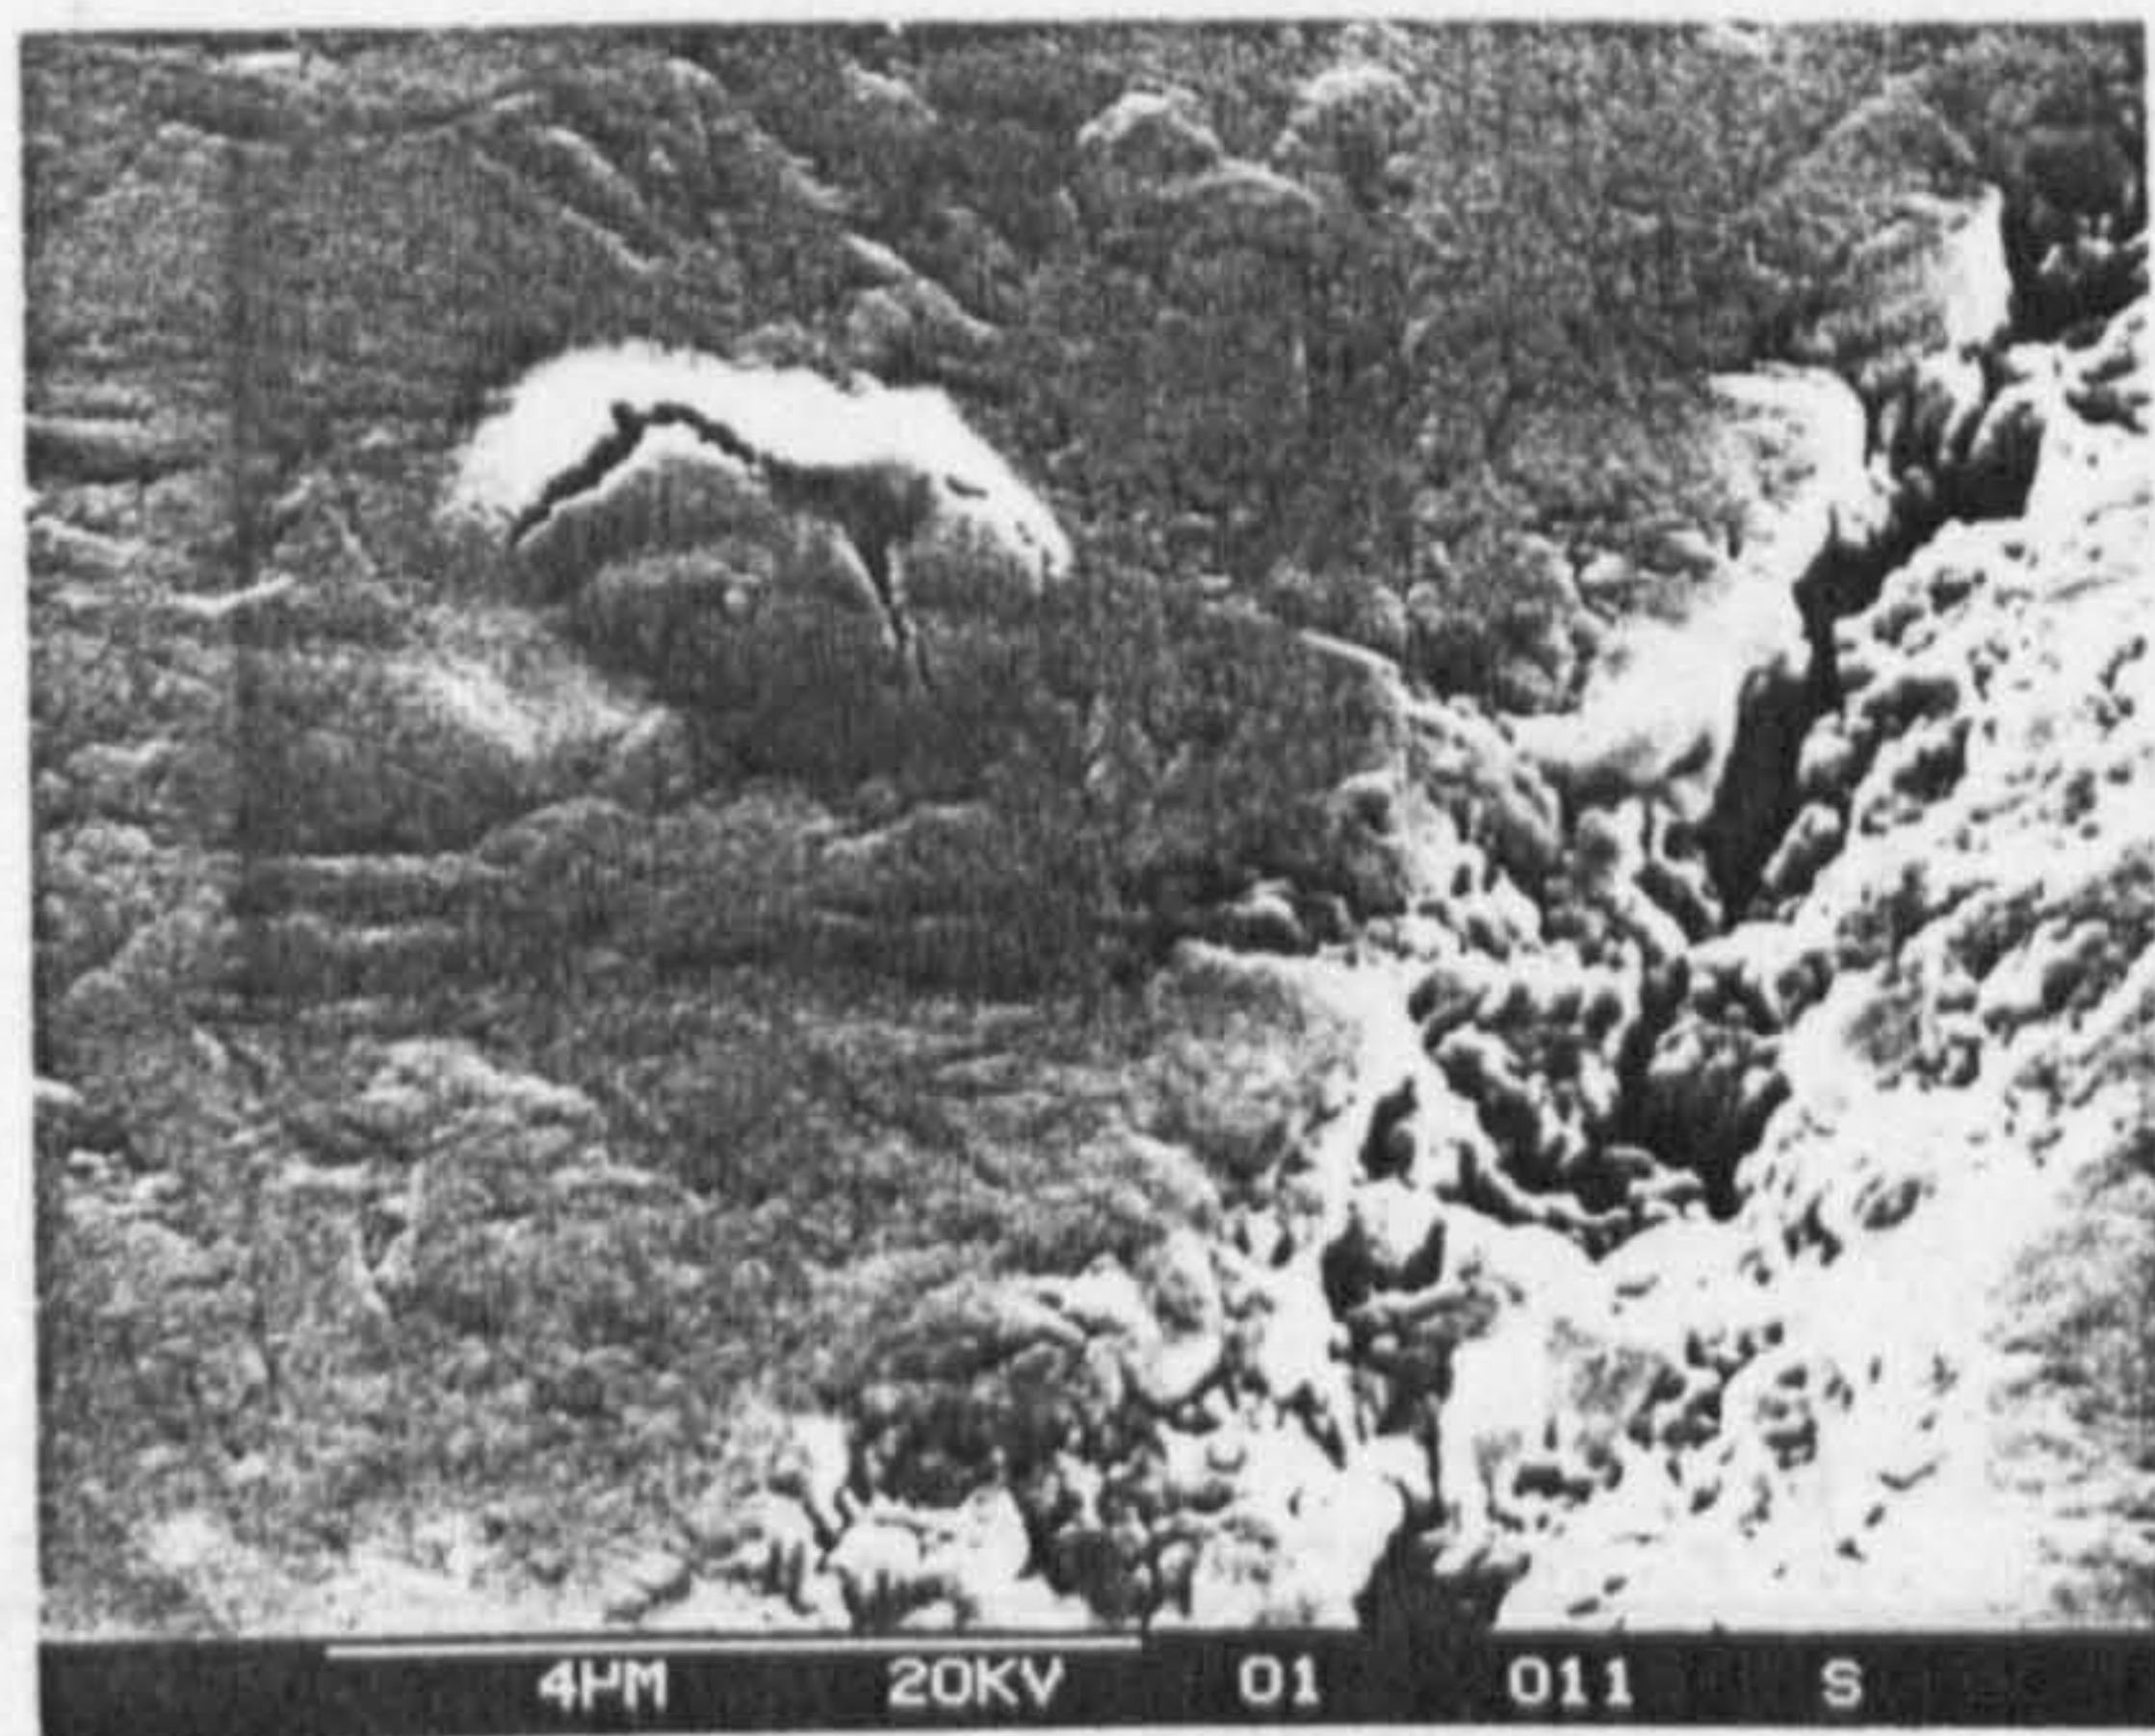
Figure 5.24 Micrographs of lower ceramic ball from test three - captions (a) to (e)

(c) Radial crack - side view

The post-test investigation of test three, figure 5.24 captions (a) to (f), produce The observations from test one provide evidence supporting new failure modes for both lower pre-cracked balls and upper steel ball. By testing with high viscosity oil, delamination occurs on lower pre-cracked balls. The high viscosity lubricant alters the fatigue failure mode by increasing the film thickness between the contacting surfaces. The spalling of the steel upper ball confirms that it also fails due to delamination. Delamination is therefore, not confined to ceramics only and is a genuine fatigue failure mode.

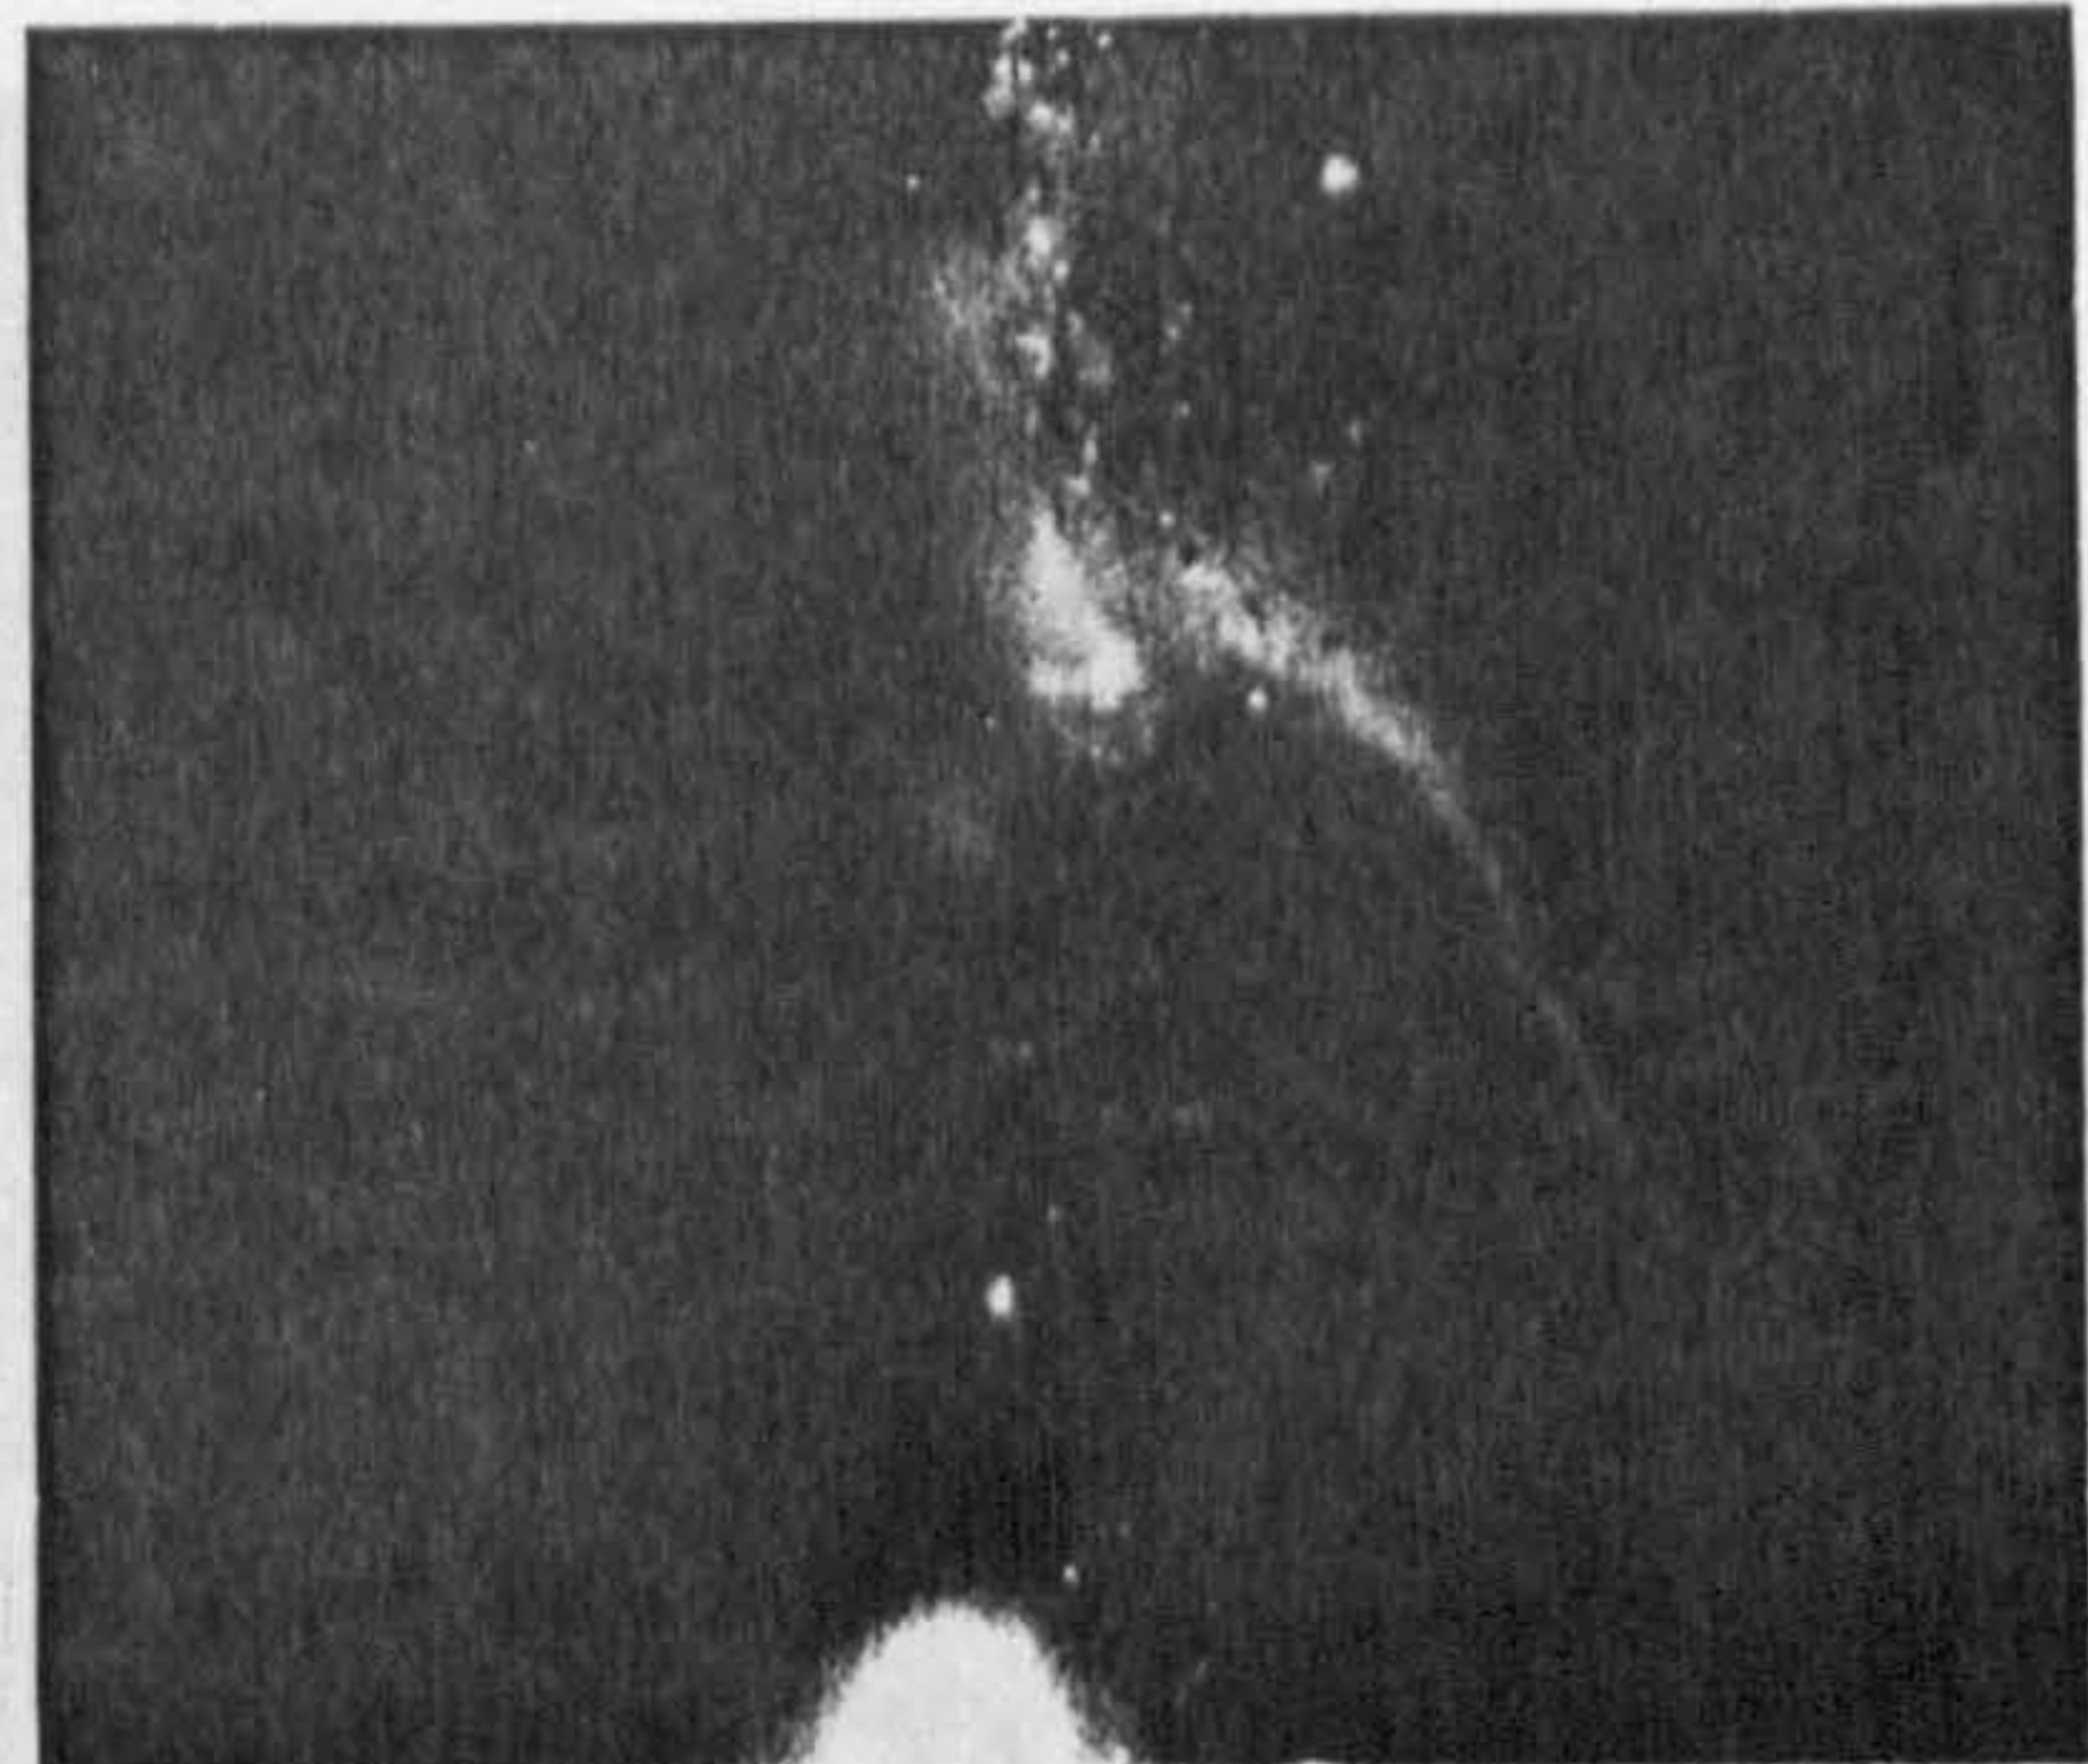
(b) Left crack section, UV x70

Figure 5.28 Photographs of sectioned incipient spall (Ball 'A')

Ball 'A' was sectioned using a diamond wheel close to the ring crack edge. The sectioned ball was then mounted in a thermosetting polymer, ground and then polished with silicon carbide and diamond abrasives. Figure 5.28 shows depth of ring crack penetration after testing. The dye-penetrant was applied before sectioning to insure that viewed crack is not a result of the ball sectioning or grinding operations. The crack can be seen to have propagated from the initial cone root, probably driven by high pressure lubricant.

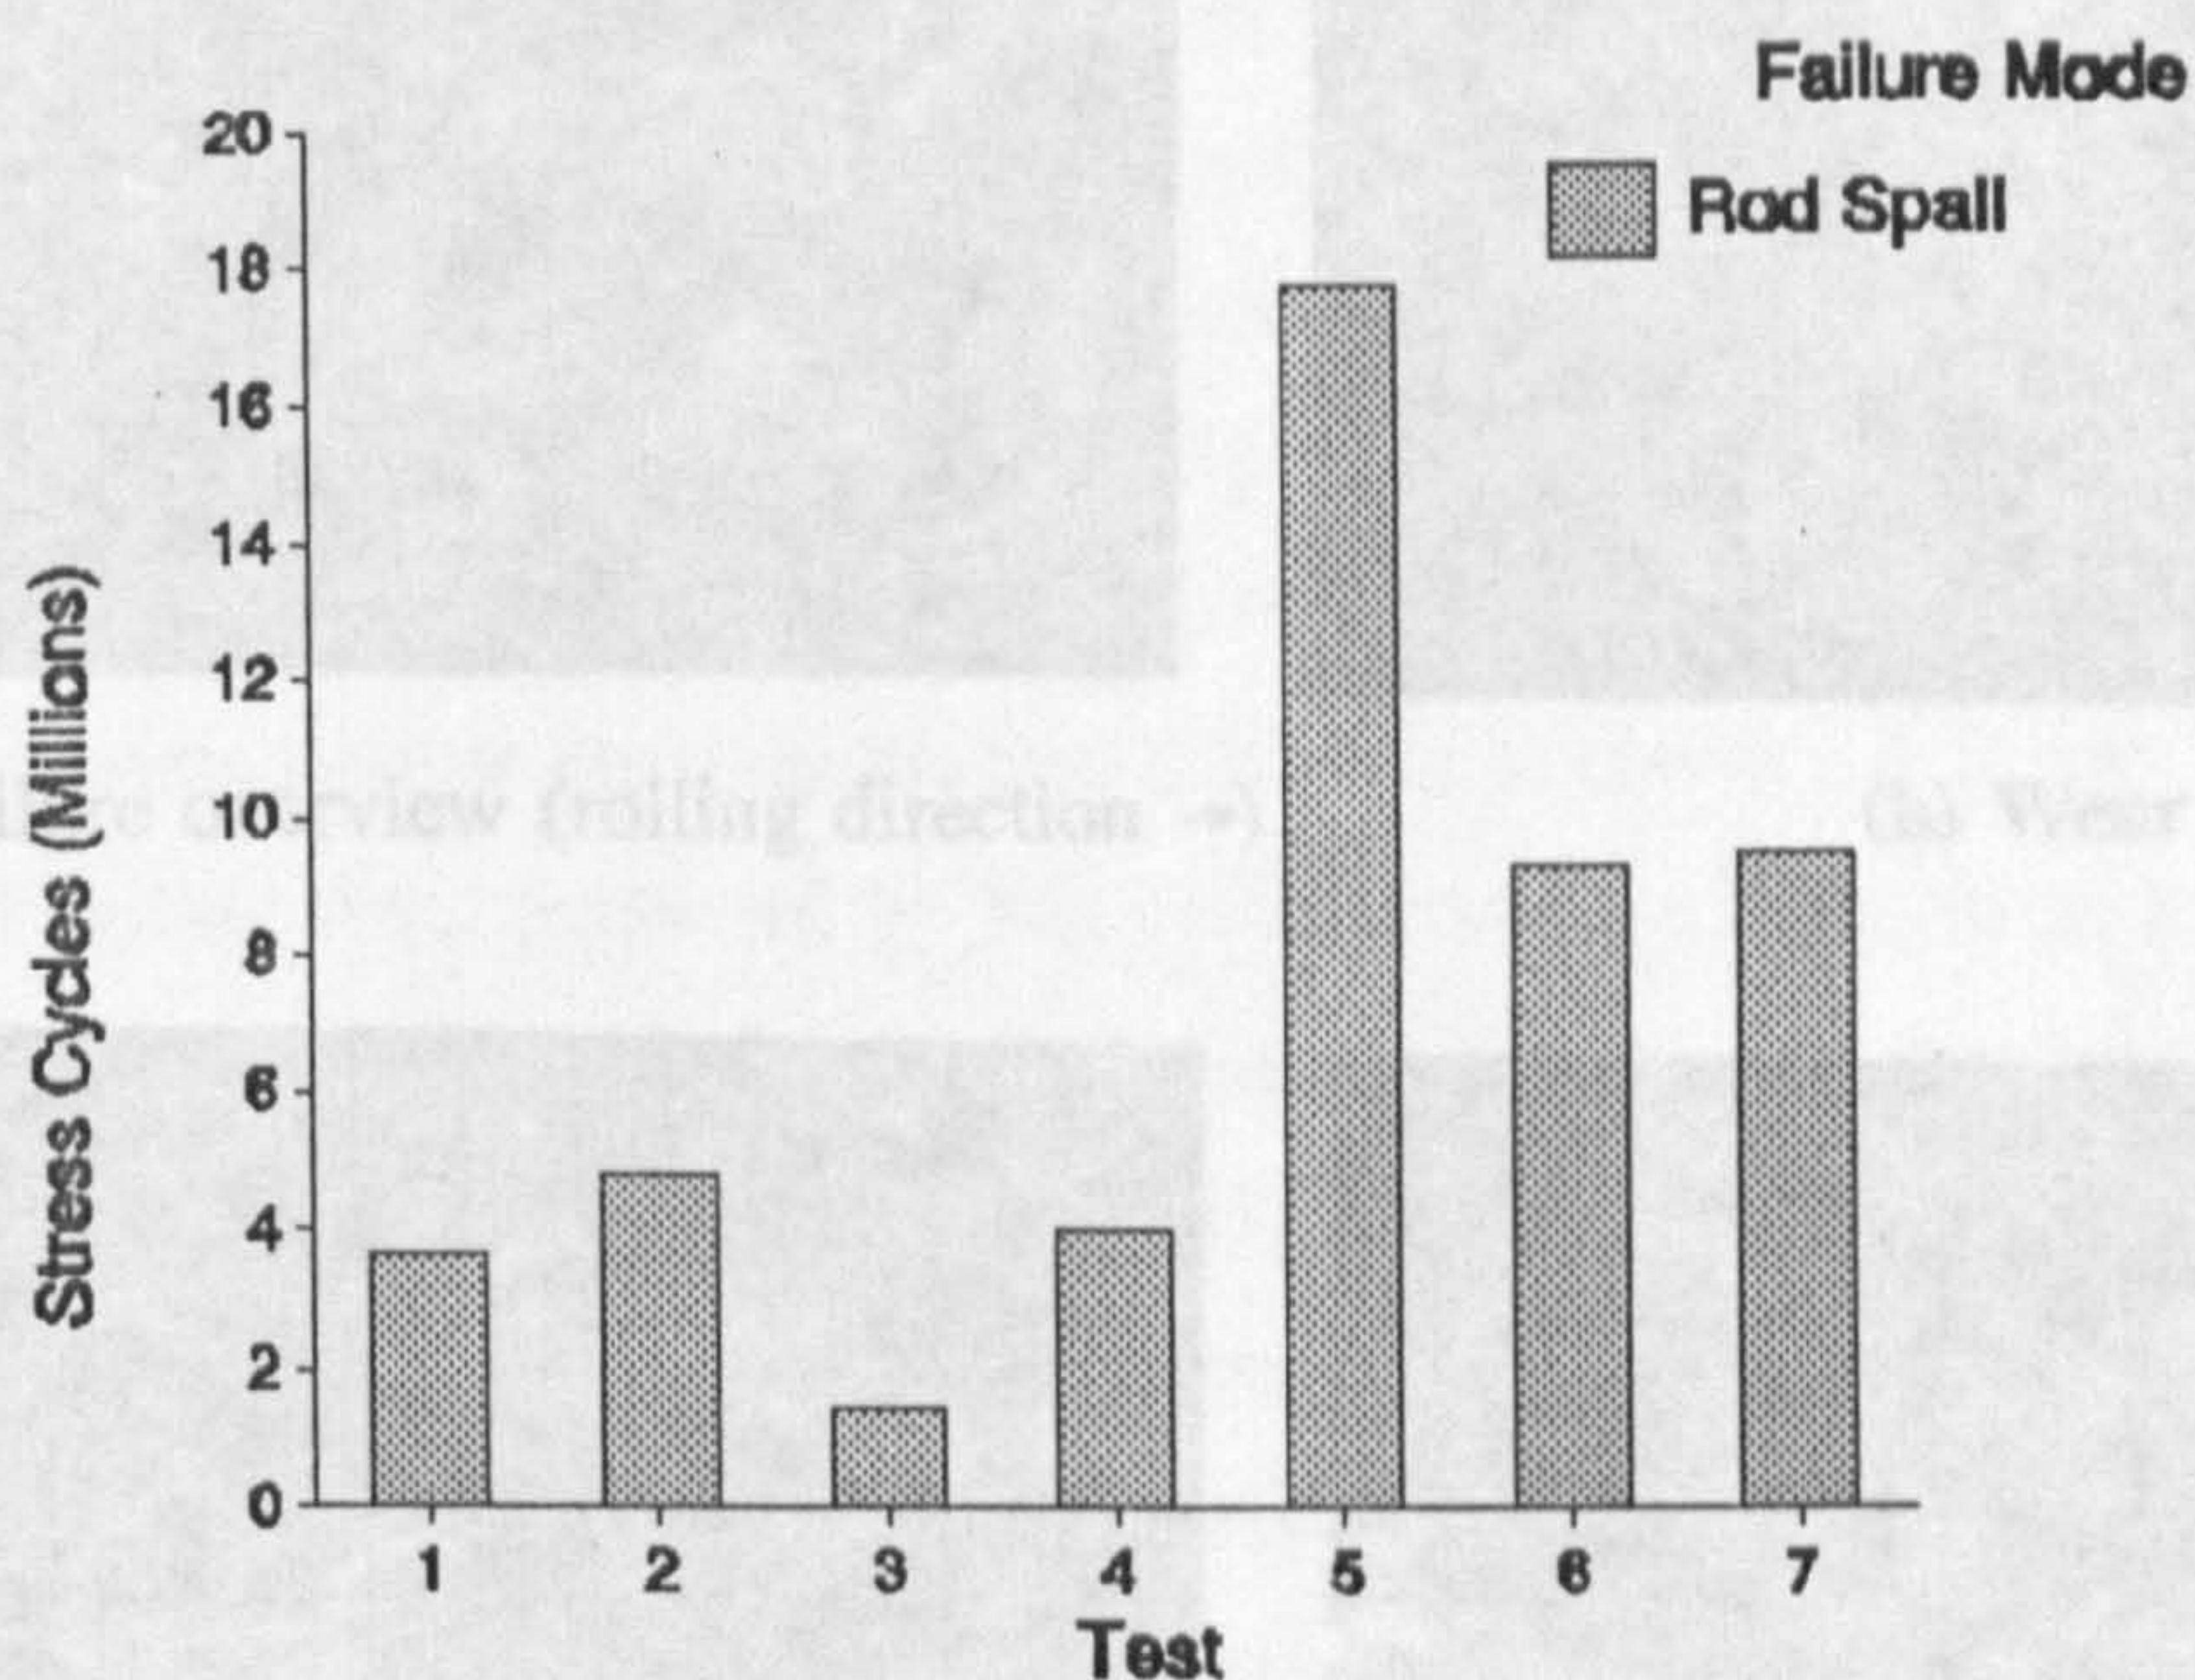
Figure 5.48 Poor grade material rod test results

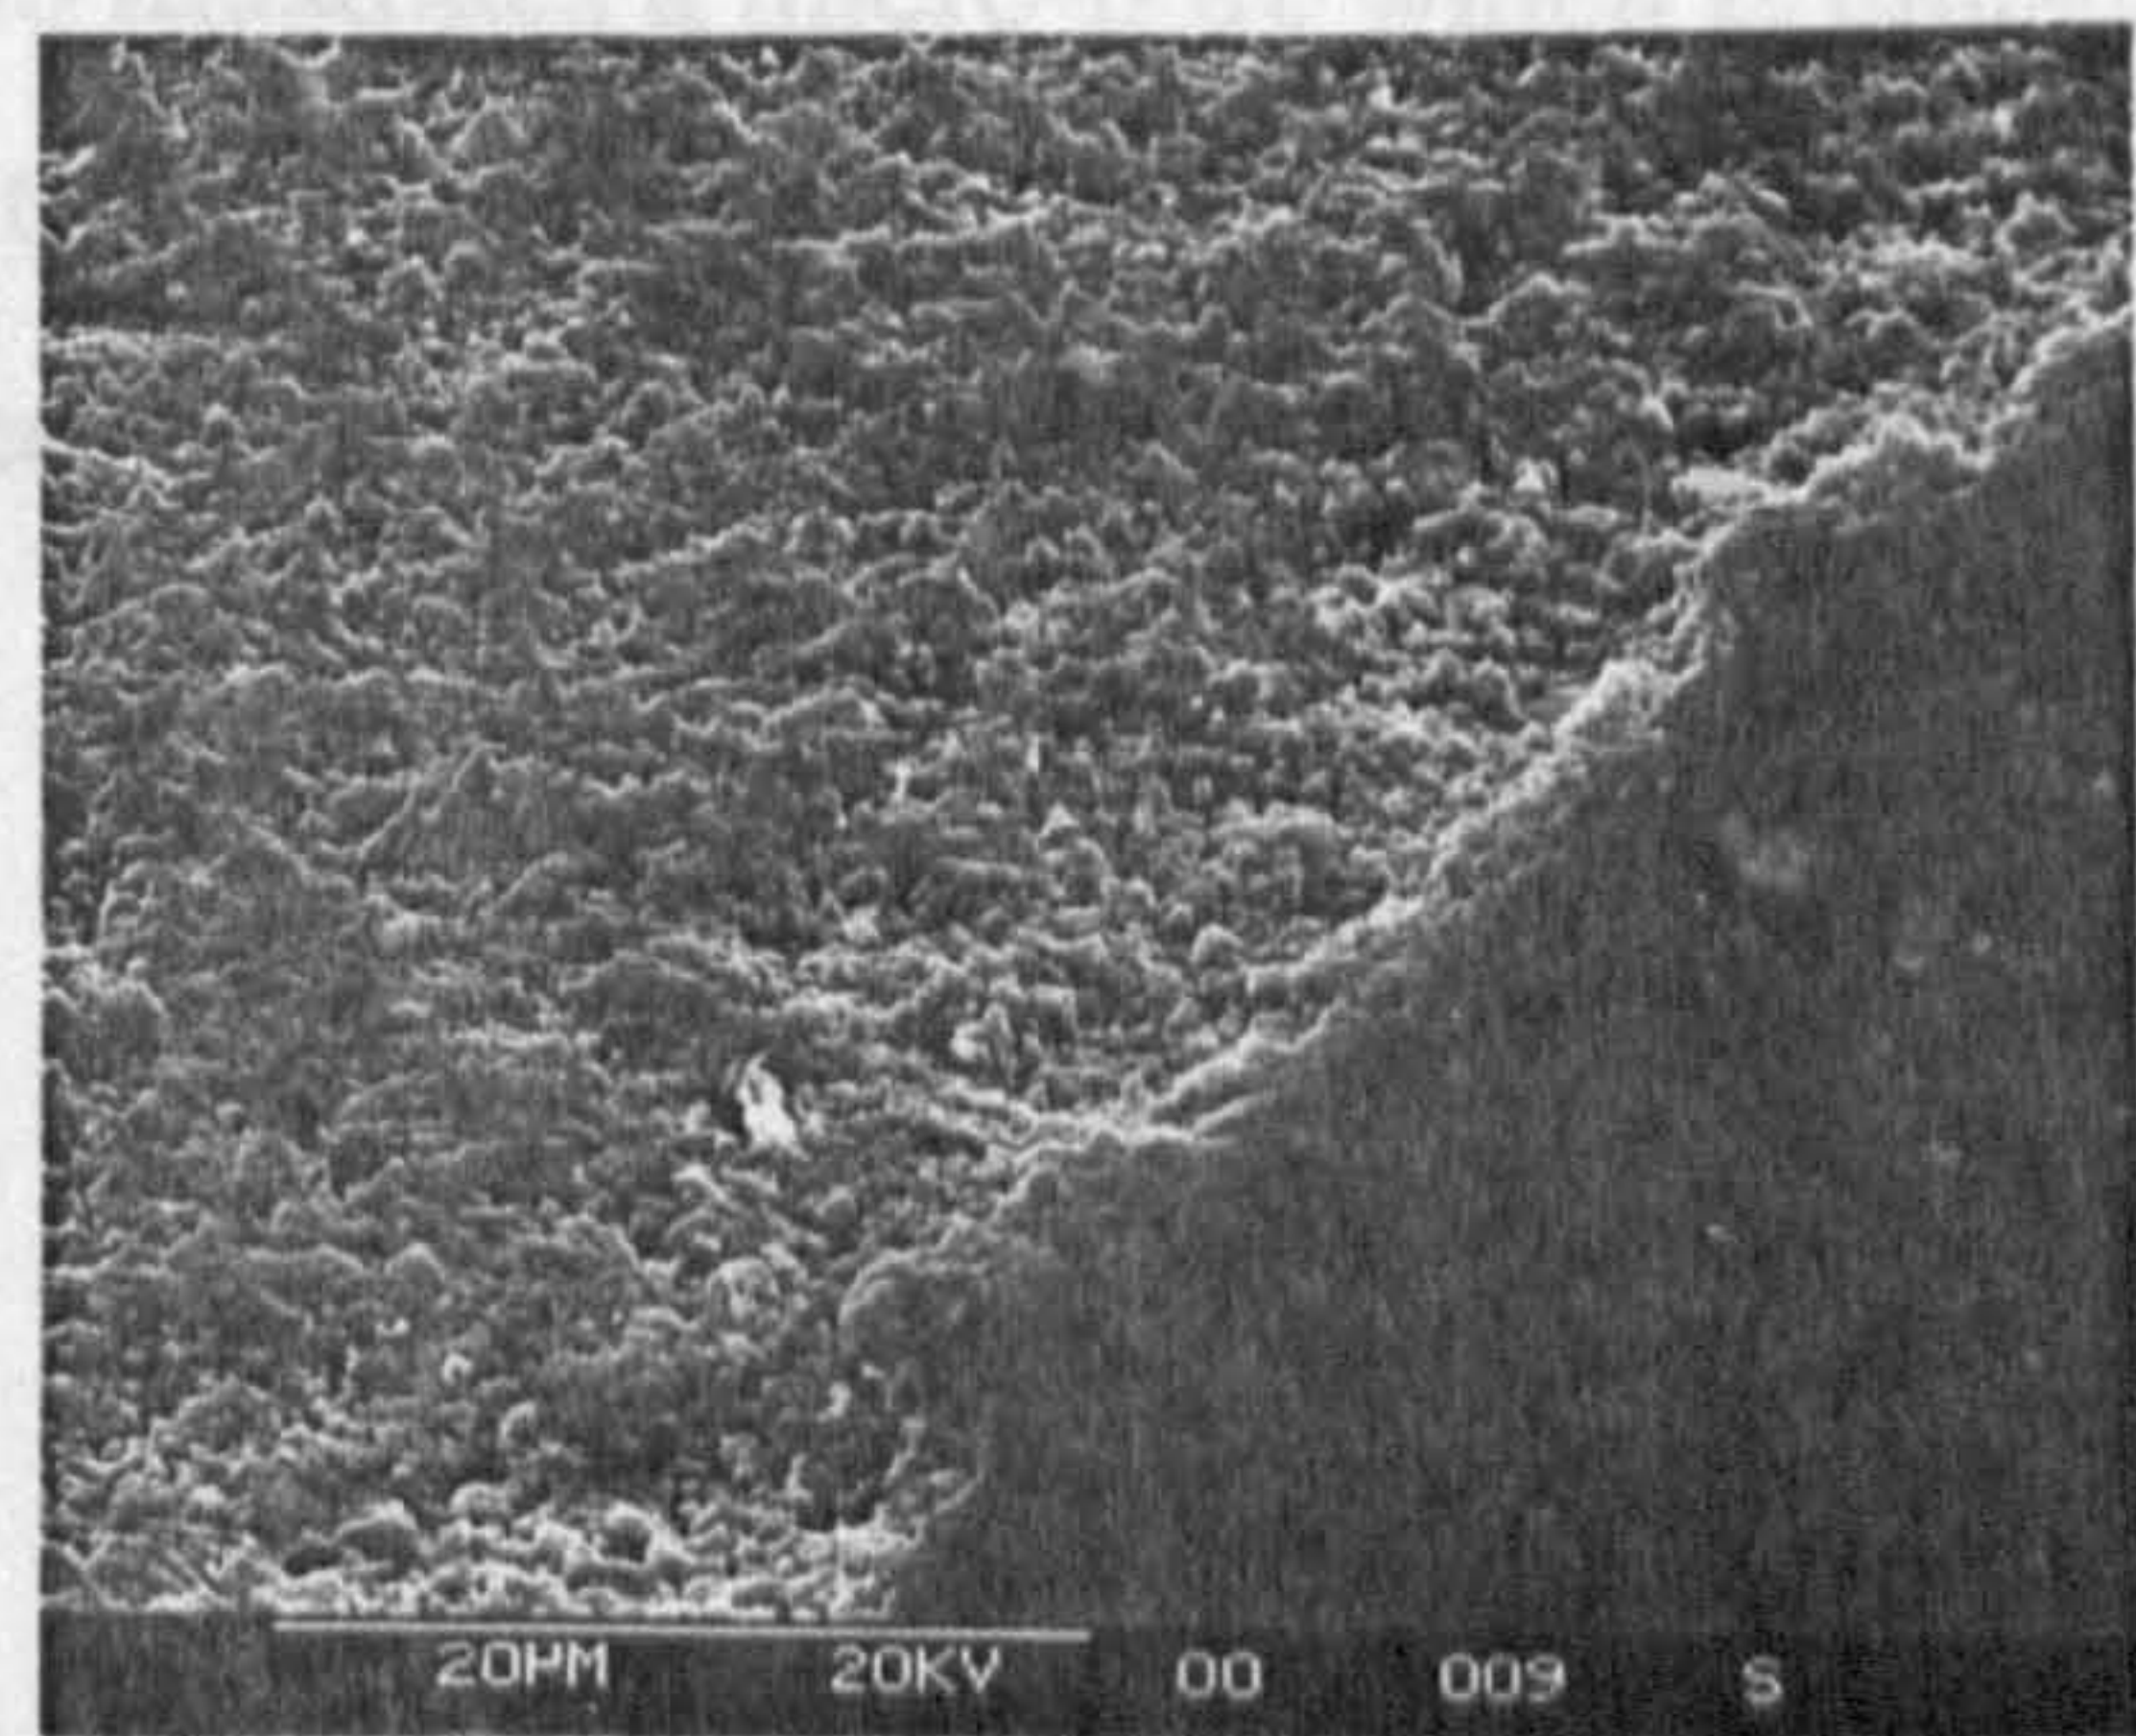
(h) Brittle area edge

Figure 6.3 Example of type 1i3p failure - captions (a) to (h)

Test Conditions of figure 6.3: Ceramic/ceramic contact, machine spindle speed 10,000 r.p.m, inclosed base oil lubricant, bulk oil temperature (59° C) - unheated, 1.6 million upper ball stress cycles, Hertzian maximum compressive stress - 7.1 GPa, theoretical lambda ratio -5.5, Surface roughness (Ra) of upper and lower balls 0.008 µm.

Type 1i3p failures occur in ceramic/ceramic contacts on silicon nitride balls when tested with a base mineral oil lubricant, and high contact stresses (6.0 to 7.1 GPa). The example shown in figure 6.3, captions (a) to (h), is a typical 'brittle flake' shape failure.

Figure 6.3, captions (a) to (h), presents a detailed survey of a type 1i3p delamination example. Caption (a) shows an overview of the failure with dimensions of 1.8 by 1.25 millimetres. The topography of brittle initiation and propagation over
