# THERMAL SEGREGATION OF ASPHALT MATERIAL IN ROAD REPAIR

Juliana, BYZYKA  
Ph.D. Researcher  
Brunel University  
United Kingdom

## ABSTRACT

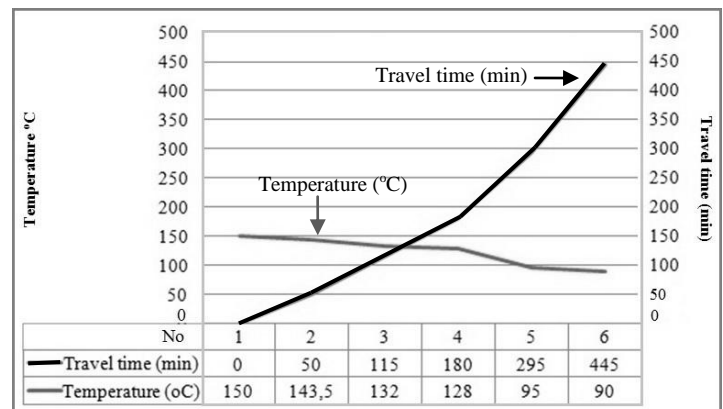
Figure 3: Asphalt temperature variation and transportation time between asphalt production facility and each repair site

There was an initial drop in temperature of 5 °C after 50min of transportation between the asphalt plant and the first repair site. The temperature reduced by up to 22 °C between the initial temperature of 150 °C and that of repair site 4.

There was a sudden drop in temperature between repair sites 3 and 4. The temperature dramatically decreased by 26% reaching 95 °C, a reduction of 37% from the initial temperature of 150 °C. In total the temperature decreased 40% between asphalt plant and repair site 5.

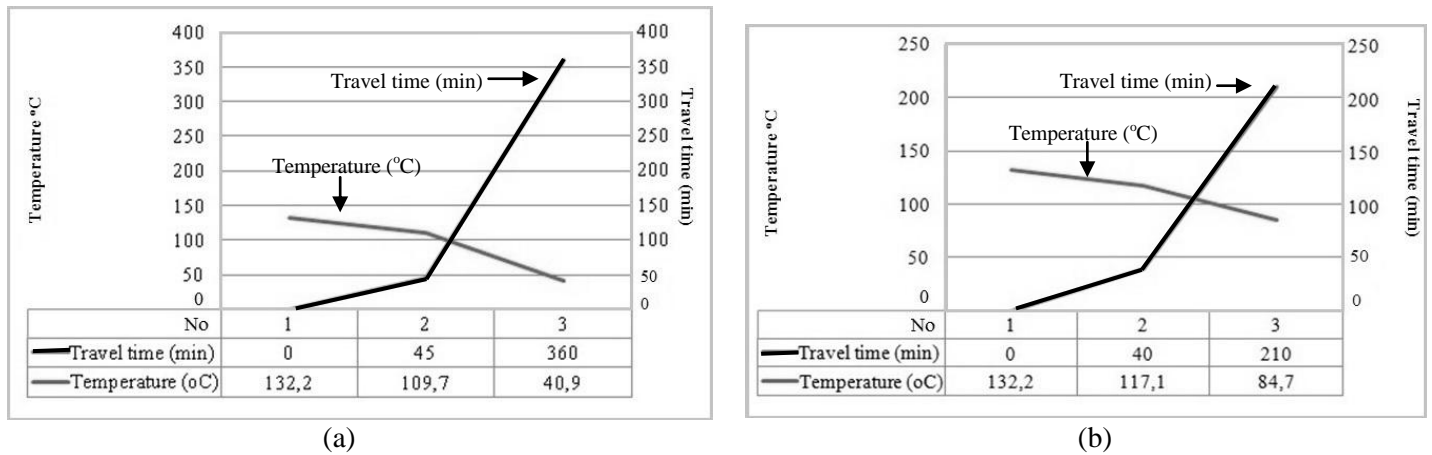
Figure 6: Asphalt temperature variation between asphalt production facilities and each paving site during (a) Day 1 and (b) Day 2

Figures 5 (a), (b), (c) and (d) present the asphalt and its thermal images when arrived at sites 7, 8, 9 and 10 respectively. Figures 6 (a) and (b) demonstrate the temperature variations when asphalt was loaded onto the truck, and when it was arrived on each repair site. As the results display, during asphalt transportation on day 1 there was an overall heat loss of 69% and on day 2 a temperature decrease of 35.9%.
