## Destructive Testing of Open Rotor Propeller Blades for Extreme Operation Conditions

To cite this article: Dacho Dachev *et al* 2018 *J. Phys.: Conf. Ser.* **1106** 012016

**Abstract.** Due to the complexity of composite material, accurate manufacturing is very complicated and carry over a large number of uncertainties, the process of optimization and validation being of primary importance.

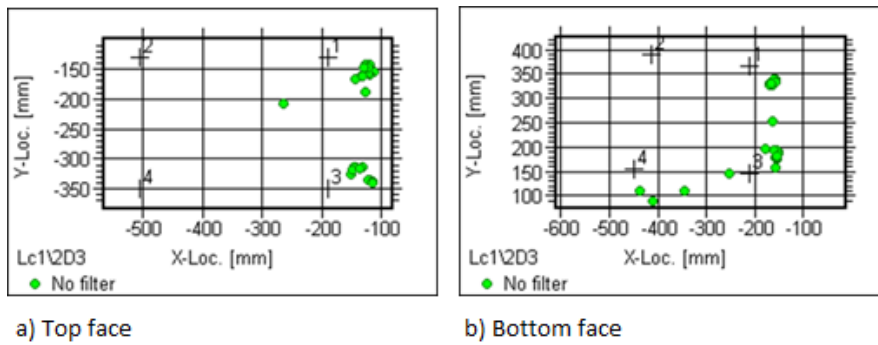
Figure 3: Calibration results for both surfaces of the blade

The test measures the velocity response between the mounted sensors by sending an impulse one to another through PLB and measuring the response with signal attenuation analysis and an average velocity calculation. The results of calibration localization of the generated events on both surfaces are accurate, validating the sensor set-up, as shown in Figure 3a, b. Four sensors are monitoring the root of the blade, where majority of the events are expected to occur based on initial analysis. Another set of four sensors are monitoring the mounting hole, the second most stressed area. Finally, two guarding sensors are introduced to be able to “split” the blade on two sections as shown with the red line on Figure 2. This is going to prevent signals to cross over and to be detected from both sets of sensors.

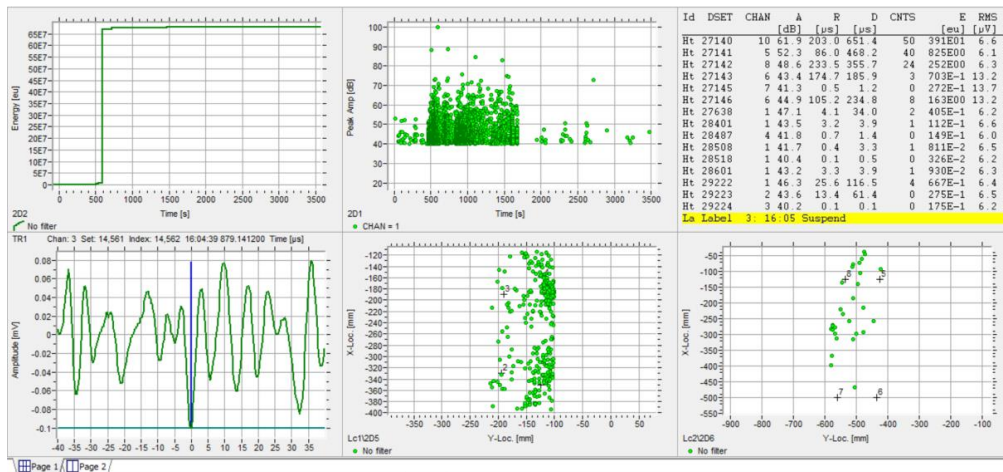
Figure 5: AE test results during the loading program

The tensile test is performed on the blade with a step loading of 1kN schedule from an initial force of 18.42kN increased until safety factors of 3.5 and subsequently of 7 are achieved (Figure 4). In the AE signals the majority of the events detected appear at the root of the blade, with less than expected events detected at the top side of the blade, where most of the events cluster around the hole and may be a result of the contact at the pin connection with the blade. Unexpectedly, events appear at the trailing edge, which could possibly be explained with slightly twisted set-up for the test, which resulted in a stress slightly off the central axis of the blade due to the very complex shape of the blade.

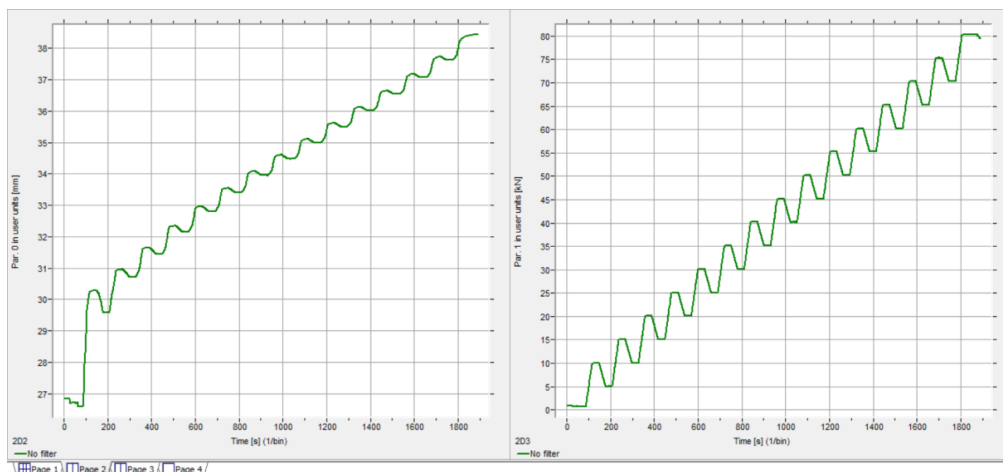
Figure 6: Second test tensile step loading

A second tensile test with a step of 5kN and the time of action of 40 seconds is presented in Figure 6.

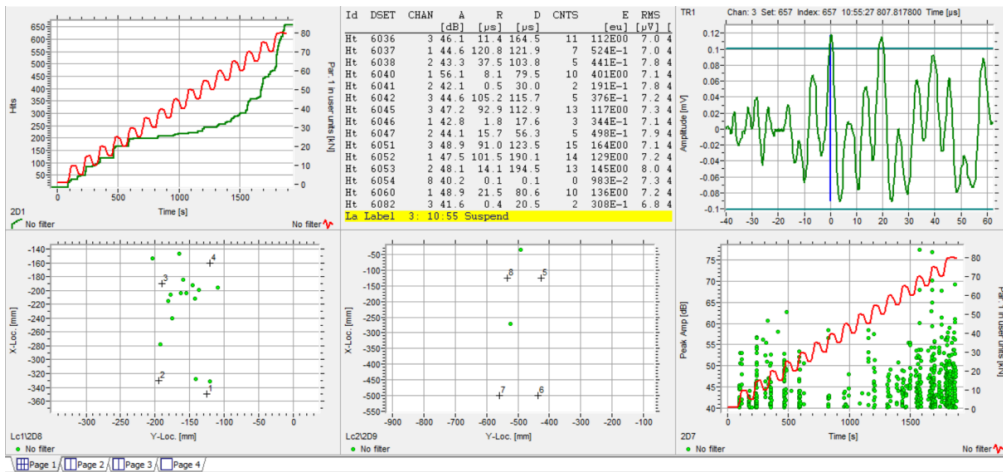
Figure 7: AE test results of the second tensile test

AE signal analysis results from this test are presented in Figure 7. As predicted, the majority of the events appear at the root of the blade. In contrast, the number of events detected in more

controlled environment is much smaller. Noise and events associated to the pin contact are minimized under

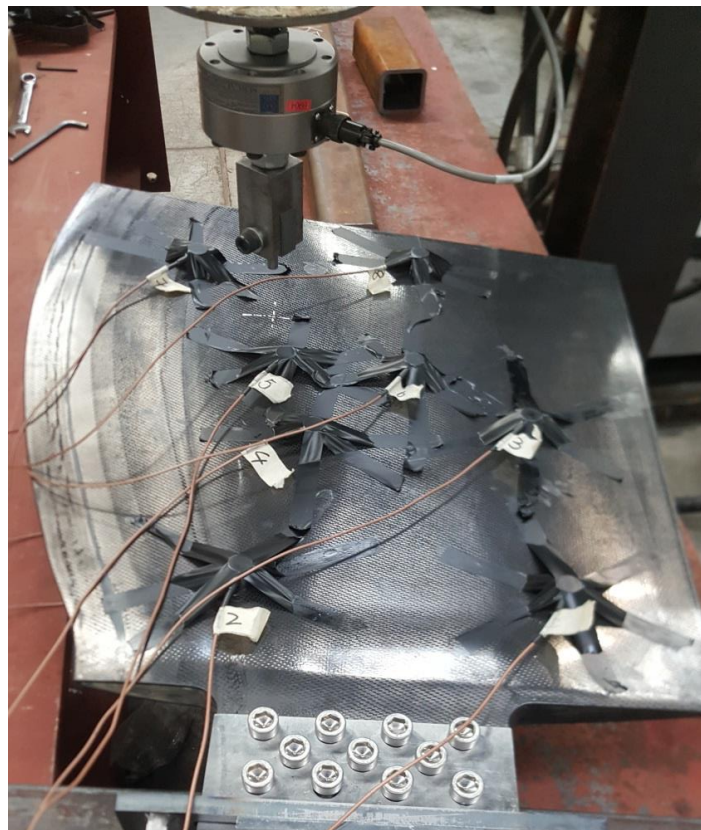
Figure 8: Test set-up and sensor configuration for the flexural test

these test conditions. In the second phase a bending test was carried out, so that the blade can be validated with safety factor 3.5 with four sensors positioned to capture and locate any event that occurs in the root area (Figure 8).

Because the load is going to be applied over relatively small area and the surface of the blade is not perfectly flat, noise can be produced in the area of contact, due to pin slip or damage as result of the concentrated stress. For that reason two guarding sensors, 5 and 6 in Figure 8, have been positioned above the main four, so any noise generated at the stress application point cannot be captured by the main sensors. Finally, two additional sensors 7 and 8 on Figure 8 have been added to monitor the top area of the blade, above the guard sensors, in case that event occur in an area not predicted by the numerical modelling simulation. A load program shown and the measured signals are shown in Figure 9.

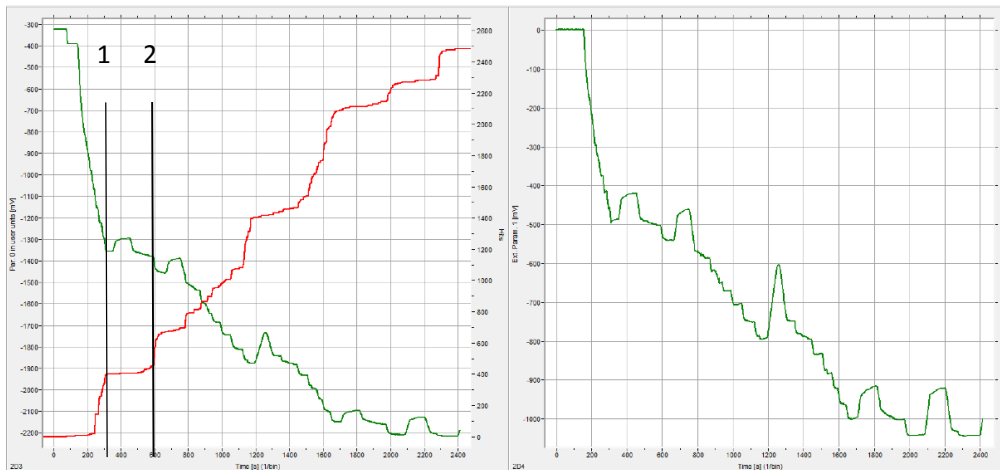
Figure 9: Load and AE cumulative hits variation with identification of the Kaiser Effect

These graphs allow a clear correlation of the AE signals with the load variation and the identification of the Kaiser Effect.

During the blade experiments, the Kaiser Effect was put in evidence, this being typically observed in testing of metallic elements but not usual for composites.
